# An Assessment of Barriers to Fish Passage in the Crane River Catchment

June 2016

*Crane Valley Partnership*

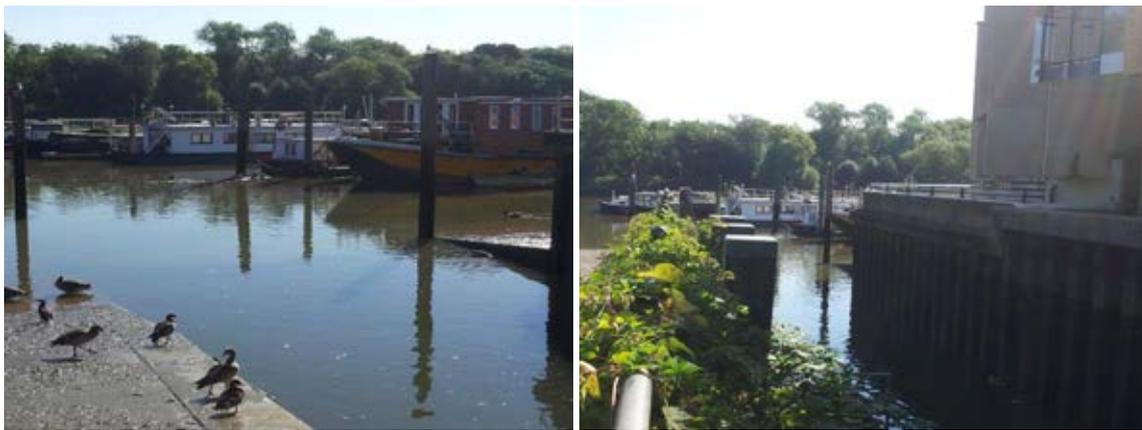
Figure 3.1.1.3a (left): At high tide, the Crane-Thames Barrier is submerged. This shows the barrier's location viewed from upstream at the left bank

Flow conditions	Passability score	Reason/s
Coarse fish	Low	0	Water depth; Step water depth; Height of step
	High	1	Barrier submerged at high tide but not at high flows.
Juvenile eels	Low	0	No substrate present; Water depth
	High	1	Barrier submerged at high tide

Flow conditions	Passability score	Reason/s
Coarse fish	Low	0	Water depth, height of barrier and number of steps may be damaging to downstream migrants.
	High	1	Barrier submerged at high tide
Adult eels	Low	0.3	Water depth, height of barrier and number of steps may be damaging to downstream migrants.
	High	1	Barrier submerged at high tide

- *Consideration of options:*  
Due to low flow conditions in summer months, easement options are limited. A maximum water depth of 4cm was taken at the crest of the structure. Technical fish passes such as larinier fish passes require a minimum depth of 10-15cm for large coarse fish, with the head of water running above the baffles of the pass not exceeding 0.5m (EA, 2010). A larinier fish pass may also be prone to blocking with debris due to the cross current of the Thames at high tide. Other options such as rock ramps also require certain depths of water to allow fish to ascend them. The provision of a 2 staged channel above this barrier may lead to improved water depths and flows at low tide. Rock ramps are prone to erosion however and may be damaged by to the cross current of the Thames at high tide.

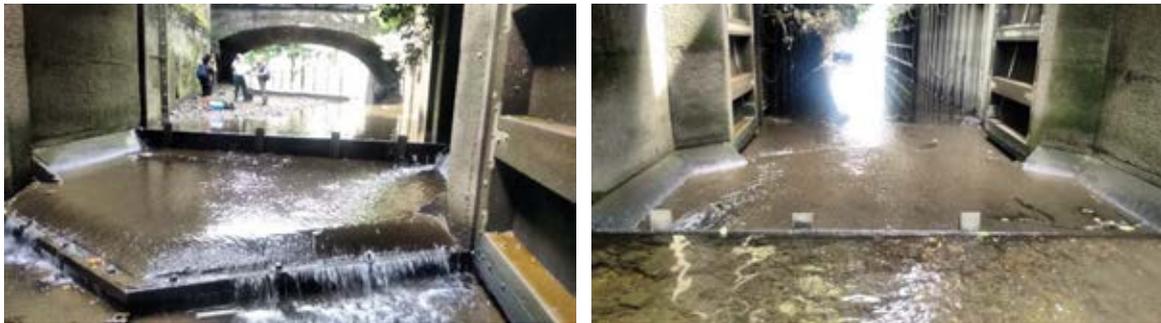
*Figure 1.2.3a (left): Tidal Crane Barrier 1 from viewed from downstream*

Flow conditions	Passability score	Reason/s
Coarse fish	Low	0	Water depth; Hydraulic head
	High	1	Barrier submerged at high tide
Juvenile eels	Low	1	No substrate present but sufficient depth of water to pass
	High	1	Barrier submerged at high tide

Flow conditions	Passability score	Reason/s
Coarse fish	Low	0	Water depth
	High	1	Barrier submerged at high tide
Adult eels	Low	0.3	Water depth
	High	1	Barrier submerged at high tide

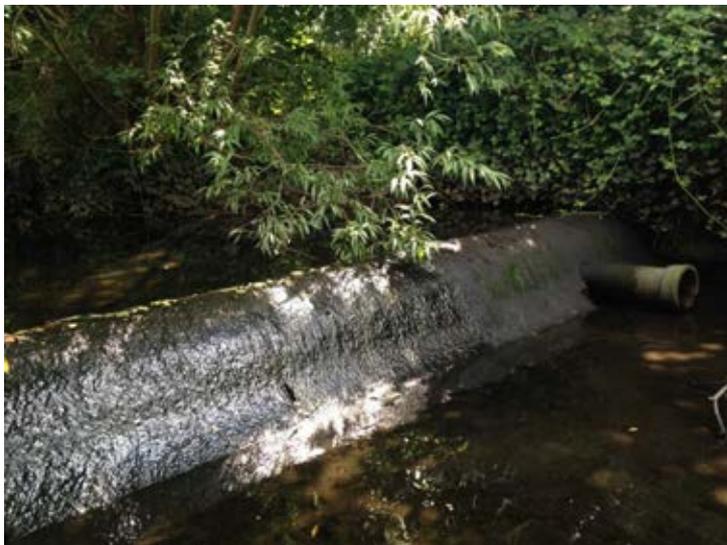
Figure 3.1.5.3a: Tidal Crane Barrier 4 viewed from downstream at right bank

Flow conditions	Passability score	Reason/s
Coarse fish	Low	0	Water depth; Hydraulic head
	High	1	Barrier submerged at high tide
Juvenile eels	Low	1	Climbing substrate present
	High	1	Barrier submerged at high tide

Flow conditions	Passability score	Reason/s
Coarse fish	Low	0	Water depth
	High	1	Barrier submerged at high tide
Adult eels	Low	0	Water depth
	High	1	Barrier submerged at high tide

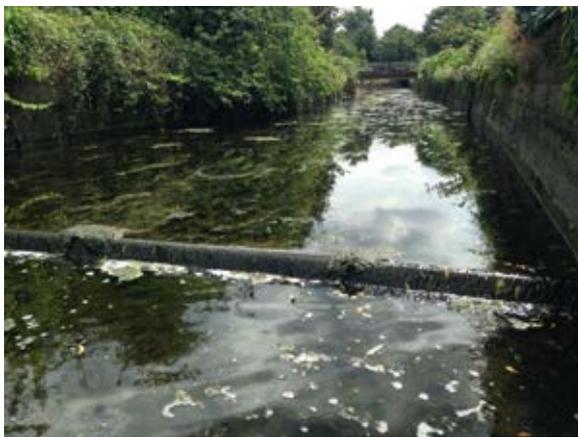
Figure 3.1.6.3a (left): Tidal Crane Barrier 5 viewed from downstream at left bank

Flow conditions	Passability score	Reason/s
Coarse fish	Low	0.6	Hydraulic head
	High	1	Barrier submerged at high tide
Juvenile eels	Low	1	Climbing substrate present
	High	1	Barrier submerged at high tide

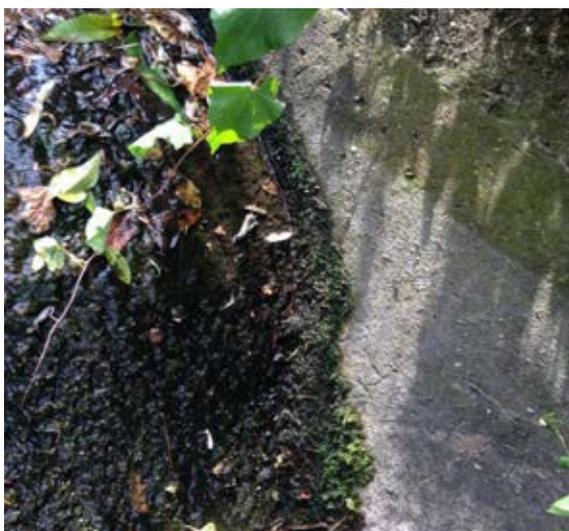
*Figure 3.1.8.3c: Potential eel climbing substrate at Tidal Crane Barrier 7*

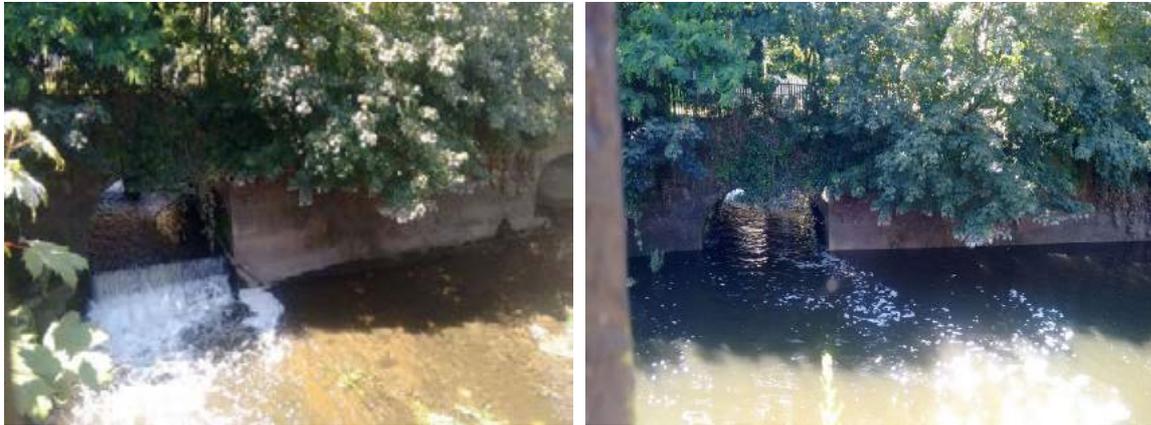
Figure 3.2.2.3a (left): Stepped barrier at low tide. Eel pass is visible at the left bank.

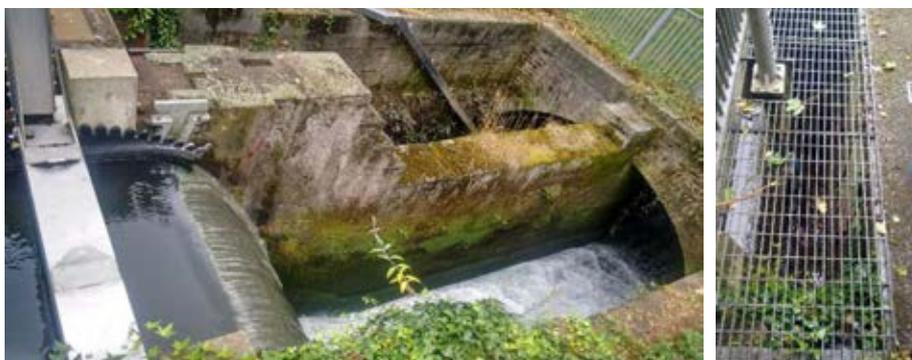
Figure 3.2.3.3c (left): The assessed vertical weir for Kids Mill Sluice viewed along the crest at right bank.

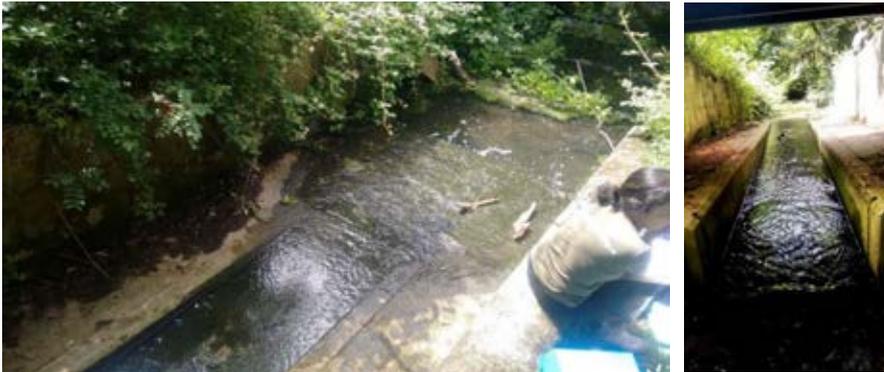
*Figure 3.4.1.3a (left): Sloping concrete section of the weir viewed from upstream at right bank.*

*Figure 3.4.1.3b. (right): Sloping section of the weir viewed at mid channel from downstream.*

The stepped barrier at the Mill Streams confluence with the Crane at Crane Park (283977; see section 3.4.1) may not be suitable for easement. At the time of survey, there was a very small amount of water passing over the barrier which may limit its suitability for easement techniques. Options for consideration are discussed in the results section.

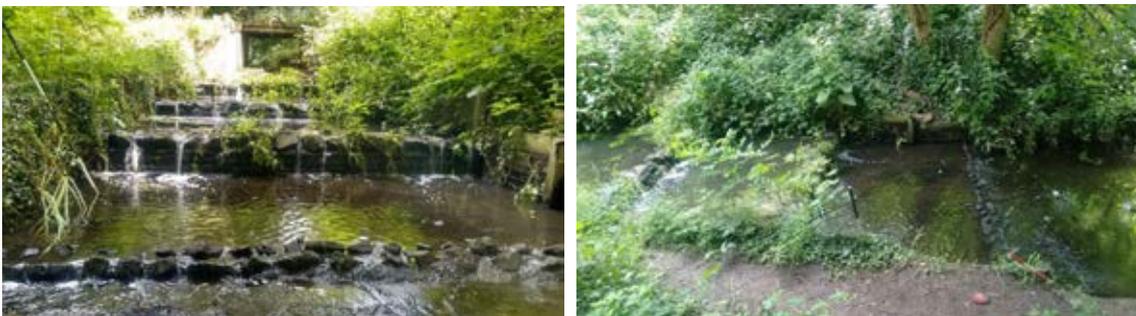
*Figure 3.4.1.3c (left): Steps made from poured concrete and masonry. Photo taken at right bank from downstream.*

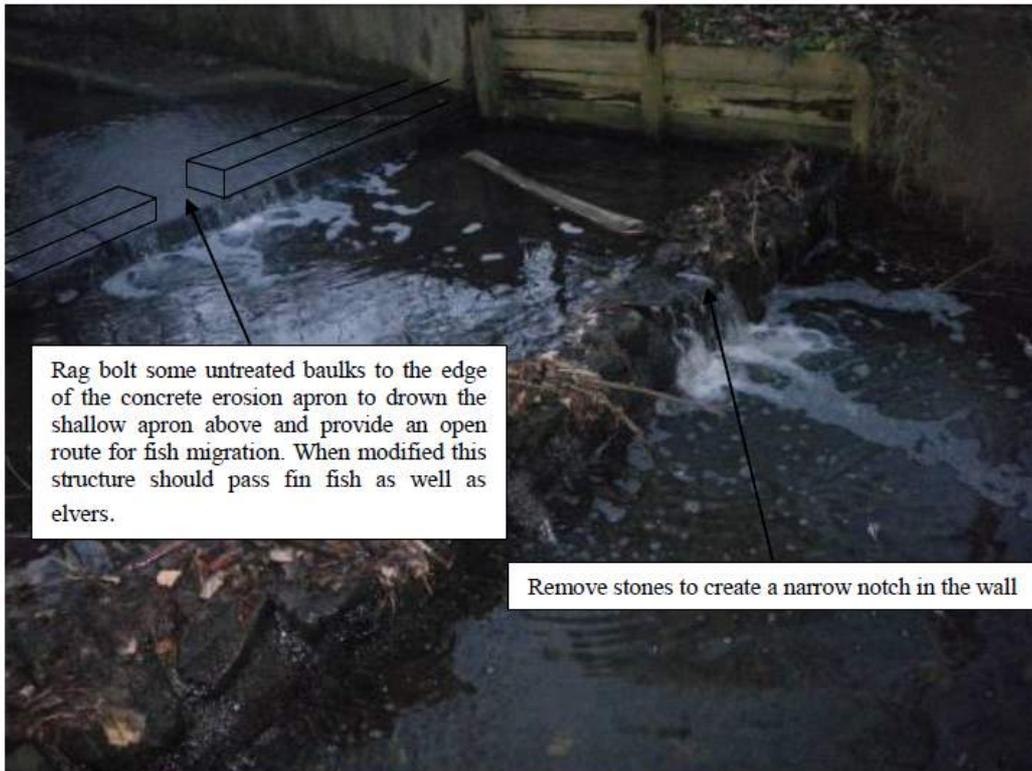
Figure 3.4.1.11a: Recommendation for barrier easement provided by the Wild Trout Trust

At the time of survey there was very little water passing through the structure, so it is uncertain whether these measures would be effective for improving fish passage at low flows. Notching each step could potentially lower the water depth of each step or cause them to dry out completely. Such an improvement may improve fish passage at high flows however.

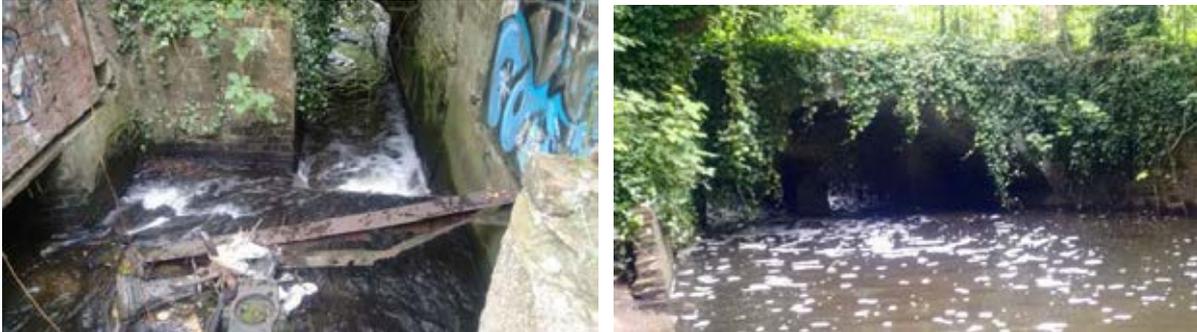
Figure 3.4.2.3a (left): Viewed from upstream, the chute on the left directs the flow of water to vertical drop where it gets culverted and opens up downstream

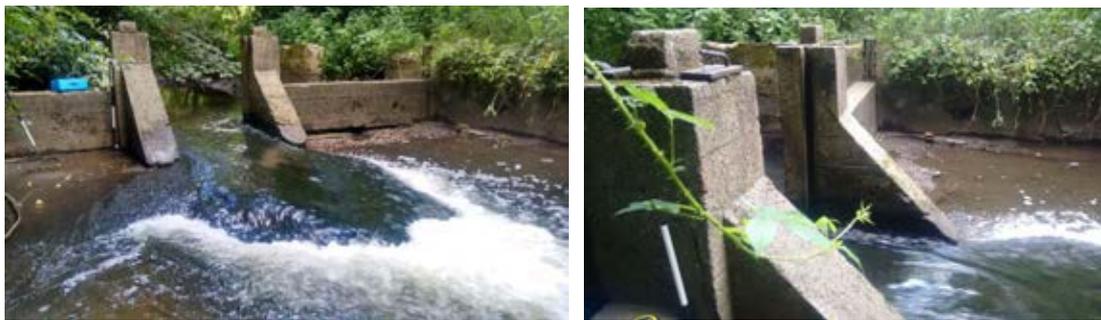
Figure 3.4.3.3b (right): Mill Stream Barrier 3 viewed along the crest from right bank showing the large breezeblock structures on either side of the weir.

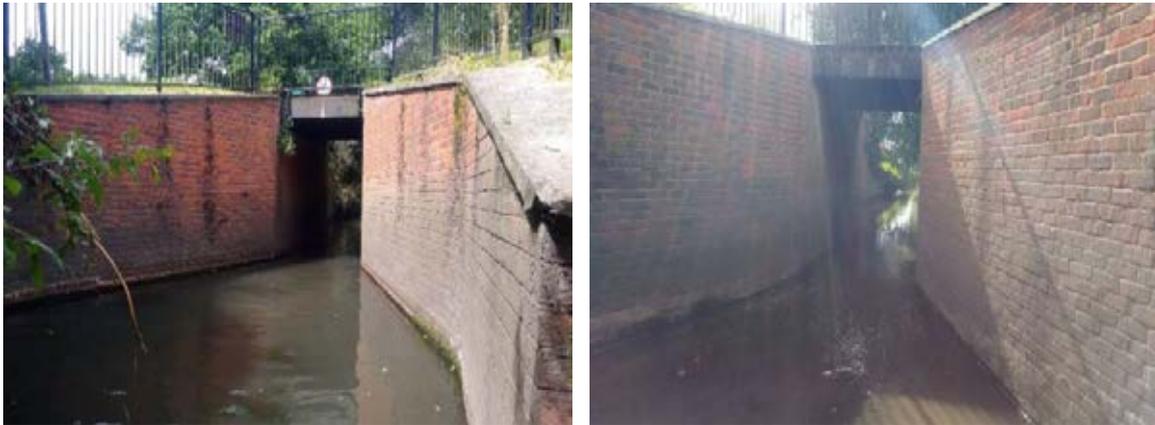
Figure 3.6.1.3a (left): Gutteridge Woods Barrier 1 viewed from upstream showing the hydrobrake narrowing the river channel

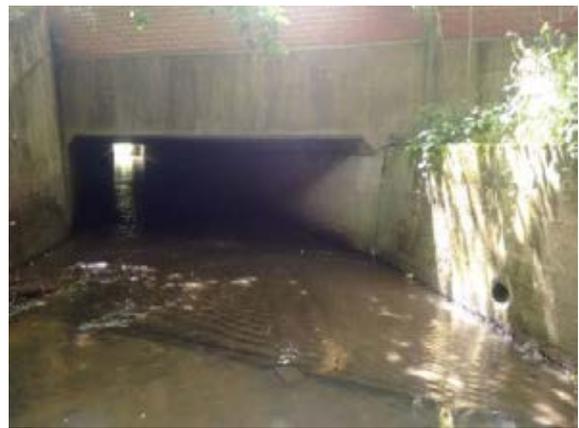
*Figure 3.6.2.3a (left): Gutteridge Woods Culvert viewed from downstream. There is a vertical drop at the outlet of the culvert.*

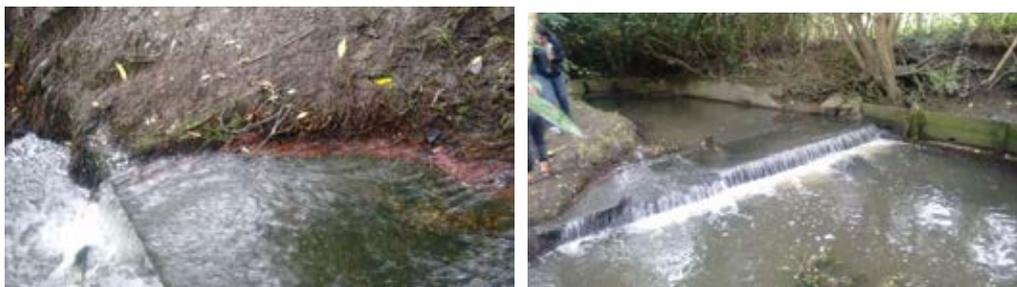
Figure 3.6.3.3c (left): Mossy, rocky and muddy ground sloping into the river at the right bank provides good climbing substrate for juvenile eels

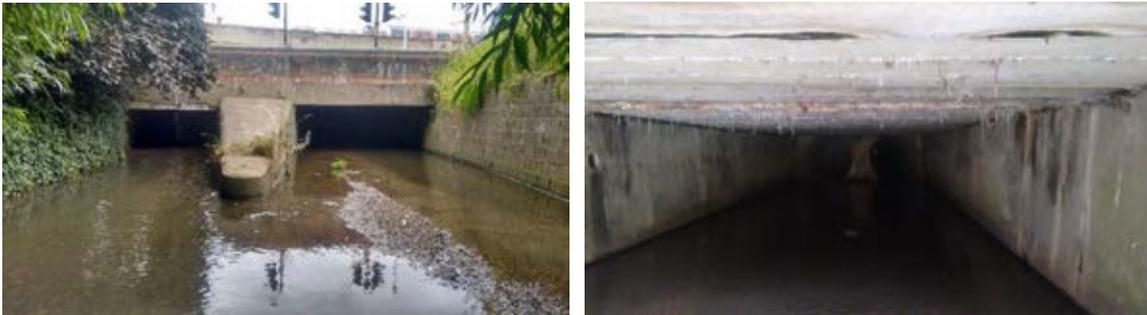
*Figure 3.6.5.3a (left): Viewed from downstream, the culvert splits into two separate paths separated by a concrete wall.*

*Figure 3.6.5.3b (right): Viewed from downstream, the right channel is further diverted into two pipes*

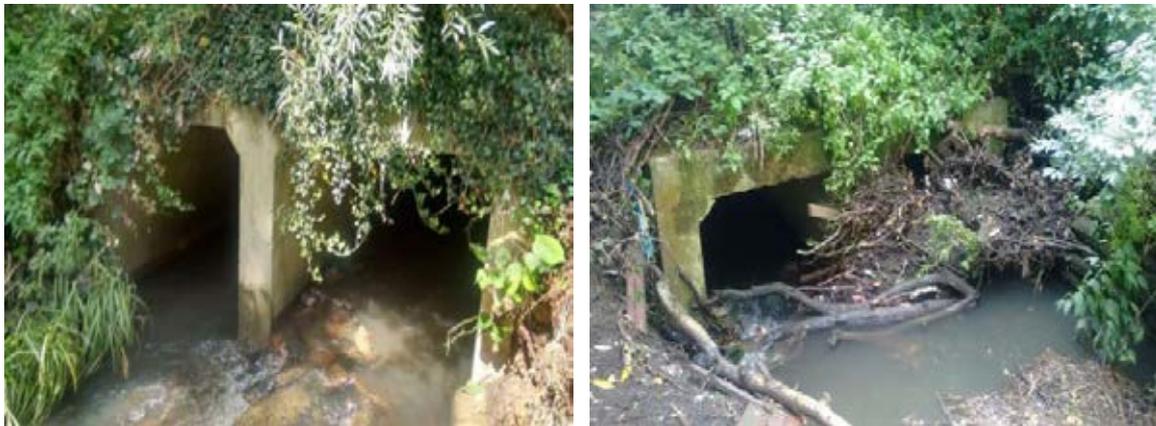
Figure 3.6.6.3a (left): Viewed from downstream, the culvert splits into two tunnels
