Lower Crane Restoration Pilot Project Report

River Crane Smarter Water Catchments Project

February 2023

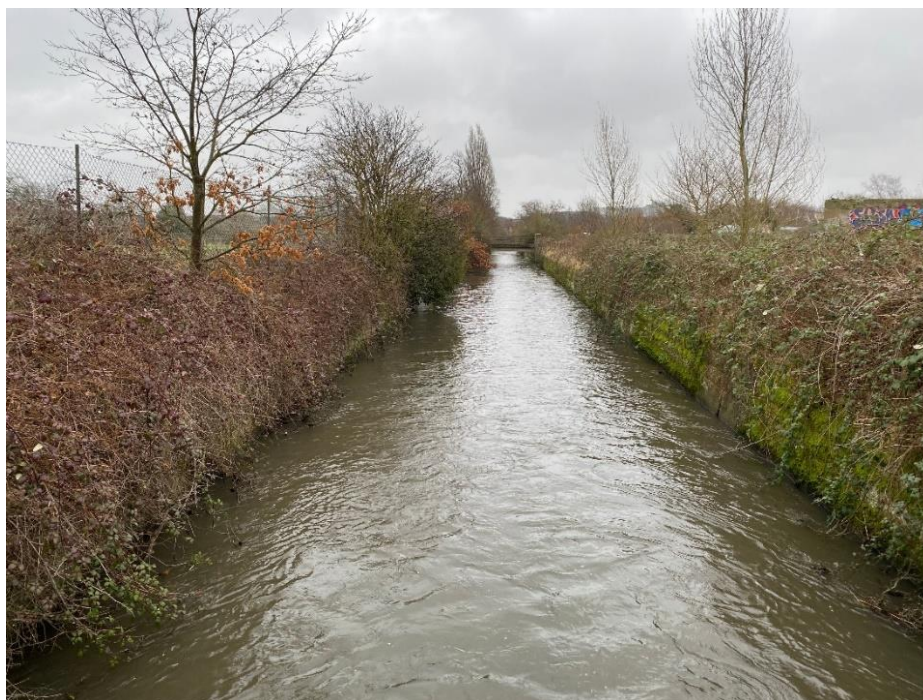
Figure 2.2: Image of lower Crane channel at the restoration site prior to improvement works. Credit: ©Wild Future.

A feasibility and options appraisal report carried out by Atkins prior to restoration in April 2019 highlighted that the Lower River Crane's significantly modified and artificially straightened structure, comprising of a concrete bed and banks, was limiting habitat diversity. The report emphasised that water depth throughout the Lower River Crane was largely shallow with poor flow diversity. In-channel and riparian vegetation were generally restricted to overhanging trees and terrestrial grass and scrub species (Figure 2.2). Some patches of marginal macrophytes were observed within the study area of the report at Craneford Way playing fields. The Atkins report indicated that this heavy modification was likely to significantly limit both instream and riparian habitat quality and biodiversity. Nonetheless, the watercourse was shown to provide a continuous 'green and blue' corridor throughout a predominantly urban environment. Furthermore, prior to restoration works, the Crane water body (2016 survey) had an overall Water Framework Directive (WFD) status of 'Poor', with an ecological status of 'Poor' (including biological quality elements) and chemical status of 'Good'.

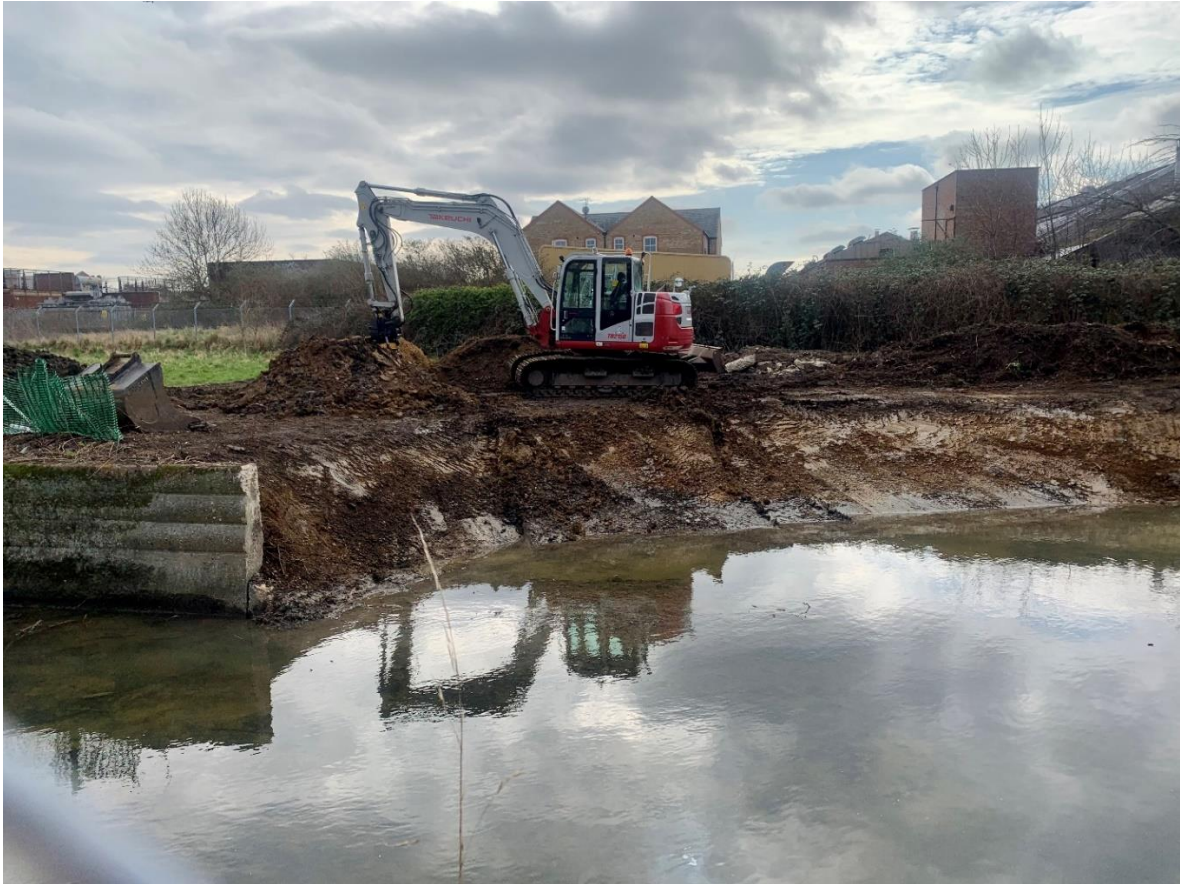
Limited information was available regarding the composition and thickness of the bed concrete and banks prior to construction. However, the width of concrete at the base of the channel walls/banks was not as thick as expected, subsequently making these easier to remove than expected.

Figure 4.1: Digger removing soil and material to create the backwater.

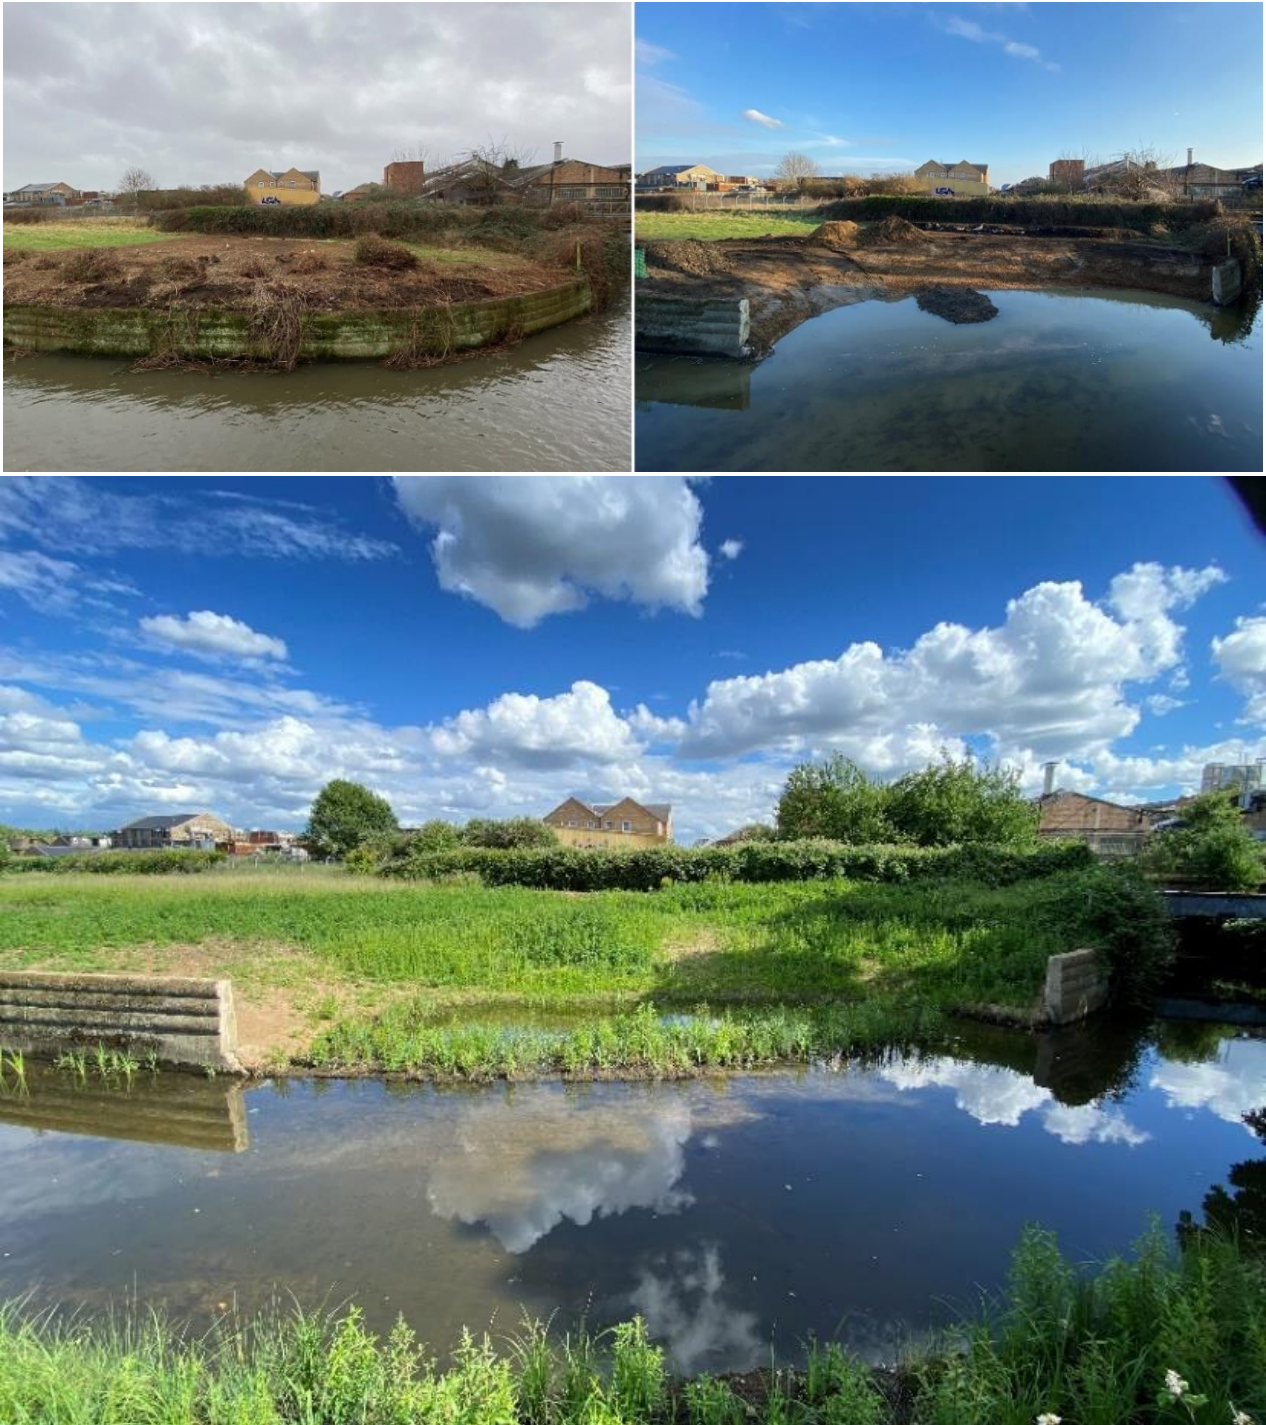
Within the new grassland and banks of the backwater, a large proportion of the wildflowers, plants and seed plugs that were planted/hydroseeded were unsuccessful. This was primarily due to germination rates being lower and slower than expected caused by the prolonged drought period and intense hot weather throughout June, July and August. The hydroseeded area was the main area of disappointment, with slow ground coverage resulting in an increased amount of disturbed ground species that germinated, significantly increasing maintenance requirements. In contrast, plant plugs in the backwater and berm were very successful (see Appendix 3).

Figure 4.3: (Top left) Pre-restoration, (Top right) Immediately following excavation work, (Bottom) Post-completion summer 2022. Credit: ©Wild Future.

Maintenance may therefore have to be considered more carefully, potentially increasing watering at the site to promote planting success. In addition, adjusting the timing of planting to take place immediately after works were completed would stabilise banks but also help to prevent undesirable plant species establishing at the site.

Timing of the project could also be adjusted/delayed to late summer, with an aim to complete by late September/early October to promote more successful seed growth and ensure better resilience to low flows and more intense dry weather conditions.

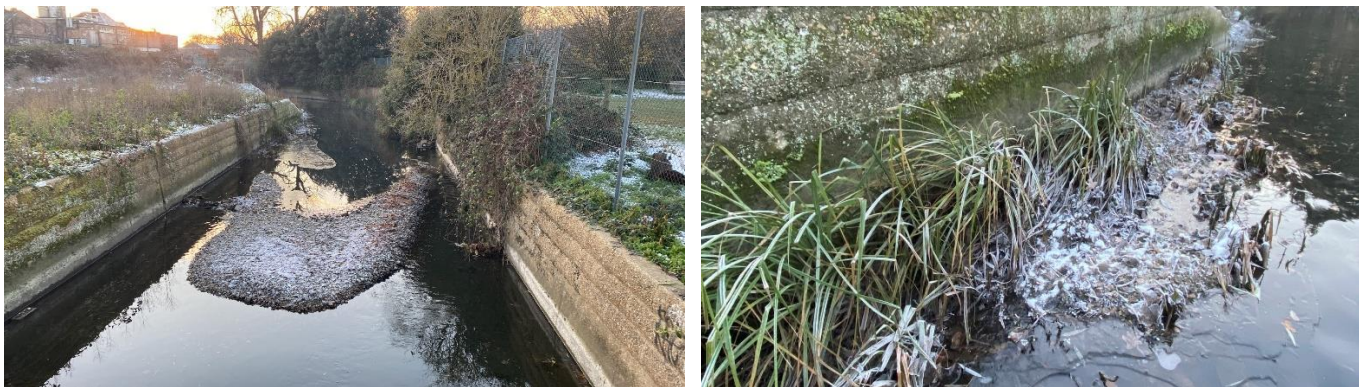
Heavy rain in early winter has mobilised large proportions of the gravel that was added as part of this restoration project into a bar across the channel at the downstream end (see Figure 4.4), with some being lost downstream of this site completely. Where planting has been carried out along the southern edge of the channel, added gravels have remained stable. Therefore, discussions are underway for an additional 40 tonnes of larger sized gravels to be added to the site.

Figure 4.4: (Left) Bar created by gravels that have been washed out of the restoration site due to heavy rainfall and subsequent high flows. (Right) Gravels retained within the planted areas of the restoration site. Credit: ©Wild Future

- Monitoring of the backwater habitat under 'normal' flow conditions should be undertaken. During periods of higher flows, the backwater has the potential to act as a refuge habitat for fish and invertebrates and should therefore be revisited.
- Monitor the movement of the gravels (through marking the upstream extent and assessing movement downstream) to gather further information on substrate suitability and the potential need to stabilise existing gravel substrates and/or consider larger substrate (e.g., cobble or boulder) augmentation within the channel.
