# Improving Fish Migration in the Crane Catchment

March 2022

UK Conservation Programme

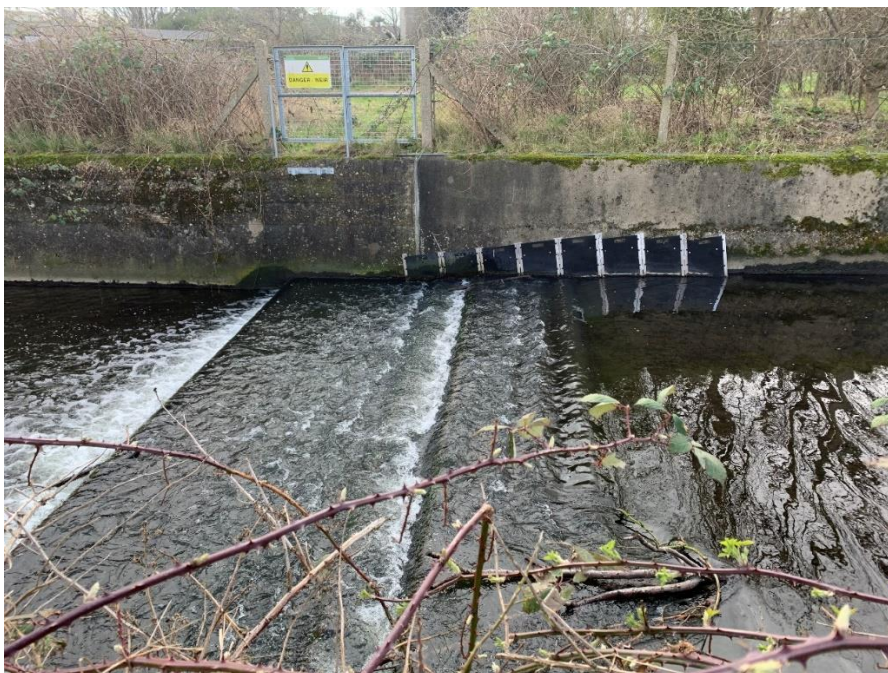
**Structure Name:** Mereway Barrier 1, ID: 192274 (LWT, 2016)

**Figure 4.1:** Image of improvements made to Mereway Barrier 1.

**Improvements:** Installation of baffles and eel tiles

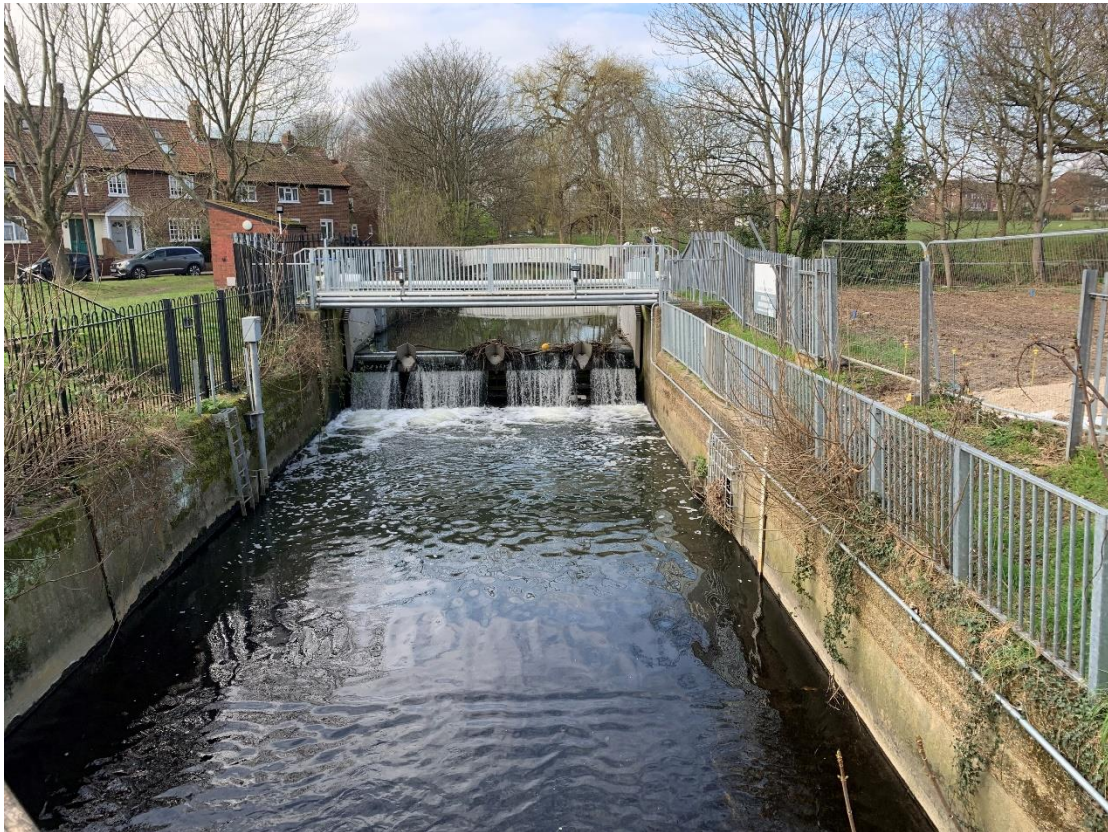
**Structure Name:** Mereway Barrier 4, ID: 192278 (LWT, 2016)

**Figure 4.2:** Image of Mereway Barrier 4 taken prior to improvement works commencing (10/03/2022).

**Improvements:** Management of the weir has changed to ensure that there is continuous flow in the lower Crane. In addition, the Environment Agency are in the process of adding a new 50m channel incorporating a spill way and Larinier fish pass to this structure to link the lower Crane to the upstream river system for the first time.

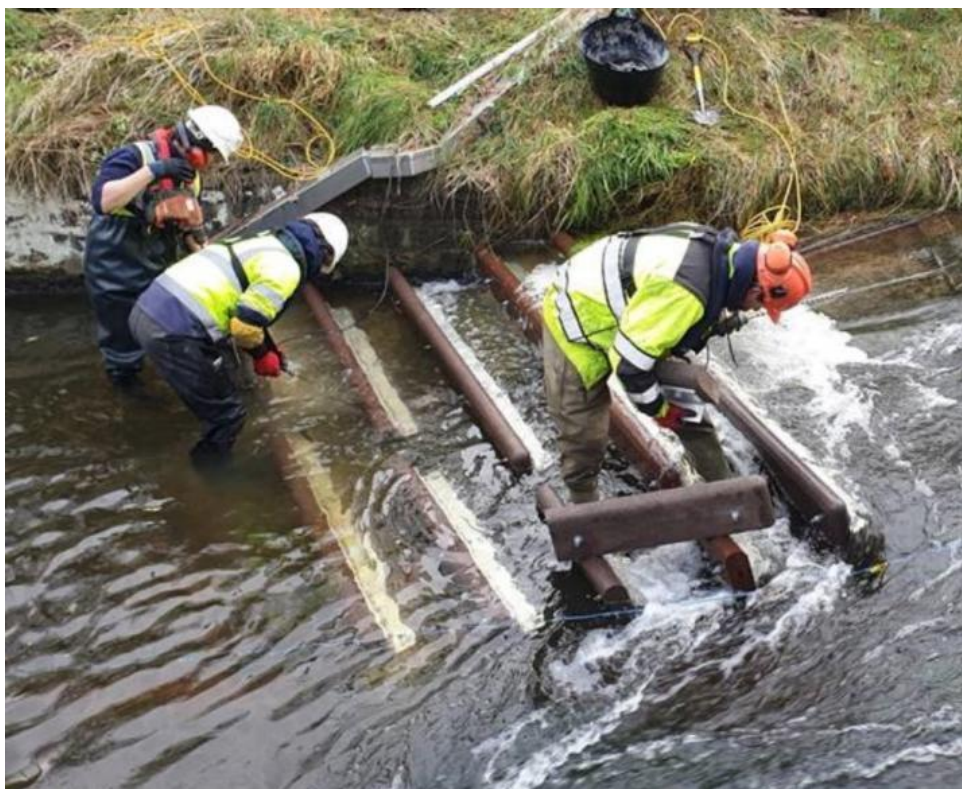
**Figure 4.3:** Image of improvement works (fish pass installation) being carried out by FishTek at Mogden Barrier 3.

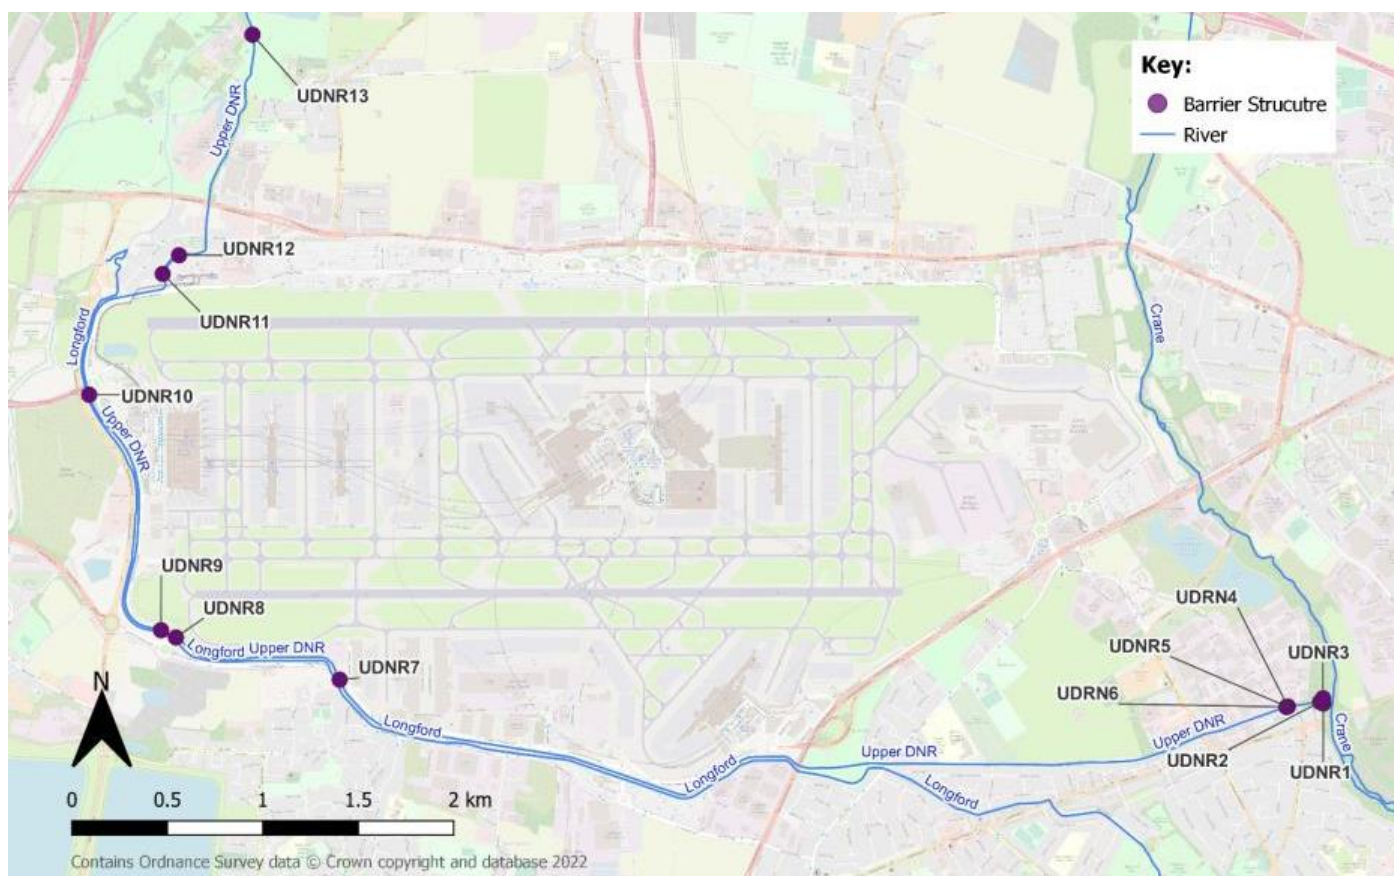
Approximately 9.3km of river were surveyed for this report, identifying 13 structures overall. Of these, five structures received an EBAT score of <10, indicating that they have the potential to be either a partial or complete barrier to upstream eel migration. Ten of the structures identified received scores that would indicate partial low, high, or complete impassability to fish. The locations of all structures surveyed can be seen below in Figure 5.1 with their scorings listed in Table 5.1.

**Figure 5.1:** Map of all structures surveyed under the scope of this investigation on the Upper Duke of Northumberland's River. Structure ID corresponds to Table 5.1.

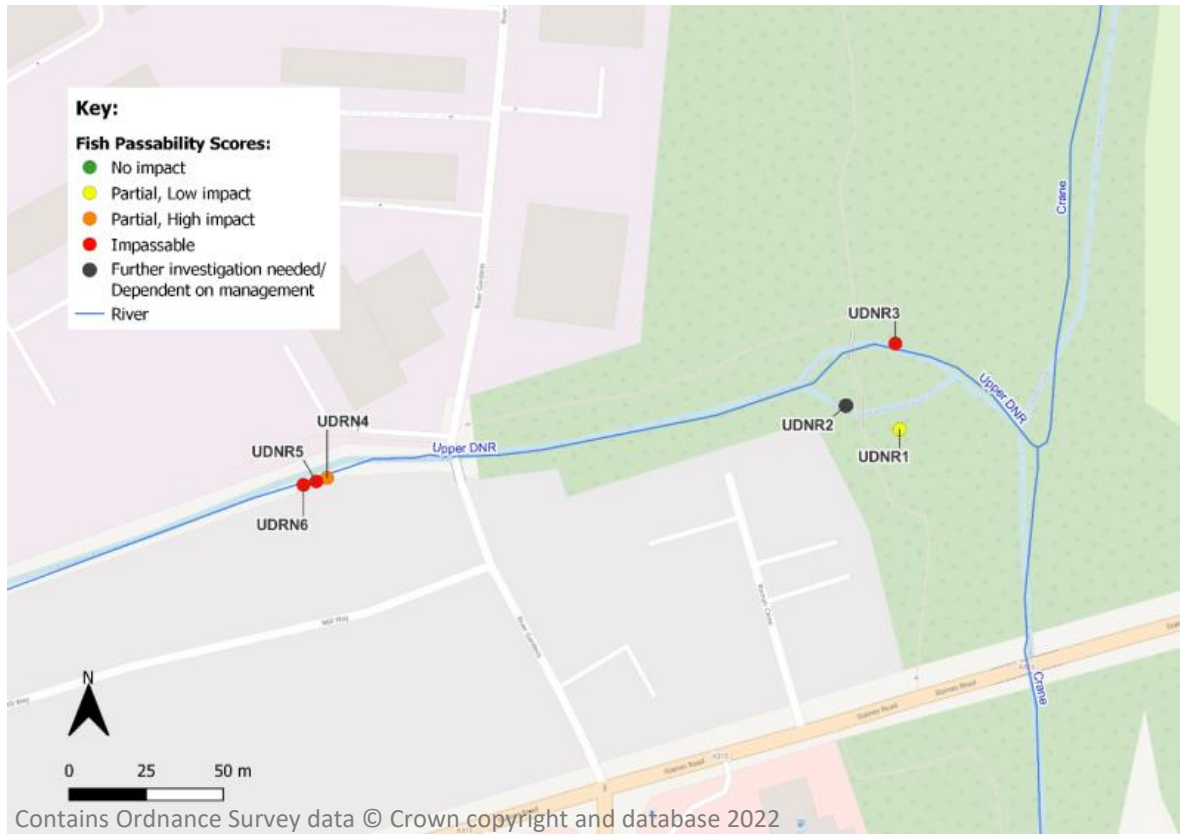
**Figure 5.2:** a) Map of all structures surveyed under the scope of this investigation with corresponding fish passage scores shown, b) Zoomed in view of structures UDNR 1-6.

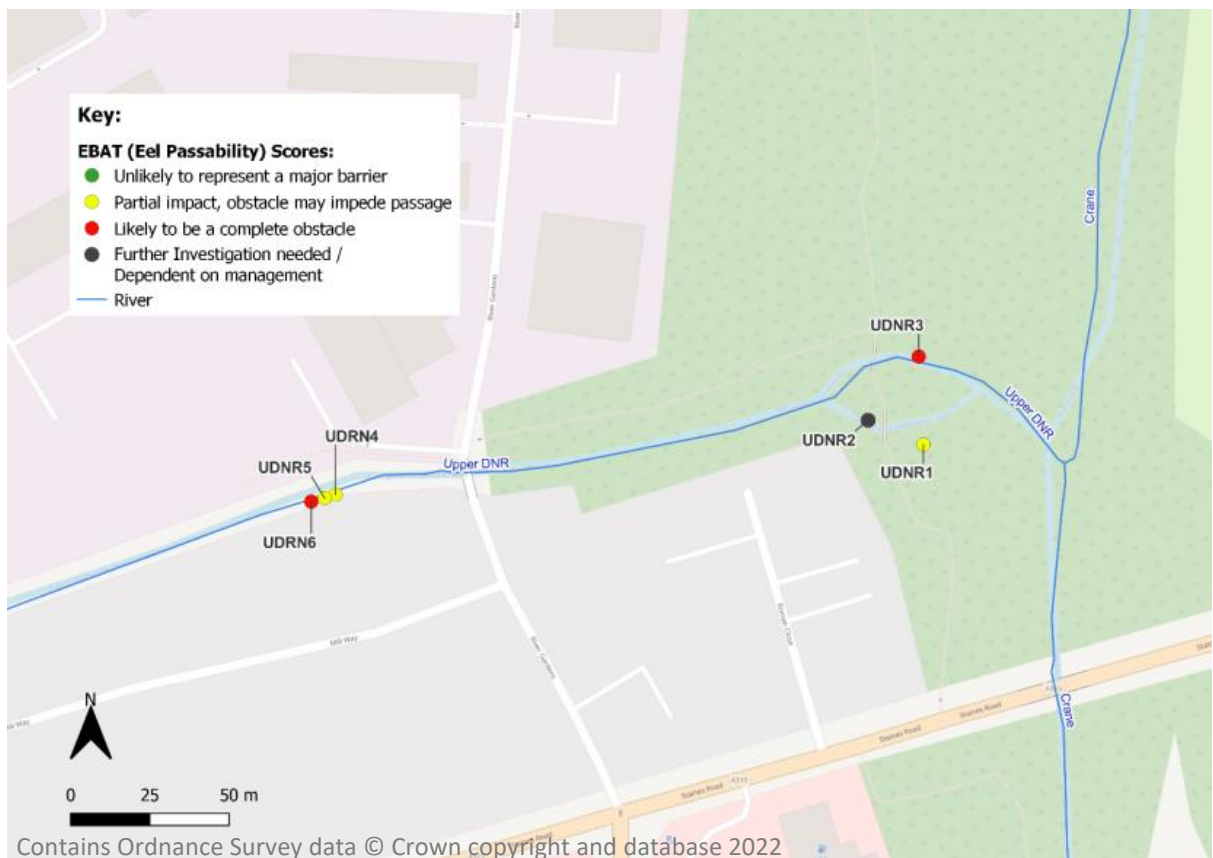
**Figure 5.3:** a) Map of all structures surveyed under the scope of this investigation with corresponding EBAT scores shown, b) Zoomed in view of structures UDNR 1-6.

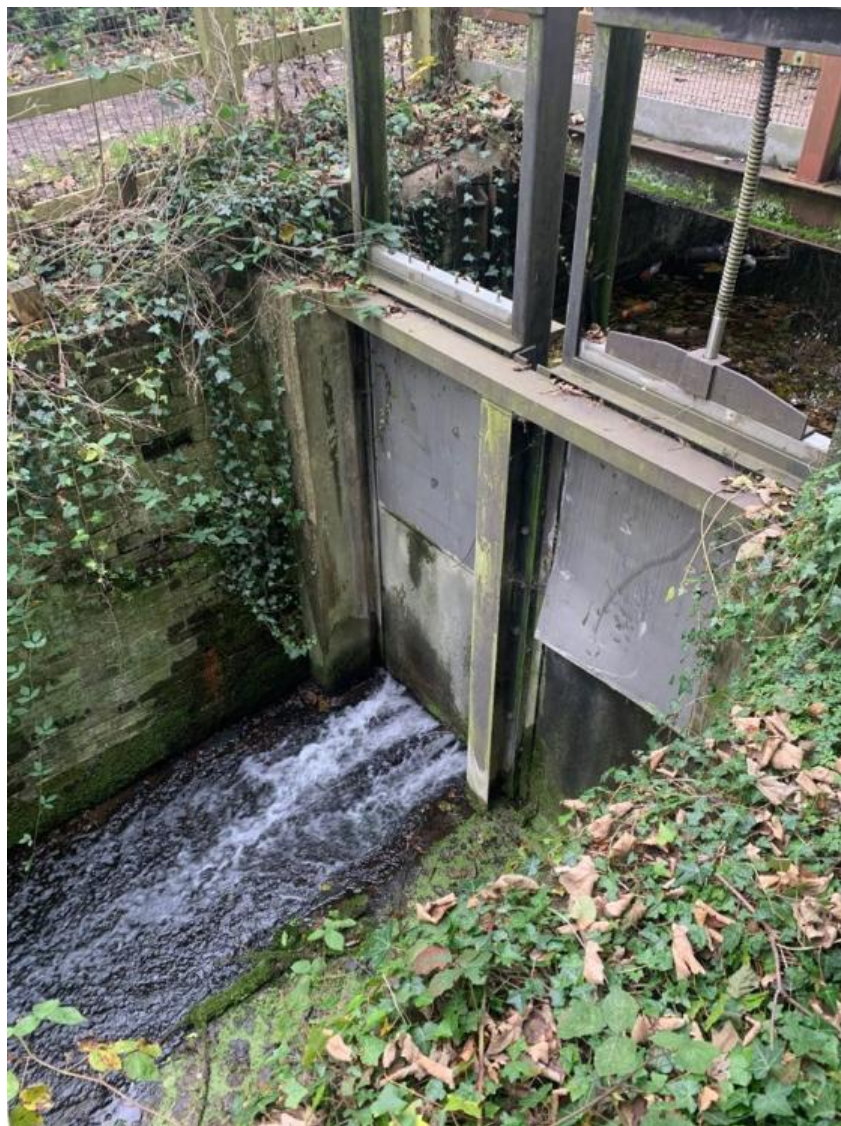
## Structure UDNR2: Donkey Wood Sluice

**Location:** 51.45978, -0.40226

**Fish passability rating:** Impassable

This sluice is located on the southern channel that splits from the Upper DNR and joins the River Crane. At the time of surveying, one of the gates of the sluice was completely closed with the other gate having a small opening (~1-2cm gap) at the base of the structure. The difference in water level between upstream and downstream of this structure was ~2.5m. There was some turbidity associated with this structure with water flowing very fast from the opening. The channel directly downstream of the structure is made of smooth concrete with some cover of crawling media which also extends up the sides of the brick channel walls. This structure is likely a complete barrier to the upstream migration of fish and eel. *Information regarding the management of structure could not be found.*

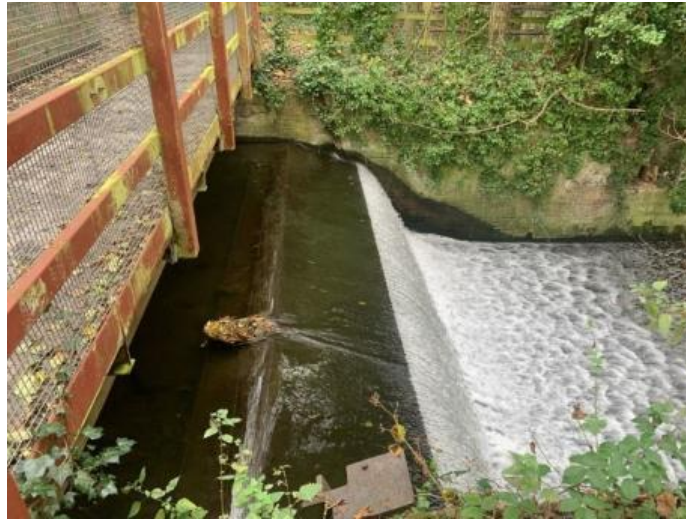
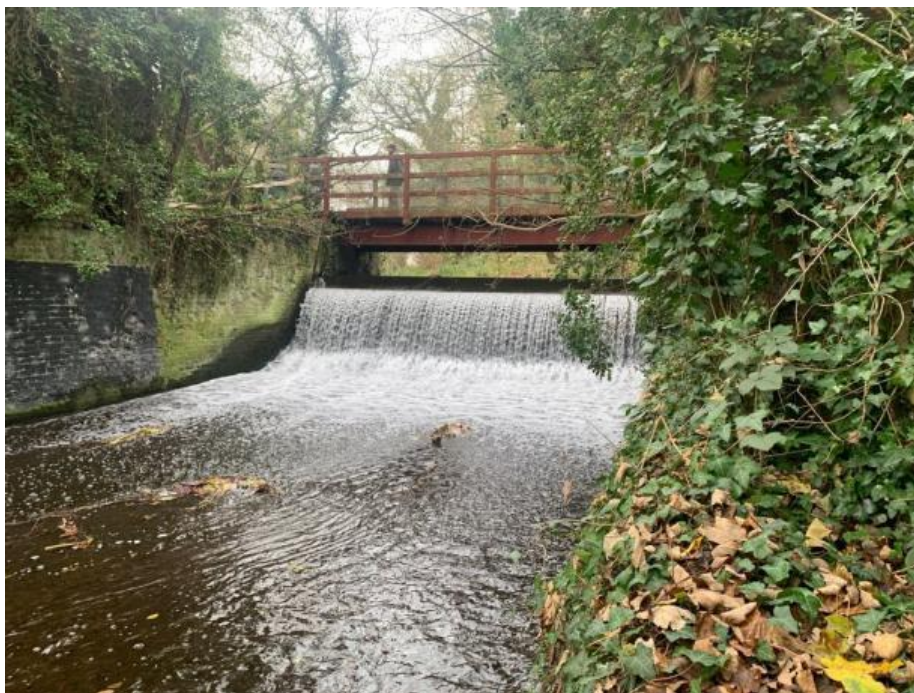
**Structure UDNR3: Donkey Wood Weir**

**Location:** 51.45996, -0.40203

**Fish passability rating:** Impassable

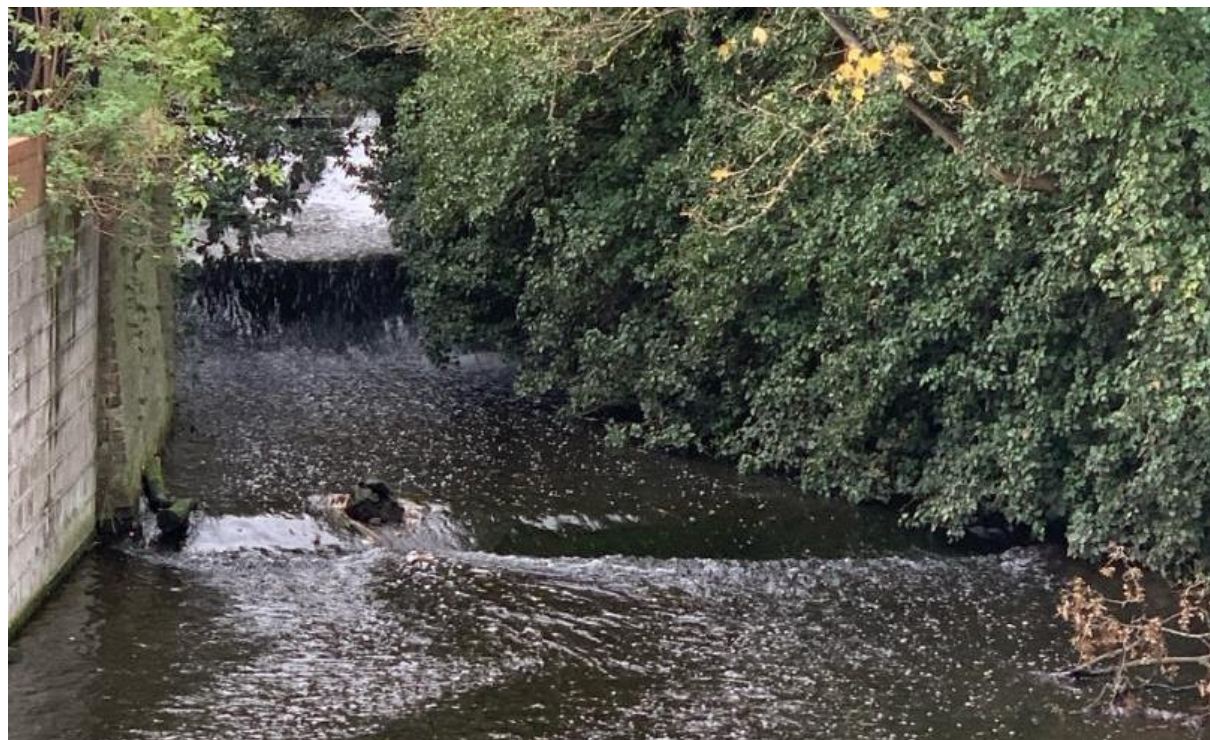
#### **Structure UDNR4: River Gardens Downstream Weir**

**Location:** 51.45957, -0.40468

**Fish passability score:** Partial high impact

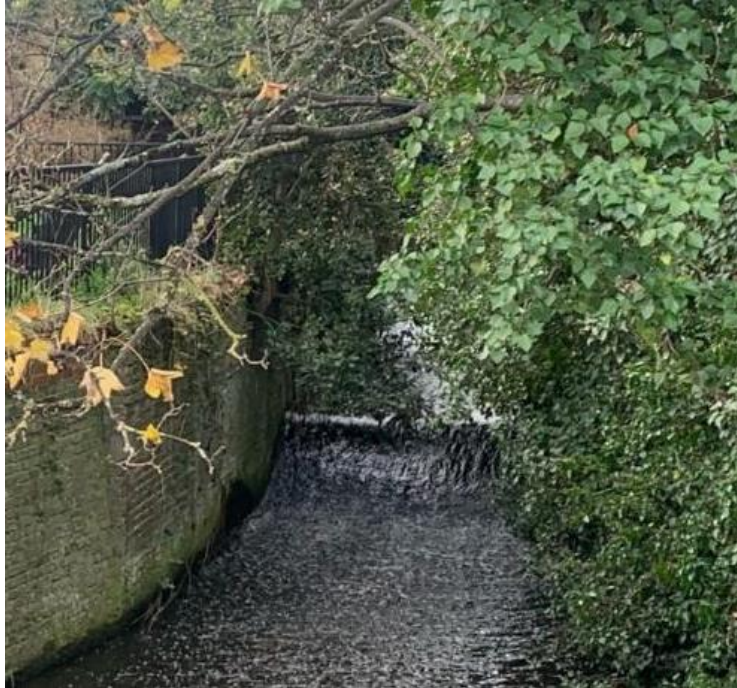
## **Structure UDNR5: River Gardens Middle Weir**

**Location:** 51.45956, -0.40473

**Fish passability score:** Impassable

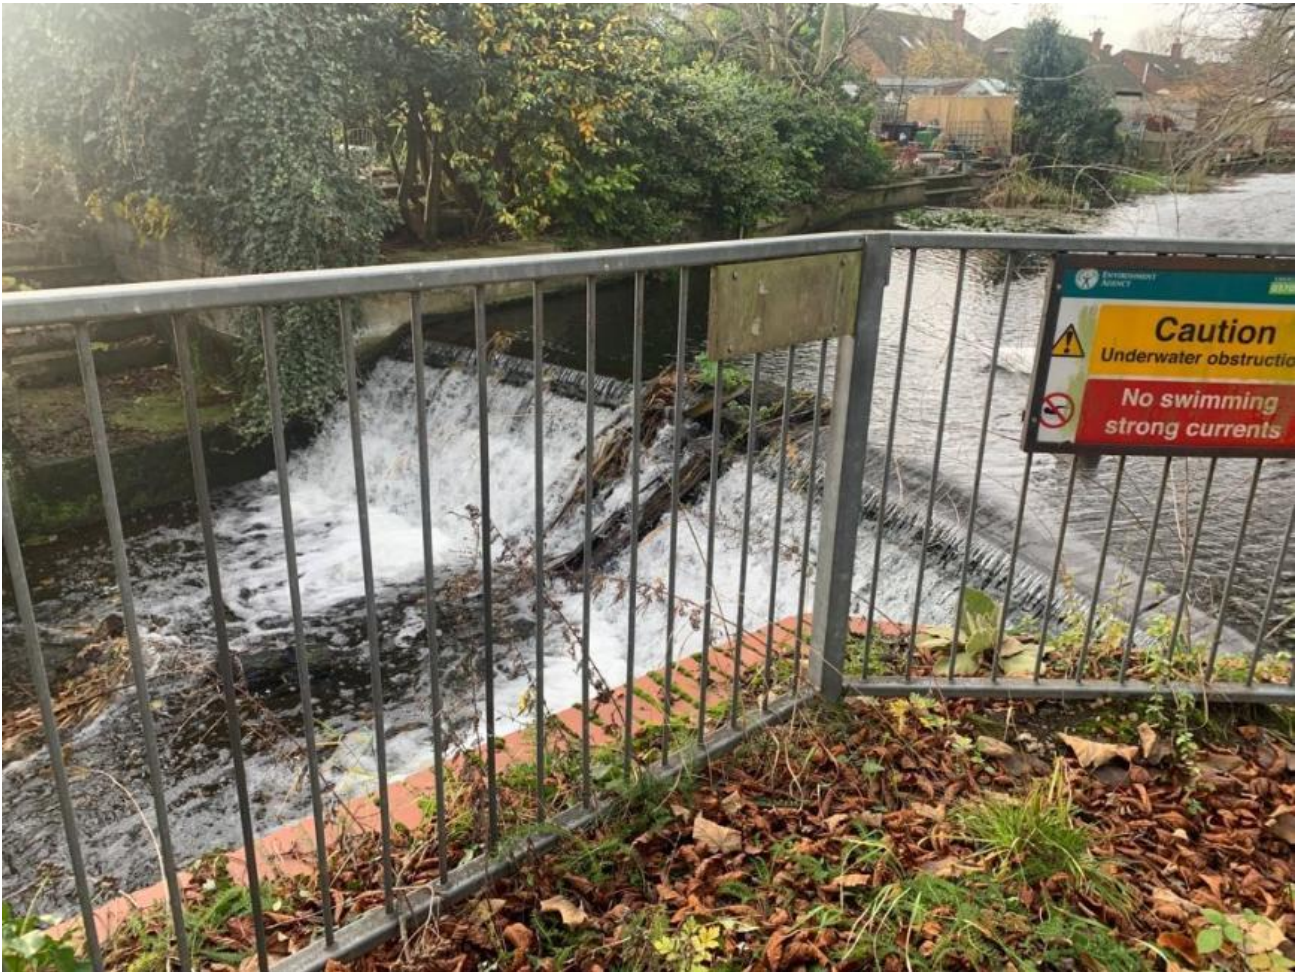
## Structure UDNR6: River Gardens top weir

**Location:** 51.45955, -0.40479

**Fish passability score:** Impassable

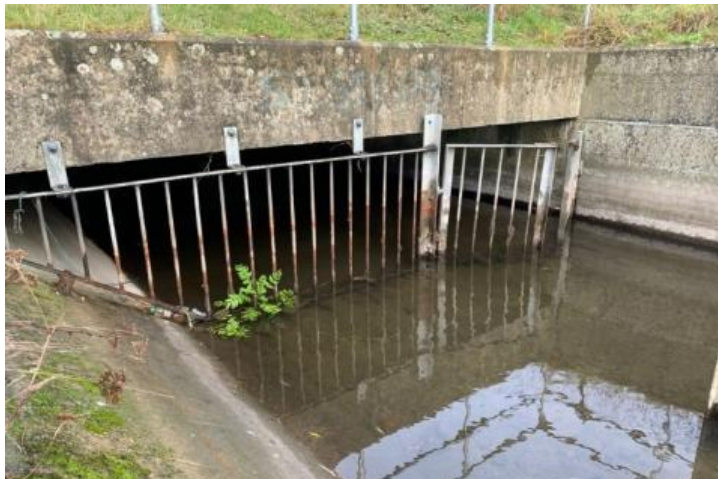
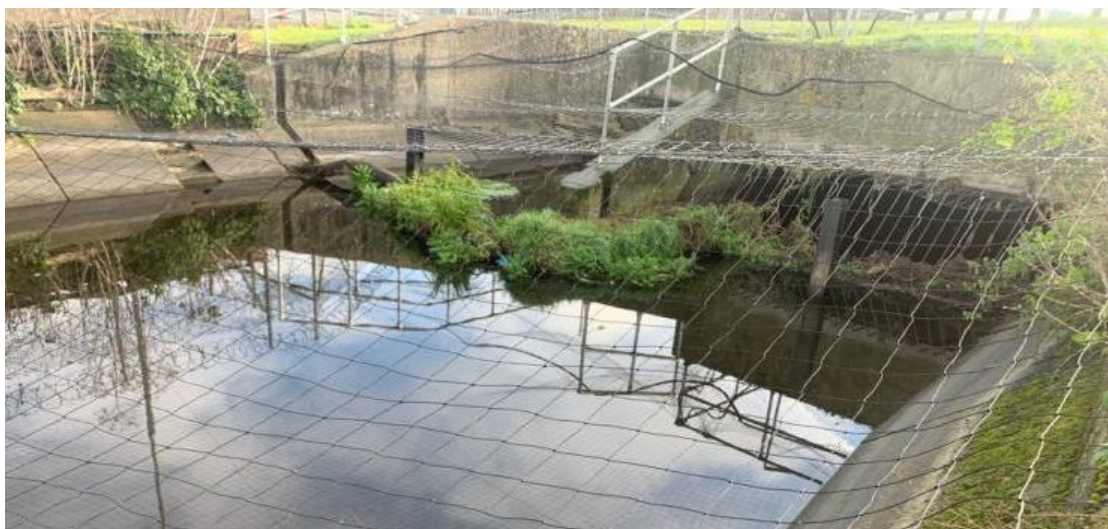
## **Structure UDNR7: Seaford Road culvert**

**Location:** DS: 51.46083, -0.47615, US: 51.46157, -0.47672

**Fish passability score:** Partial low impact

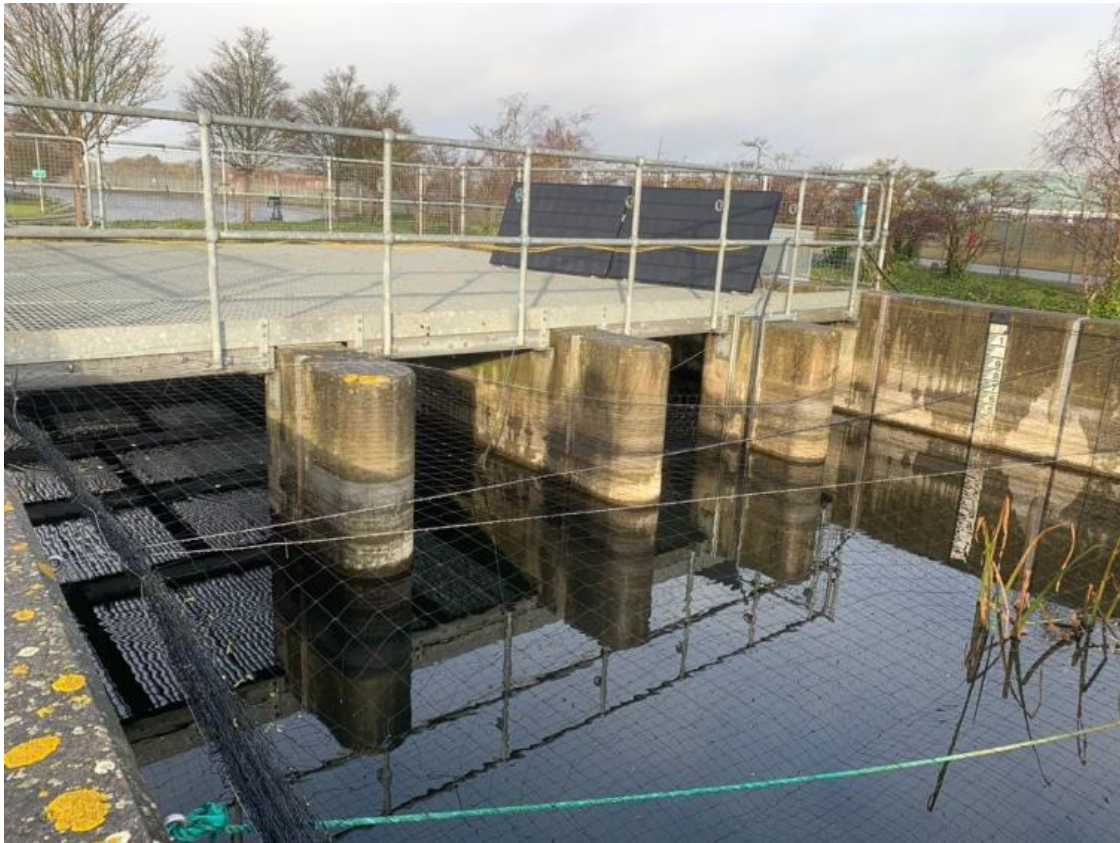
**Structure UDNR8: Perimeter Roads roundabout culvert (DS)**

**Location:** DS: 51.46281, -0.48849

**Fish passability score:** Partial low impact

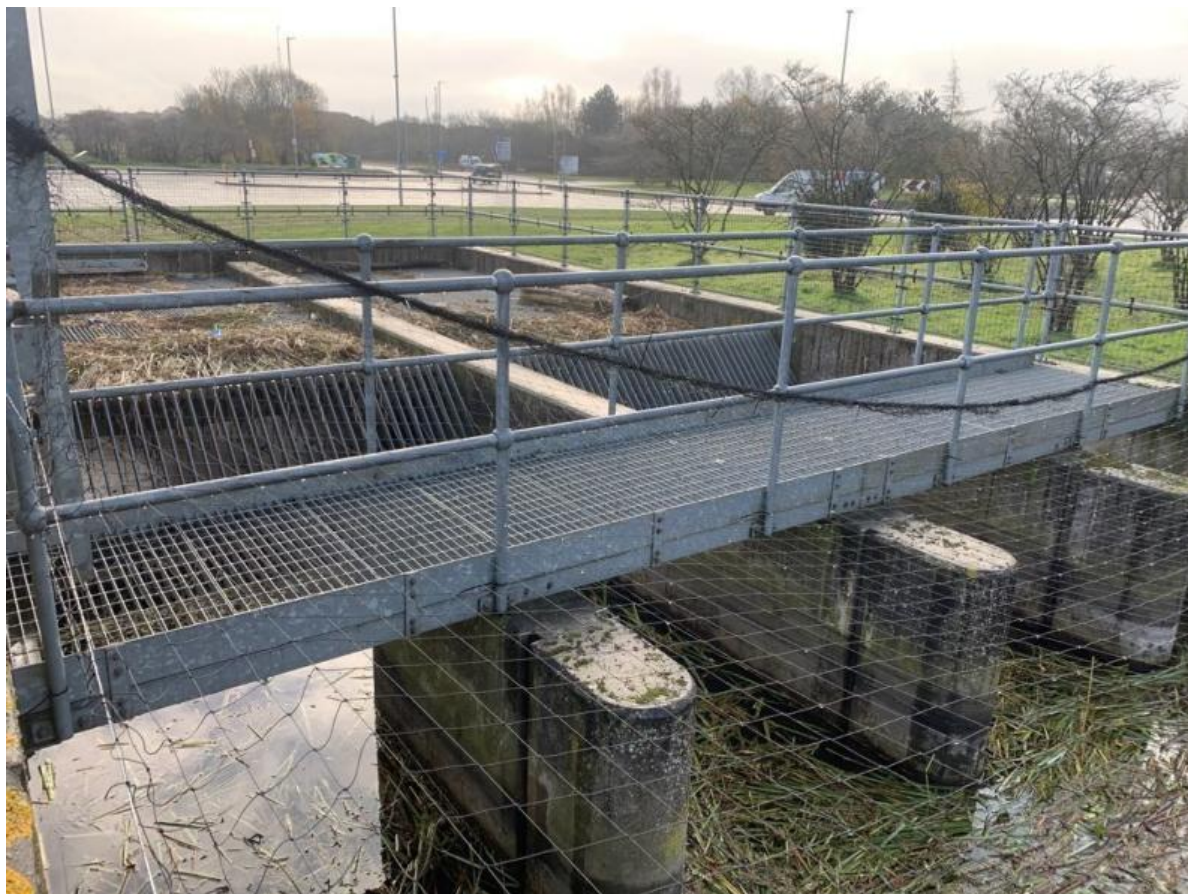
**Structure UDNR9: Perimeter Roads roundabout culvert (US) – Inverted Siphon**

**Location:** US: 51.46315, -0.48958

**Fish passability score:** Further investigation needed

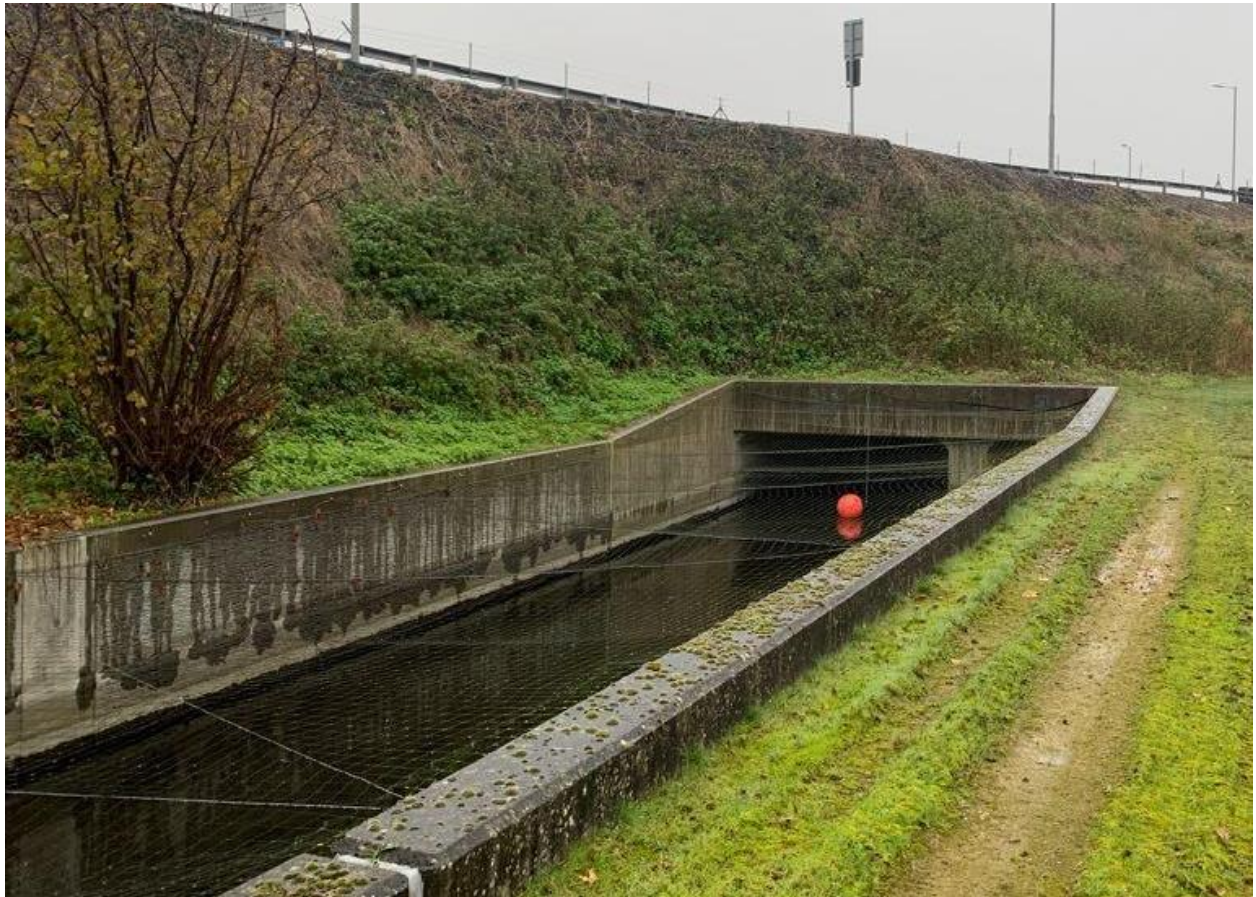
## **Structure UDNR10: T5 Roundabout culvert**

**Location:** DS: 51.47419, -0.49503, US: 51.47512, -0.49539

**Fish passability score:** Partial low impact

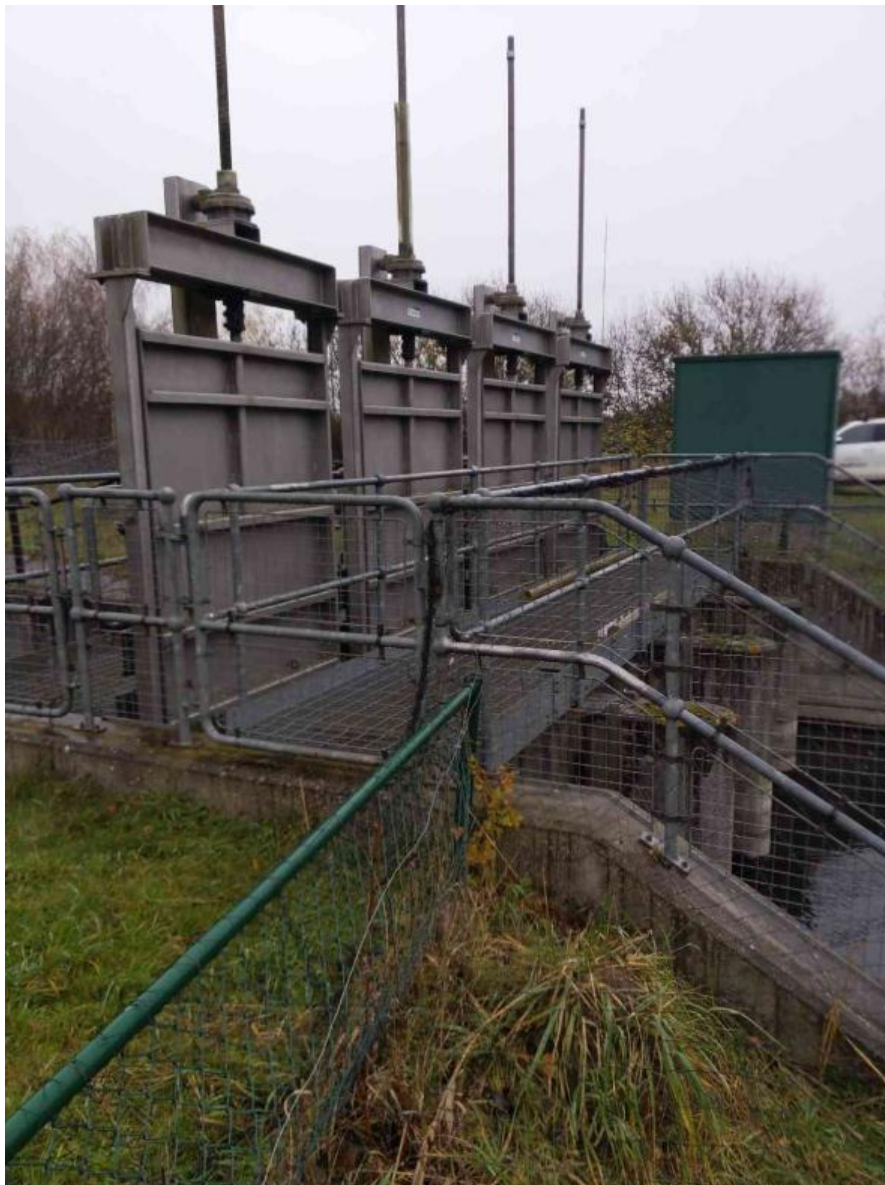
## Structure UDNR11: Heathrow pod sluices

**Location:** 51.47986, -0.48949

**Fish passability score:** No Impact

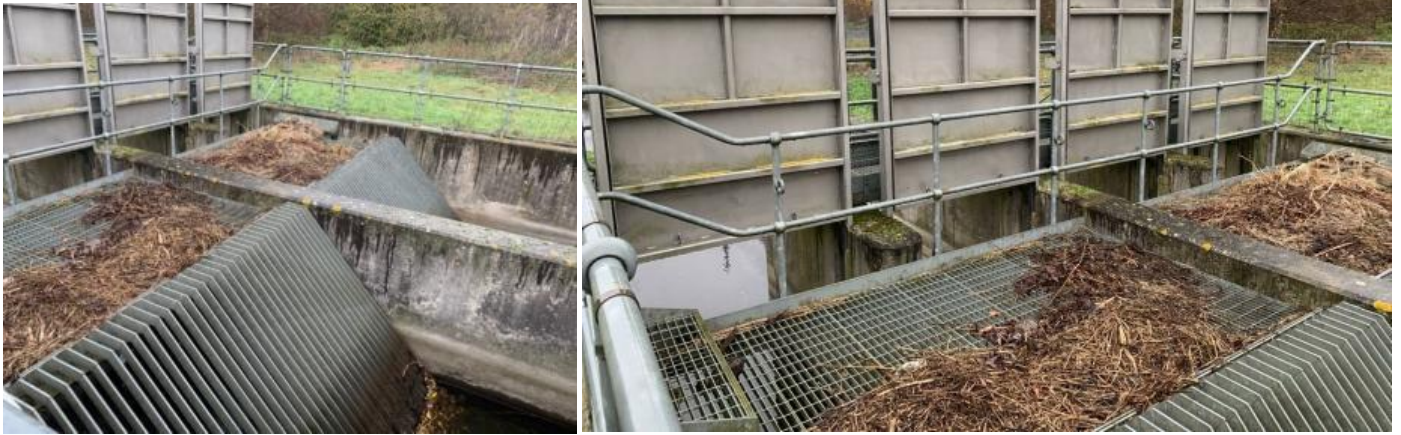
## **Structure UDNR12: White Horse sluices**

**Location:** 51.48073, -0.48826

**Fish Passability Score:** Partial low impact

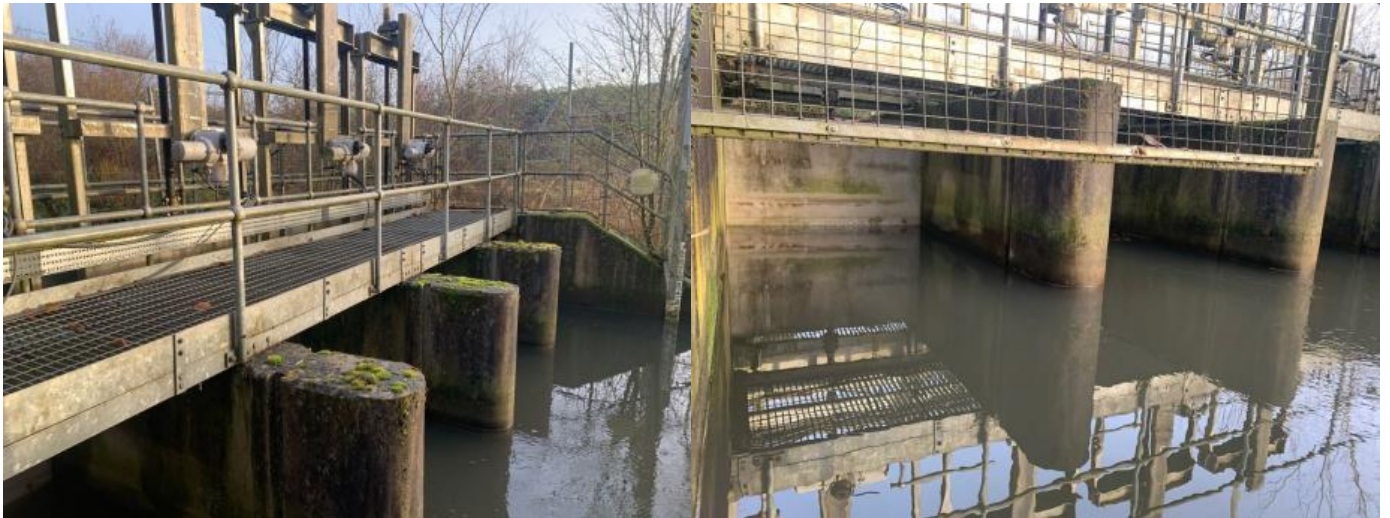
## Structure UDNR13: Saxon Way Sluice

**Location:** 51.49107, -0.48272

**Fish Passability Score:** Impassable (no impact when open)

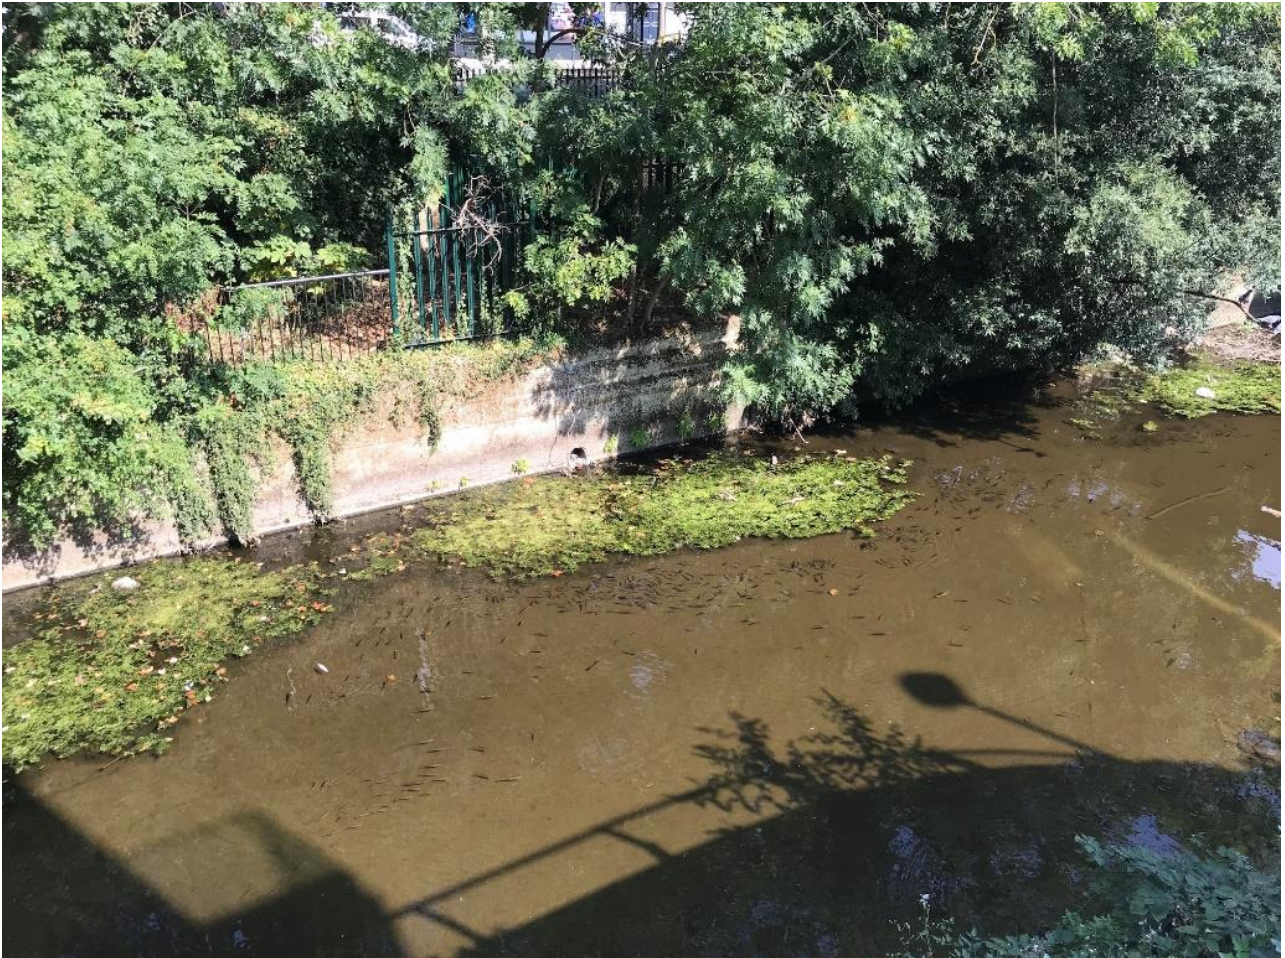
**Figure 6.1:** Fish, likely juveniles, gathering around the limited habitat available in this section of the lower River Crane near London Road Bridge, Twickenham. Photo Credit: John Waxman.

Addressing the numerous small barriers in the lower Crane coupled with more habitat improvements would increase the accessibility for fishes found in the tidal Thames. This includes species such as flounder, dace and brown/sea trout that rely on tidal currents to move upriver and spawn as well as European eel that migrate upstream on estuarine tides in search of habitat in which to grow and feed (Wheeler, 1980). Brown/sea trout are found in the tidal Thames and we are aware of a report of one individual recently caught by an angler at the mouth of the Crane. Brown/sea trout migrate to improve growth and survival with life histories being dependant on a number of complex and interacting factors including the availability and connectivity of functional habitats (Nevoux *et al.*, 2019). They migrate upstream in autumn/ winter to spawn on clean gravels. The apparent lack of this species within the lower Crane could indicate that migration into the catchment is limited by a lack of suitable habitat.

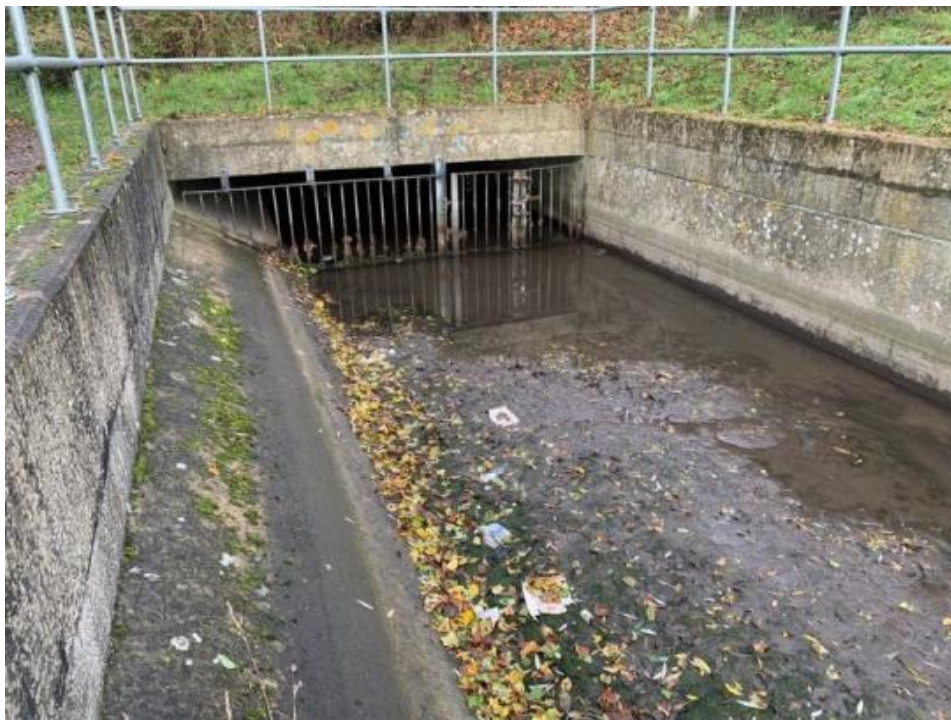
**Figure 6.2:** A channelised section of the Upper Duke of Northumberland’s river at the entrance to a box culvert, reflective of conditions across large sections of the river. Concrete bed and banks, low water levels, with no presence of aquatic macrophytes or quality habitat and only a small covering of moss, algae and leaf litter.

species should be coupled with significant habitat improvements. Lack of functional habitat (see Figure 6.2) can be considered a barrier in itself, and habitat improvement works should be viewed as a priority activity to be carried out alongside structural works on barriers within the Crane catchment. The benefits of habitat improvement, coupled with improving connectivity with the Colne catchment will in turn help to build resilience at a catchment level and overall, act as a sustainable solution to improving fish diversity and abundance within the Crane system.

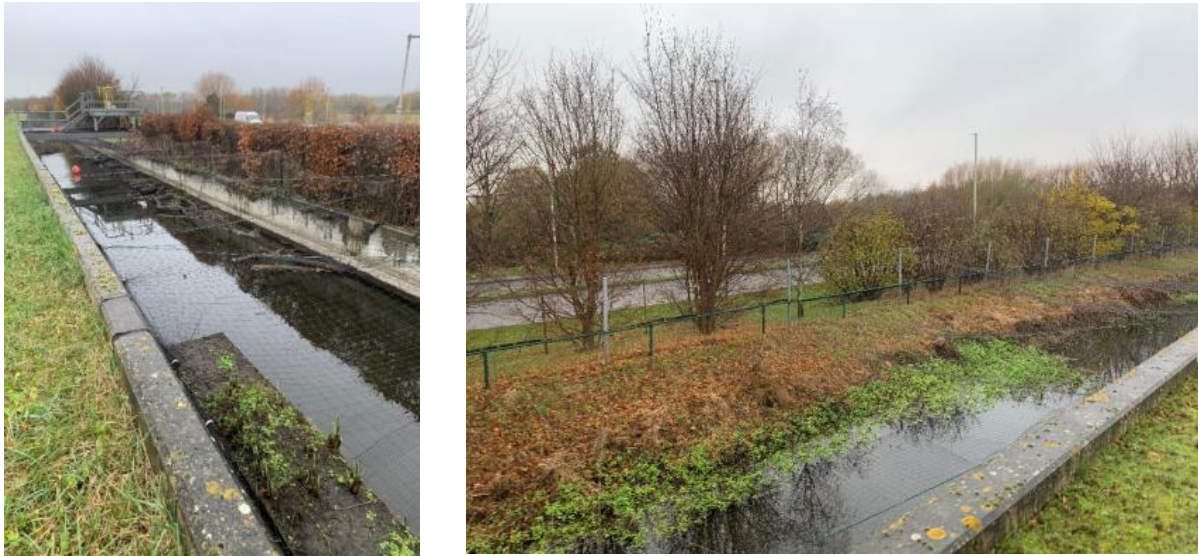
**Figure 6.3:** (Left) Image of gabions and large woody material installed in the Upper Duke of Northumberland's River by Heathrow Conservation and Biodiversity Team. (Right) Image showing the growth of marginal vegetation planted in the Upper Duke of Northumberland's River at Heathrow.

Some habitat improvements have been carried out within this section of the catchment already, particularly within the Twin Rivers system (Longford and Upper Duke of Northumberland’s Rivers) to try to improve the heterogeneity of habitats and flows and reduce the mobilisation of fine sediments through the installation of gabions, the strategic placement of large woody material and the planting of marginal vegetation (see Figure 6.3). However, throughout much of its reaches, the Upper Duke of Northumberland’s remains heavily channelised, culverted and lacks key habitats such as the deeper pools and gravel riffle habitats that are required by many fish species to complete their lifecycle.

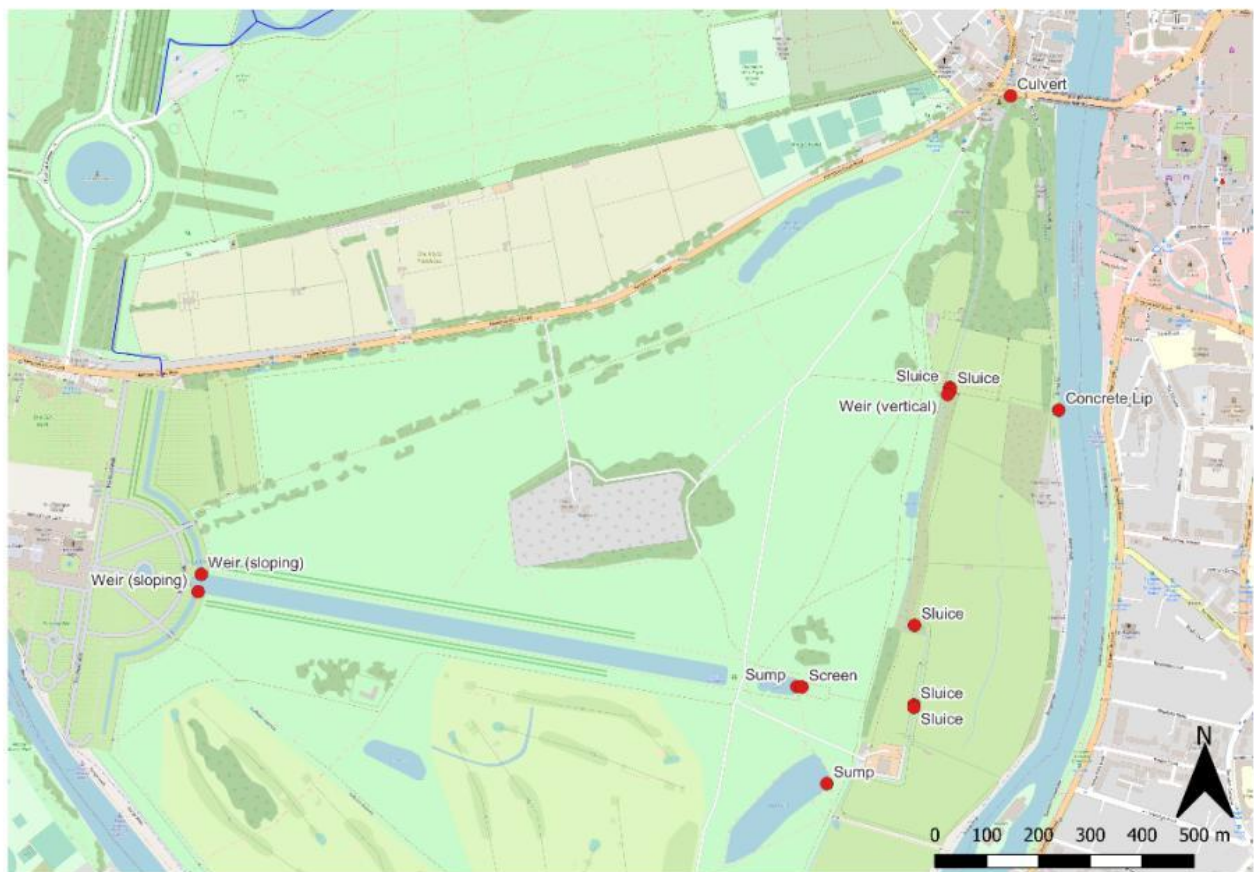
**Figure A1.1:** Home Park potential barriers to fish and eel upstream migration (culverts not accounted for).

In 2014, APEM was appointed to carry out a hydromorphological survey of the Longford River for The Royal Parks (TRP). The final report compiled existing reports and surveys on the Longford River to provide both management and environmental information specific to the River Longford. APEM carried out a hydromorphological field survey and mapping exercise to provide an up-to-date record of the river condition which included information on key barriers and flow control structures (see Figure A1.1)

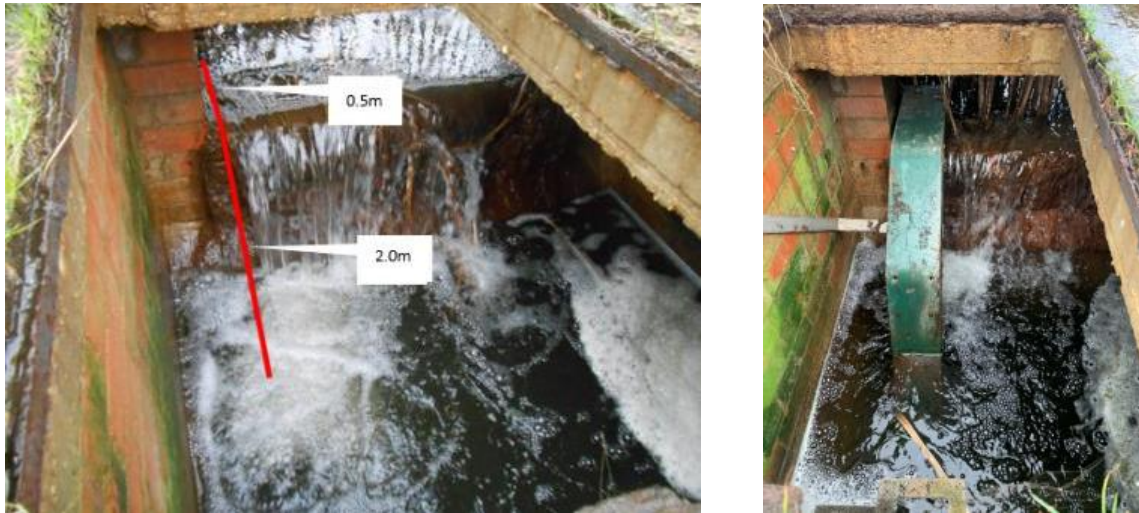
**Figure A1.2:** Before (left) and after (right) images of an eel pass installed to the sump of the off-take of Rick Pond.
