# Improving Fish Migration in the Crane Catchment

March 2022

UK Conservation Programme

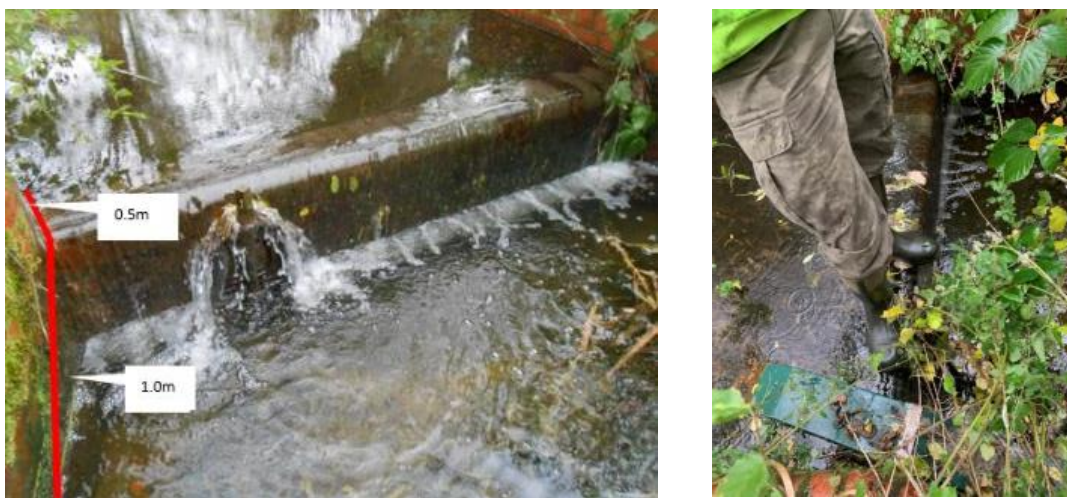
**Figure A1.3:** Before (left) and after (right) images of an eel pass installation to a vertical weir in Home Park.

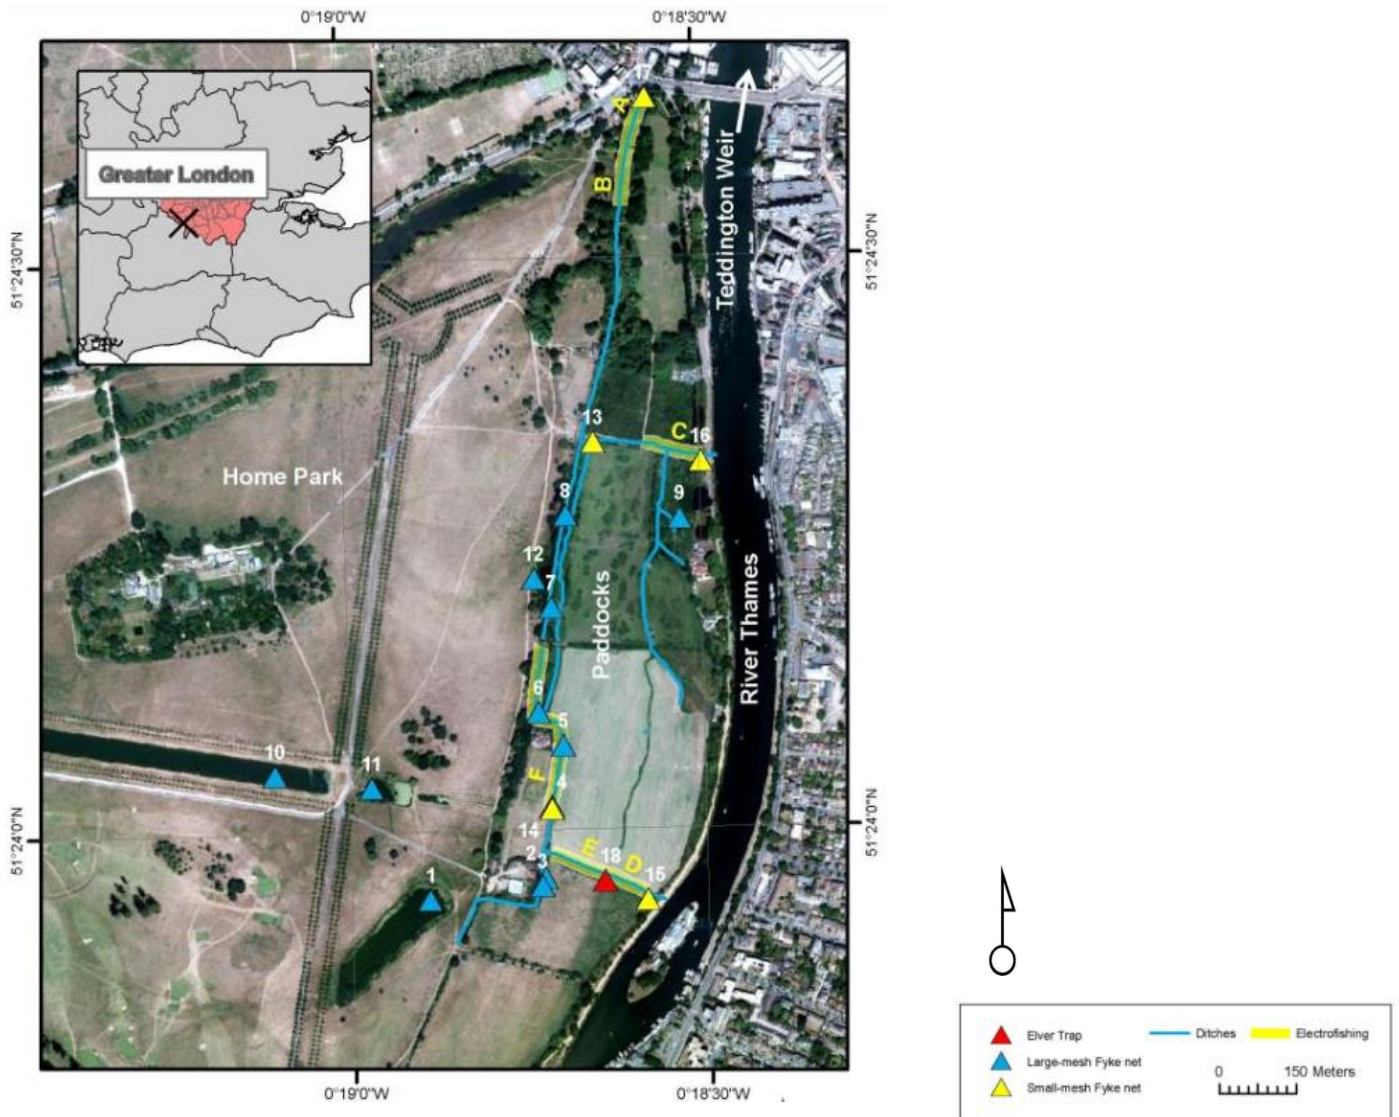
**Figure A1.4:** Map of sample sites and sampling method used by Pryor (2013) within Home Park and surrounding paddocks.

Pryor (2013) sampled fish populations using a range of fishing methods. Species found were analysed by location and hydrology to identify lateral links with the river. No historic data existed with which to compare the results. Sample locations can be seen in Figure A1.4 taken from Pryor 2013, with the most upstream sample being Sample 10, at the lower end of the Long Water Canal. The report highlights that at this site, the 'apex' of the network is connected by a culvert between to the Overflow Pond (Sample 11) which has a drop of approximately 3m and is
