An audit of the surface water outfalls, 'Outfall Safari' in the Crane Catchment

September 2021

Marine and Freshwater Conservation Programme

Zoological Society of London

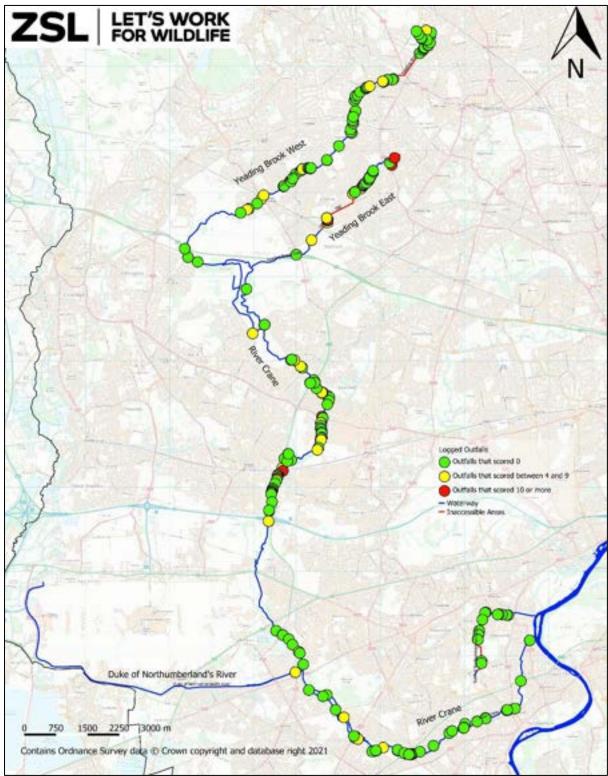
Figure 1: Results of the 2021 Crane Catchment Outfall Safari

255 outfalls were located and assessed durving the survey. 51 outfalls were allocated an impact score of \ge 4 the details of which are given in **Table 1.** 8 outfalls score 10 or more.

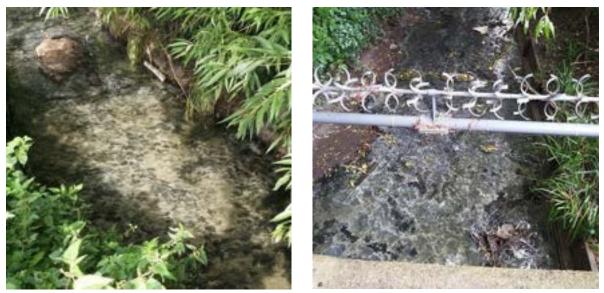
The pollution was evident upstream of the combined sewer overflow at Field End Road – ID number 71 and 72. Sewage fungus extended downstream of the culvert at Civic Way, ID number 55. The brook was also badly affected downstream of the railway culvert with sewage fungus still in evidence close to where the Yeading Brook East flows past the Polish War Memorial (TQ11038452).

Figure 1: Complete covering of sewage fungus recorded at Field End footbridge, South Park Way, Ruislip, HA4 6UN

On 26/09/2021 pollution in the Yeading Brook East was reported to both Thames Water and the Environment Agency.

- Thames Water incident ref: 10826634429
- Environment Agency incident ref: 1986368
