Test lowering of Mereway Weir November 2017 to November 2018

Draft Report, August 2019 Version 1

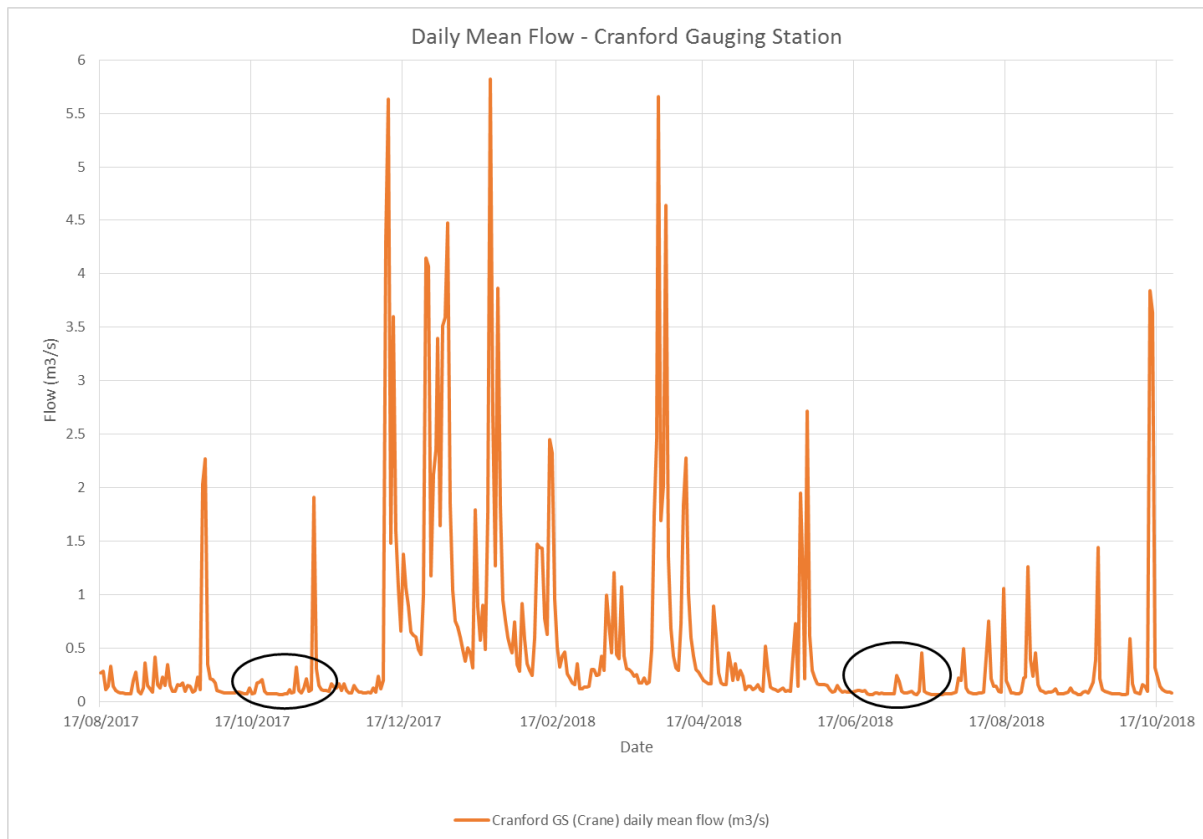
Figure 6. Daily mean flow measured at Cranford gauging station. The circled areas highlight similar periods of low flow before and after the test.

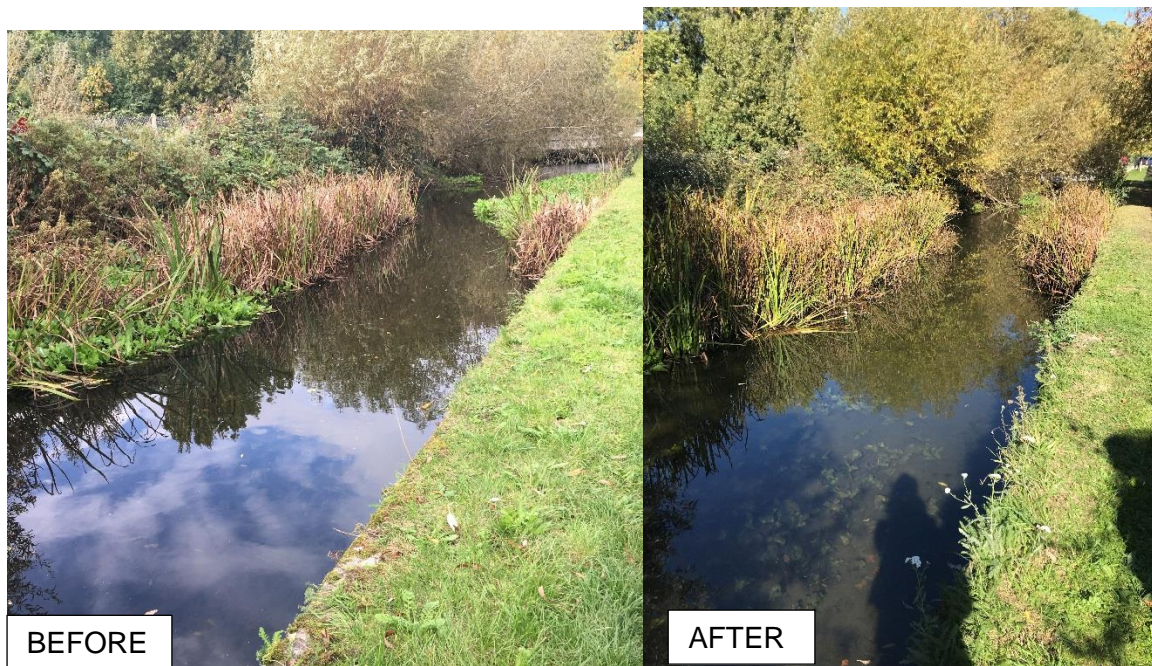
Figure 12: Before and after photographs of a location in reach C upstream of Kneller Road on 04/10/17 (Before) and 09/10/18 (After).

The vast majority of sites showed expected patterns of changes throughout the year, with few noticeable differences between 2017 and 2018. For example in Figure 12 the vegetation that has established in the summer season, is visible in both pictures. This common reed helps to narrow the channel. Flow appears consistently low both before and after the Mereway Weir lowering. The flow velocity in the channel is still low and channel likely over-wide. It is therefore likely that the lowering of the weir has not had a significant impact on the flow conditions within this reach, where the reeds naturally narrow the channel to increase flow velocities.

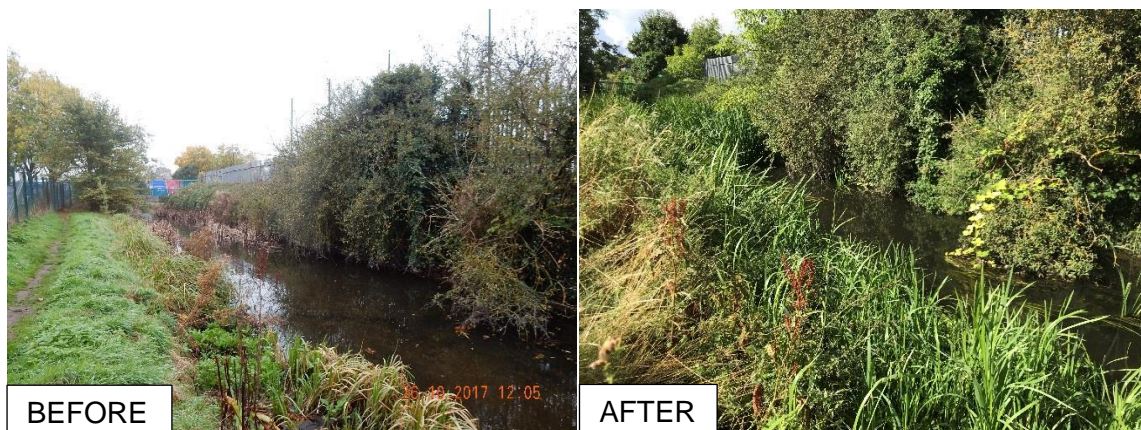
Figure 13: Before and after photographs of a location in reach C near Twickenham Stadium on 16/08/17 (Before) and 10/08/18 (After).

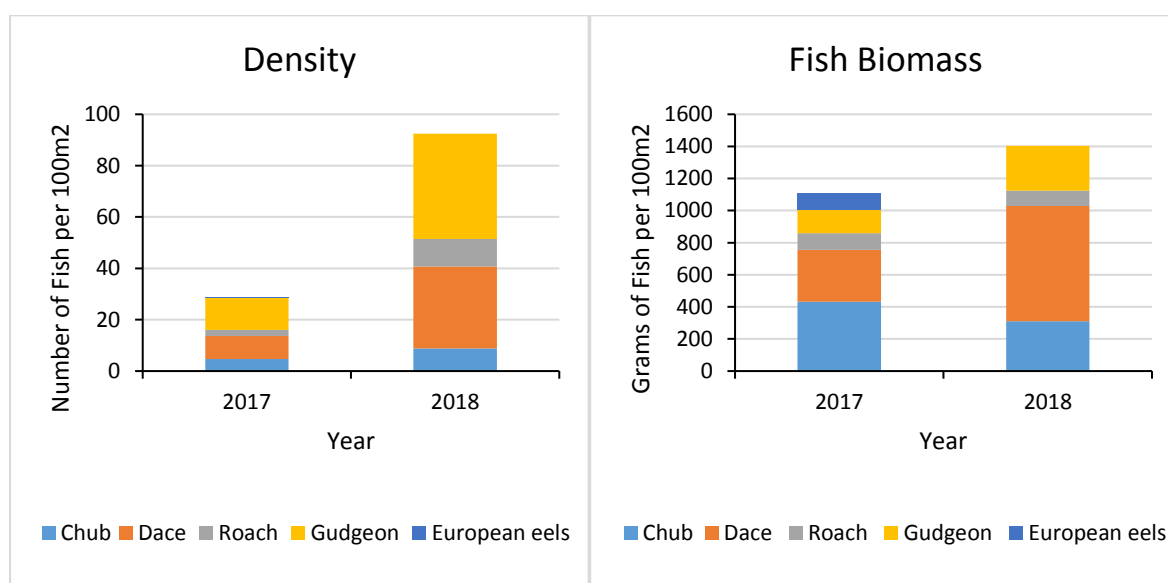
This variation in water depth had no negative effect on the resident fish population. In fact, the density and biomass for this section increased between 2017 and 2018, see figure 23. The large increase in density is due to a rise in numbers of dace and gudgeon. This fluctuation is unsurprising given their shoaling and migratory behaviour. The overall increase in biomass appears to be less drastic than the difference in density, because of the size of fish which were found within the section. 2018 produced a lot of juvenile fish indicating there has been a successful spawning nearby. Bullhead, stone loach, and minnows were all found in similar abundances in both years (10-99, 1-9 and 100-999 respectively).

Figure 23. Density and Biomass graphs comparing 2017 and 2018 fish surveys at the Harlequins site.

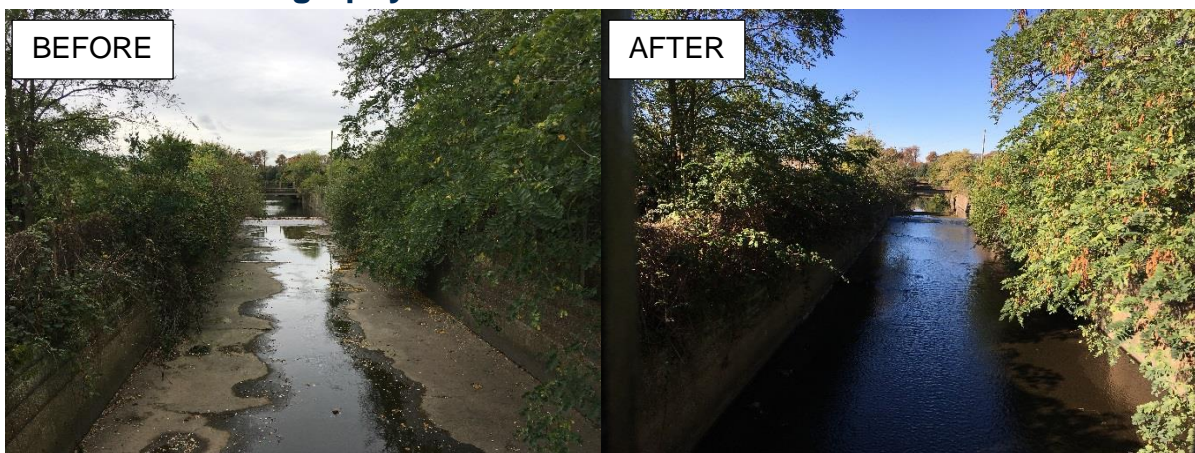
Figure 30. Before and after photos of Reach A on the River Crane. (Picture on left taken 04/10/2017, and picture on right taken 02/10/2018).

The Crane showed signs of improvement throughout the spring and summer. There is a noticeable increase in levels post-lowering on the River Crane. During the summer months of 2017, the reach shown above was partially dry, exposing concrete bed. Fixed point photography indicated that the bed was consistently wet during the test period. Filamentous algae is visible in the late summer months, likely due to the drier and warmer than average summer. This would be exacerbated by the overwide channel, and the lack of tree cover on the River Crane. The vegetation growth in the DNR, which works to narrow the channel in spring and summer, would help increase velocity and prevent this algal growth.

Crane Playing Fields scored “no perceptible flow” in 2015 and “smooth flow” in 2018 post Mereway Weir Adjustments. Looking at the pictures in figure 30, it can be shown that this improvement is a direct result of the weir lowering.

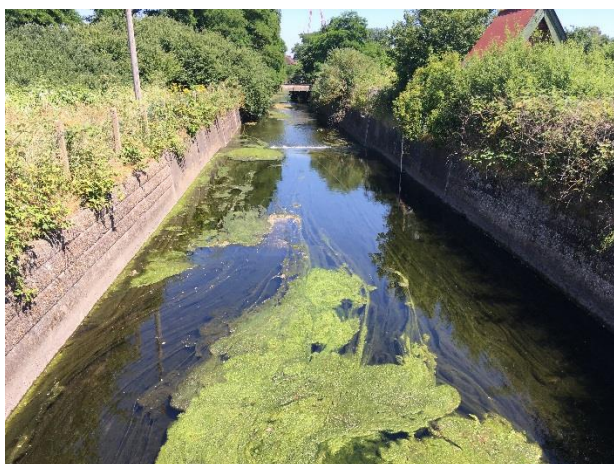
Figure 31. Photo of Reach A in the River Crane taken 27/06/2018 showing filamentous algae growth.

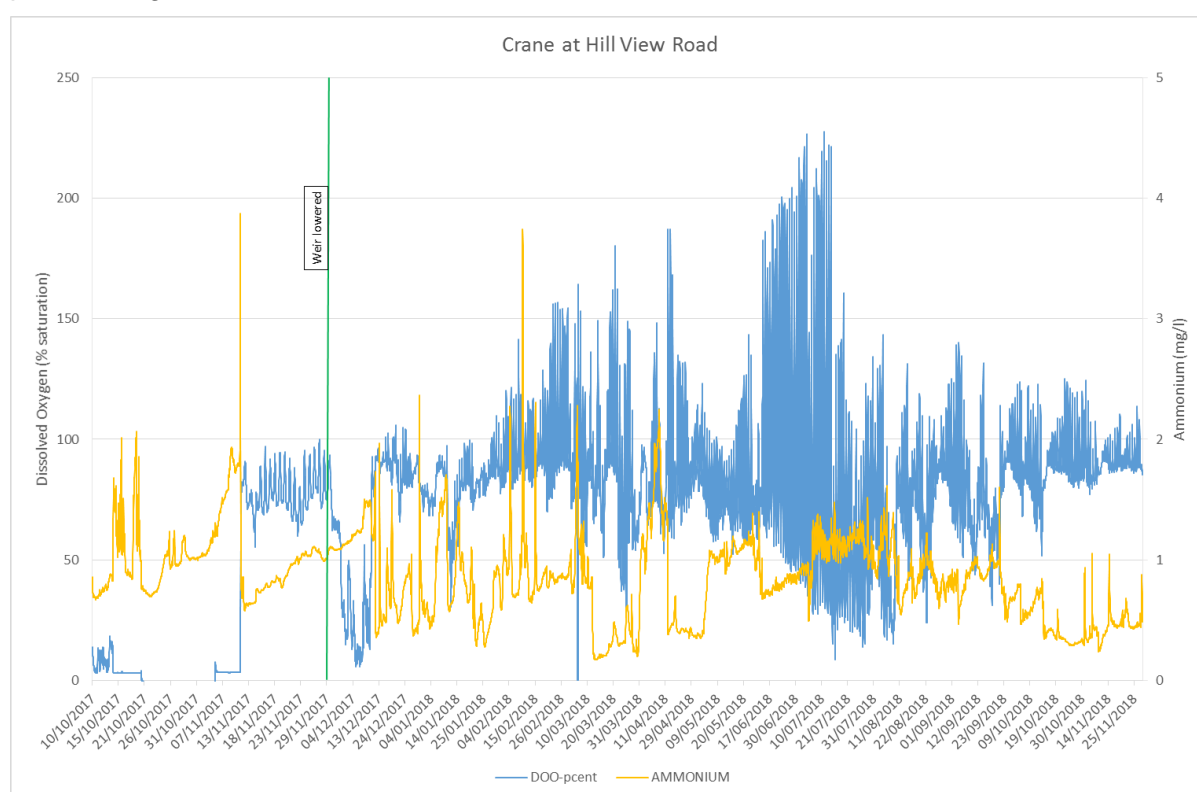
Moving into spring and summer of 2018 the spikes in ammonium became lower, but the diurnal variation in DO became increasingly extreme, until it swung between a max of 227% and a min of 9% in July. This is due to algal activity caused by eutrophication, and probably

Figure 32. Dissolved Oxygen (% saturation) and Ammonium (mg/l) recorded in the DNR from November 2017 to November 2018.

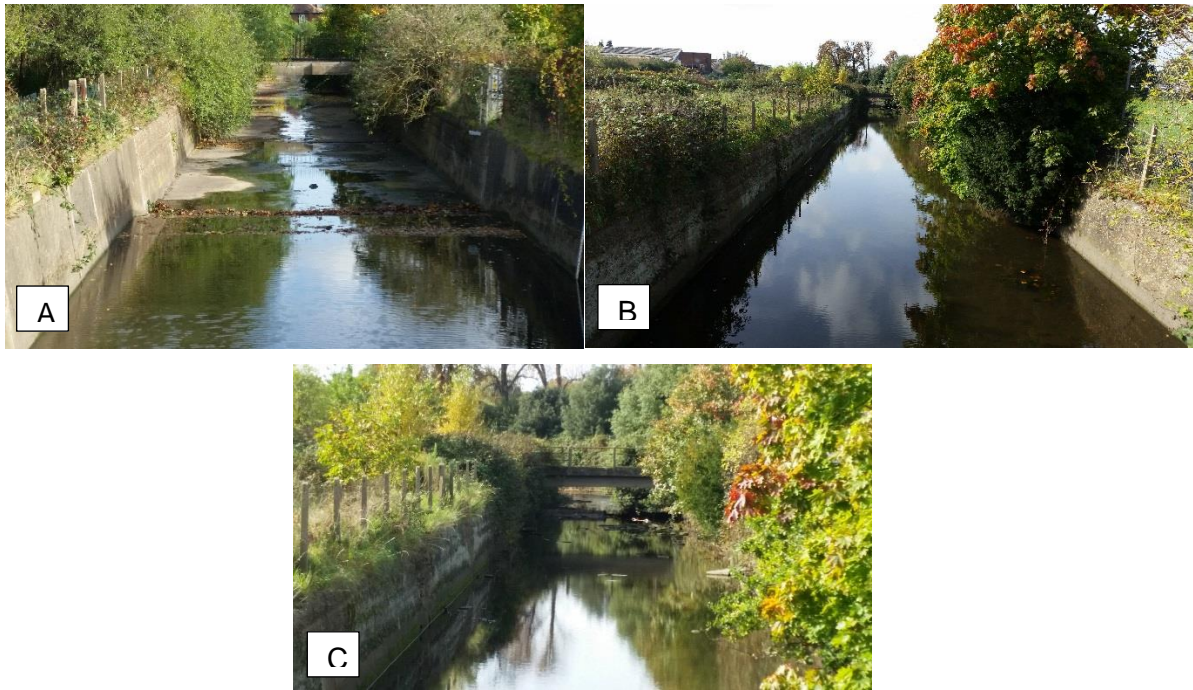
In 2017 the river both immediately upstream and downstream of the survey area consisted of a small trickle flow and dry concrete river bed (see figure 36). Since the weir was lowered there has been a more constant flow of water through the survey section in particular.

Figure 36. (from top left to bottom right) photos from the 2017 fish survey. (A) A photo of the River Crane downstream of the survey section, (B) a photo of the middle of the survey section, (C) a photo of the top of the survey section.

Since the weir was lowered there has been a more constant flow of water through the survey section in particular. Both upstream and downstream of the survey site had flowing water with no concrete bed exposed when the survey was conducted in 2018.

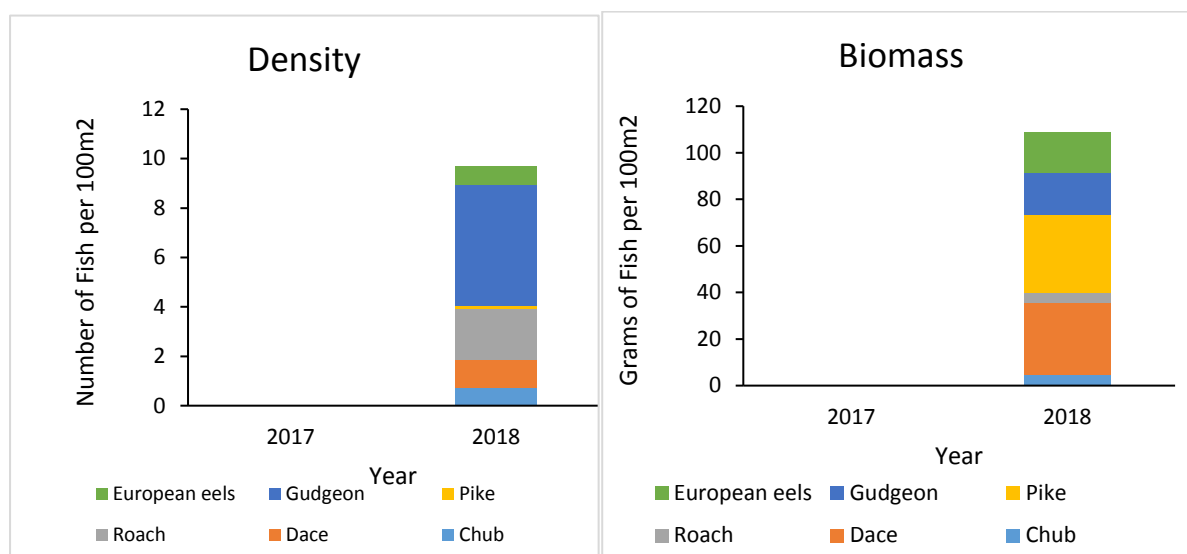
Figure 38. Density and Biomass of major fish species graphs comparing 2017 and 2018 surveys at Marsh Farm. No major species were found in the River Crane in the 2017 survey, resulting in 2017 on the graphs being blank.
