Evidencing the Impact of Constructed Wetlands: Headstone Manor Park

River Crane Smarter Water Catchments Project

March 2023

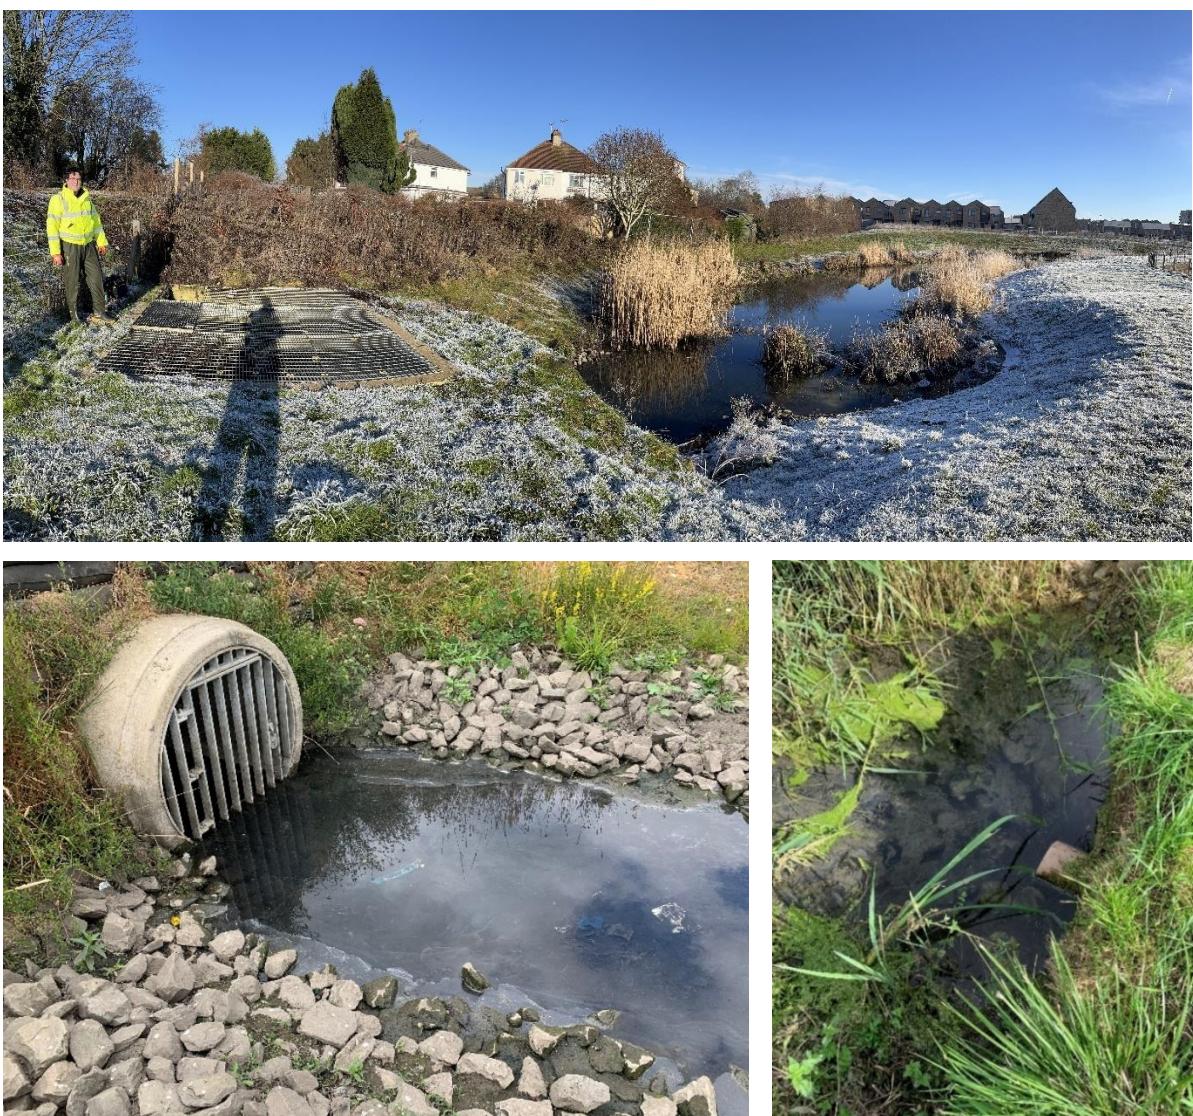
Figure 2.1: (Top) Wetland inlet, with inlet sondes installed below metal grating. Credit: Adrian Butler, Imperial College London (Bottom left) Location of the wetland inlet spot samples. (Bottom right) Location of the wetland outlet sonde and spot samples.

Level sensors were also deployed alongside the sondes to measure water levels every 30 minutes at the inlet and outlet to the wetlands. One inlet sonde was deployed behind the metal grate where the culvert pipe enters the wetland. Water samples were taken from the area of water seen in Figure 2.1, just in front of the grate. The outlet sonde was deployed approximately 1m from the 10cm diameter outlet pipe that leads into a manhole that flows into the Headstone Manor moat. Water samples were also collected at this location.

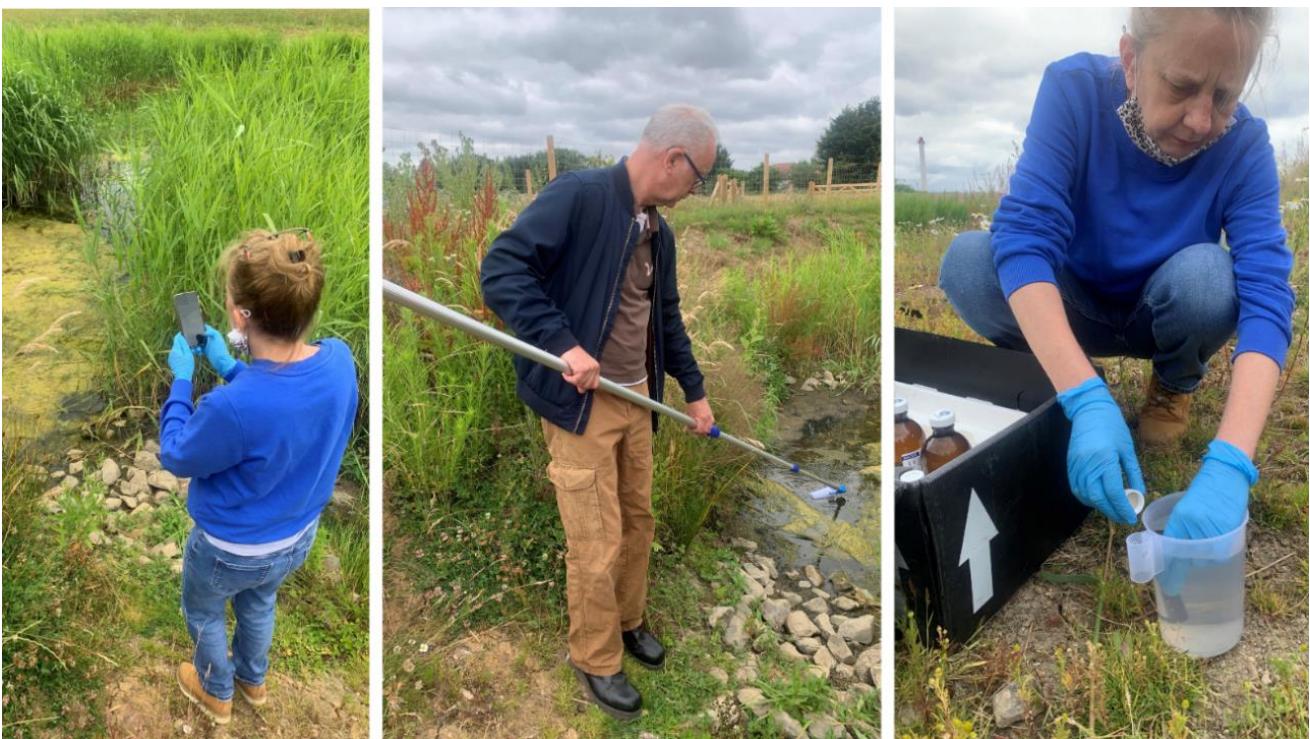
Figure 2.2: Citizen scientists collecting water samples at the Wetlands and entering data to EpiCollect5.

All samples were collected by groups of volunteers from the Friends of Headstone Manor Park who had been trained by ZSL staff. Two 300mL bottles and two 40mL vials of water were collected at each monitoring location (inlet and outlet) using an extendable sampling pole (see Figure 2.2). Sample bottles were labelled, stored in a chilled box, and sent directly to the i2 Analytical laboratory for analysis.

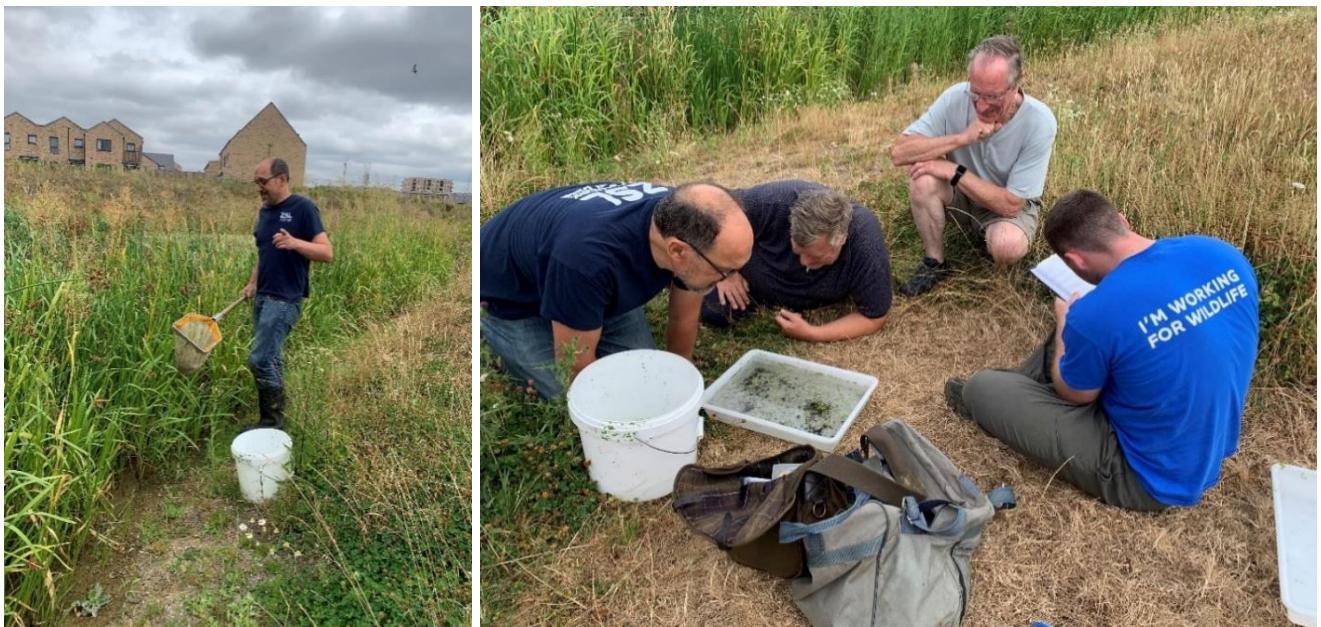
Figure 2.3: (Left) Hand netting of waters within marginal vegetation for invertebrates (Right) Identification and recording of invertebrates in the field.

ZSL staff conducted two minutes of hand netting within the reed beds and vegetation at the perimeter of both the wetland inlet and outlet cells. Netted samples were dispensed into trays and invertebrates were identified and scored by ZSL staff and volunteers using the PSYM (Predictive System for Multimetrics) methodology (Environment Agency and Ponds Conservation Trust: Policy & Research, 2002). Any additional non-PSYM species, including fish were also identified and recorded (see Figure 2.3).

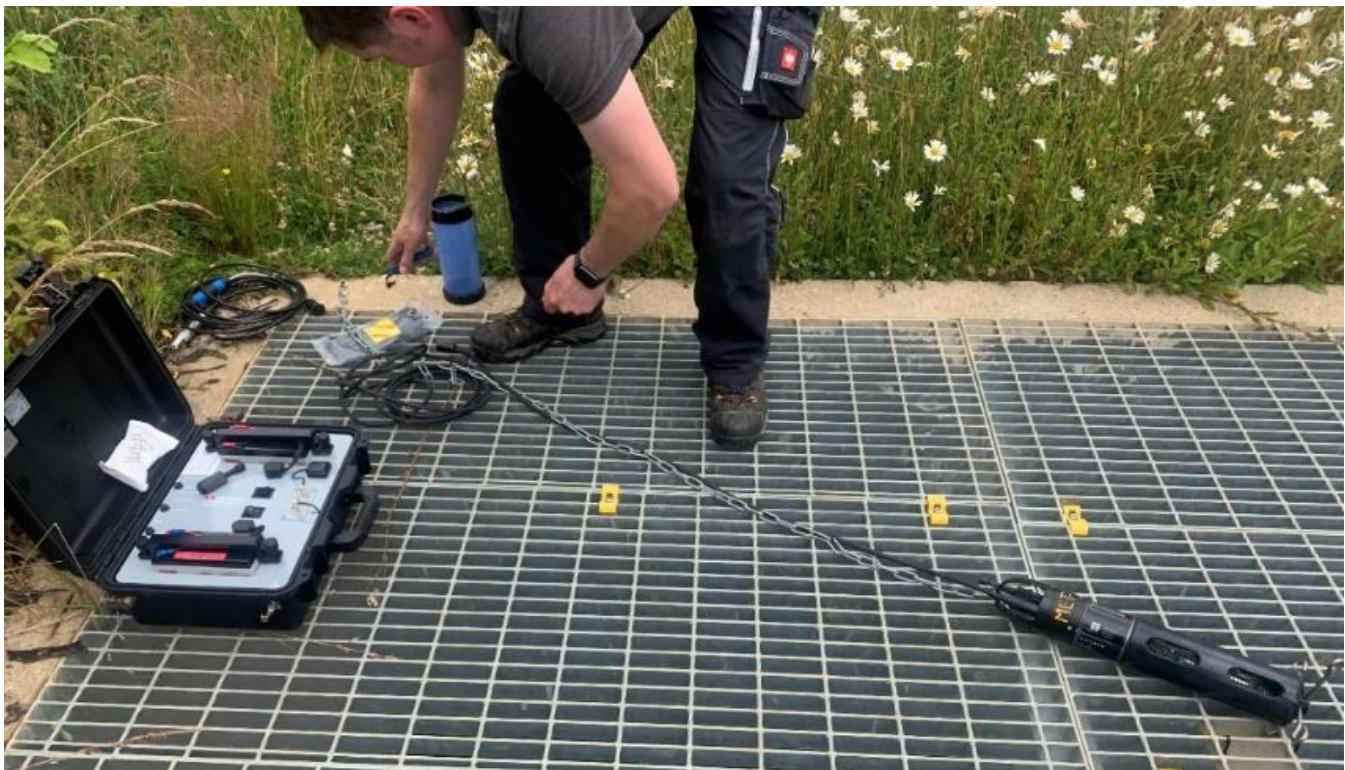
Figure 2.6: Image of the inlet sonde being installed for the summer monitoring period.

Sonde data from the wetland inlet and outlet were uploaded in real time to the Meteor Data Cloud. Data were checked regularly by ZSL and Meteor staff to ensure that sensor readings were not drifting and that water levels were high enough for accurate reading to take place.

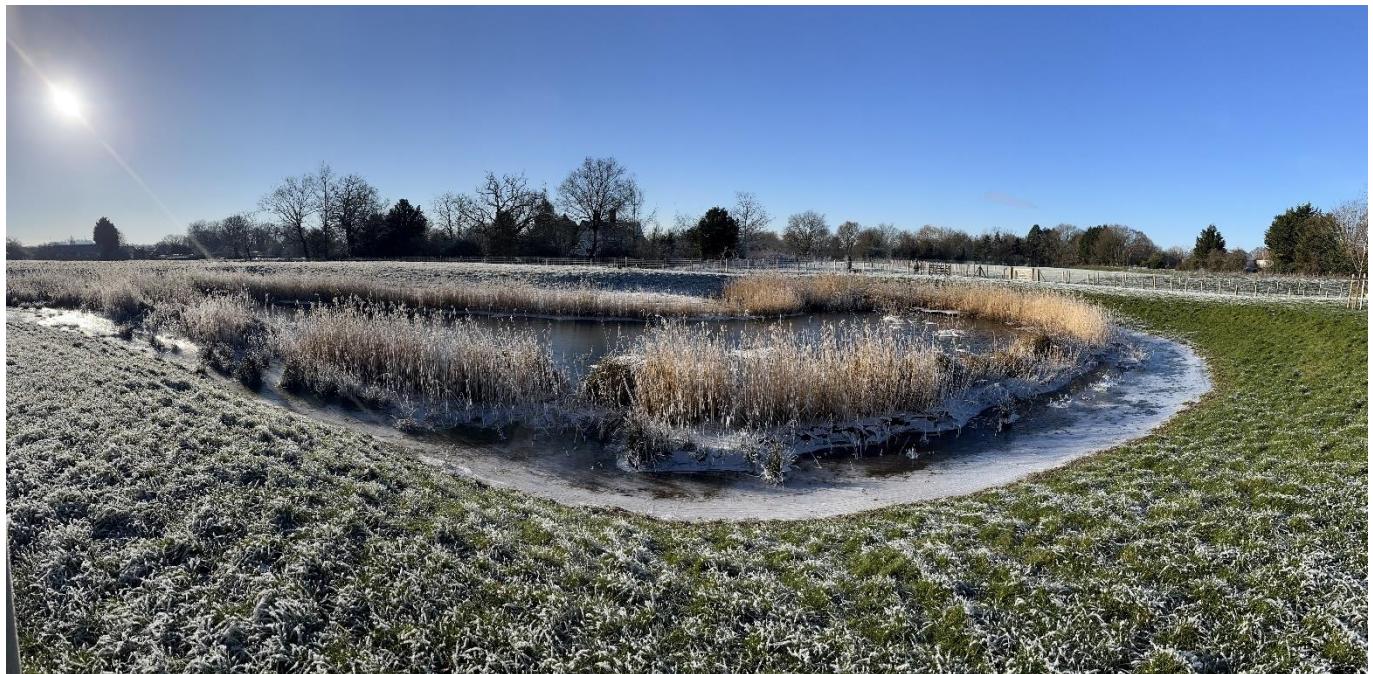
Figure 4.1: Image taken of the Headstone wetland outlet cell (Cell 3) during the particularly cold period in December, showing frozen sections of the wetland. Credit: Adrian Butler, Imperial College London.

During the winter water quality monitoring period, starting at the end of November 2022, conditions throughout the second two weeks of December were particularly cold, bringing snow and ice across the catchment with temperatures falling to as low as -7°C (see Figure 4.1).

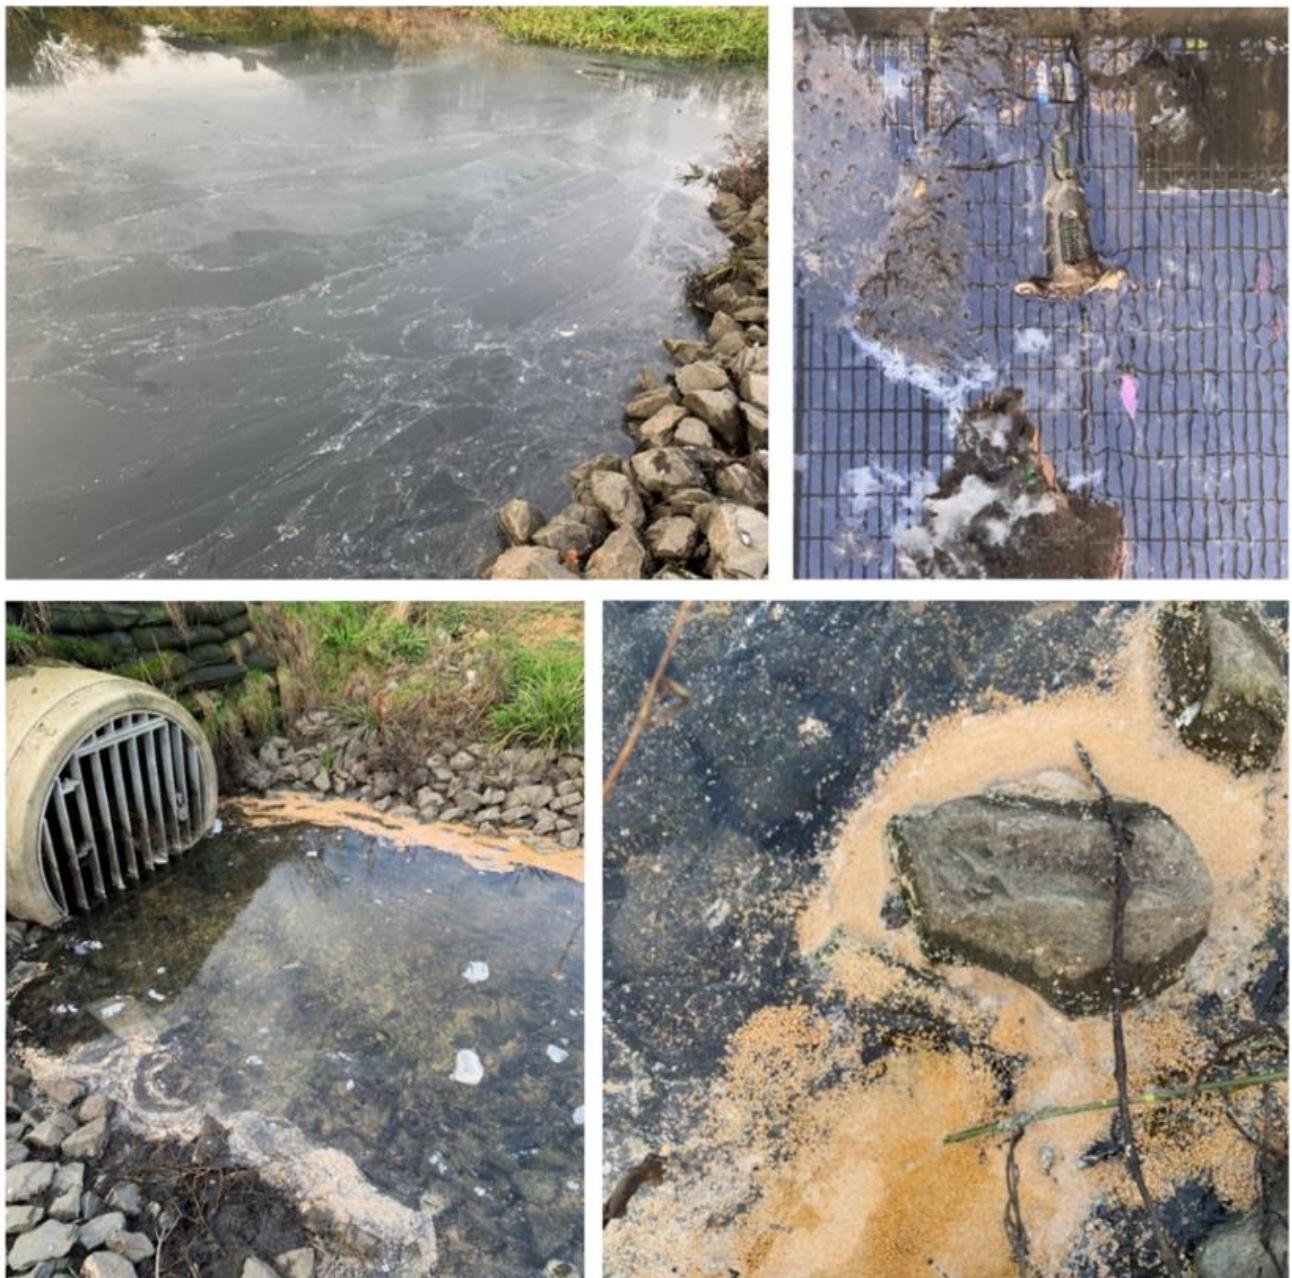
Figure 4.2: Examples of visual signs of pollution at the wetland inlet.

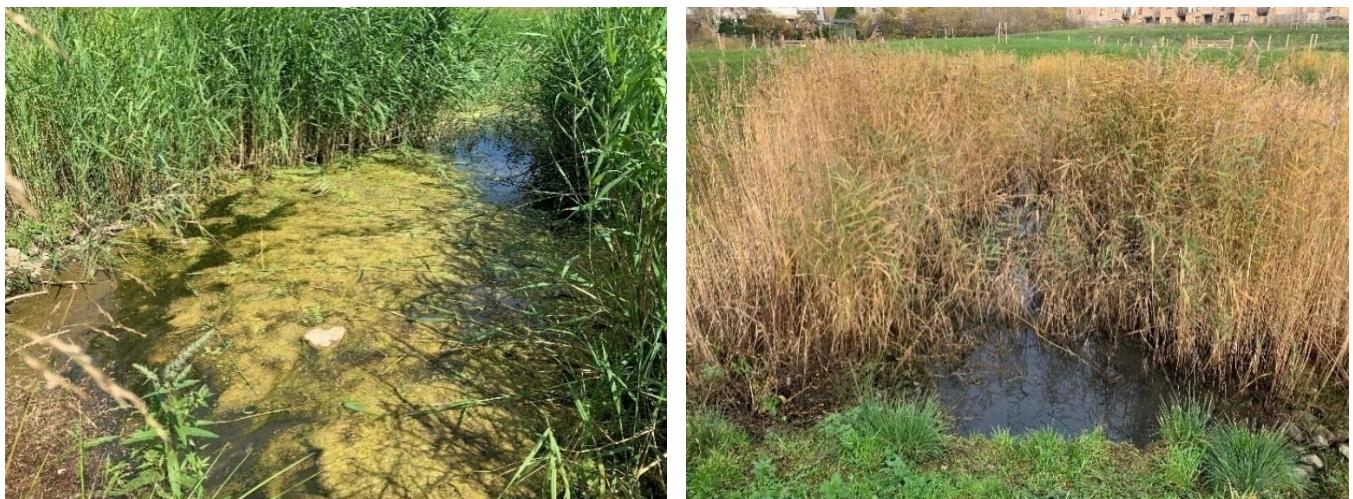
Figure 4.8: Images of algal coverage and dense vegetation taken at the outlet sampling location on (Left) 14/07/2022 and (Right) 01/12/2022.

Elevated TSS can be caused by a range of factors, including runoff, disruption to bottom sediments causing resuspension, untreated wastewater and much more. However, in this case, the gravimetric methodology used to calculate TSS (i.e. results determined by weight) means that results are likely impacted by algal material transported from the wetland due to the system being highly productive and eutrophic. Therefore, although the wetland may be trapping fine sediments, the increase in TSS concentrations at the outlet, is likely a result of the growth and suspension of algal material that is not seen in the inlet samples (see Figure 4.8).

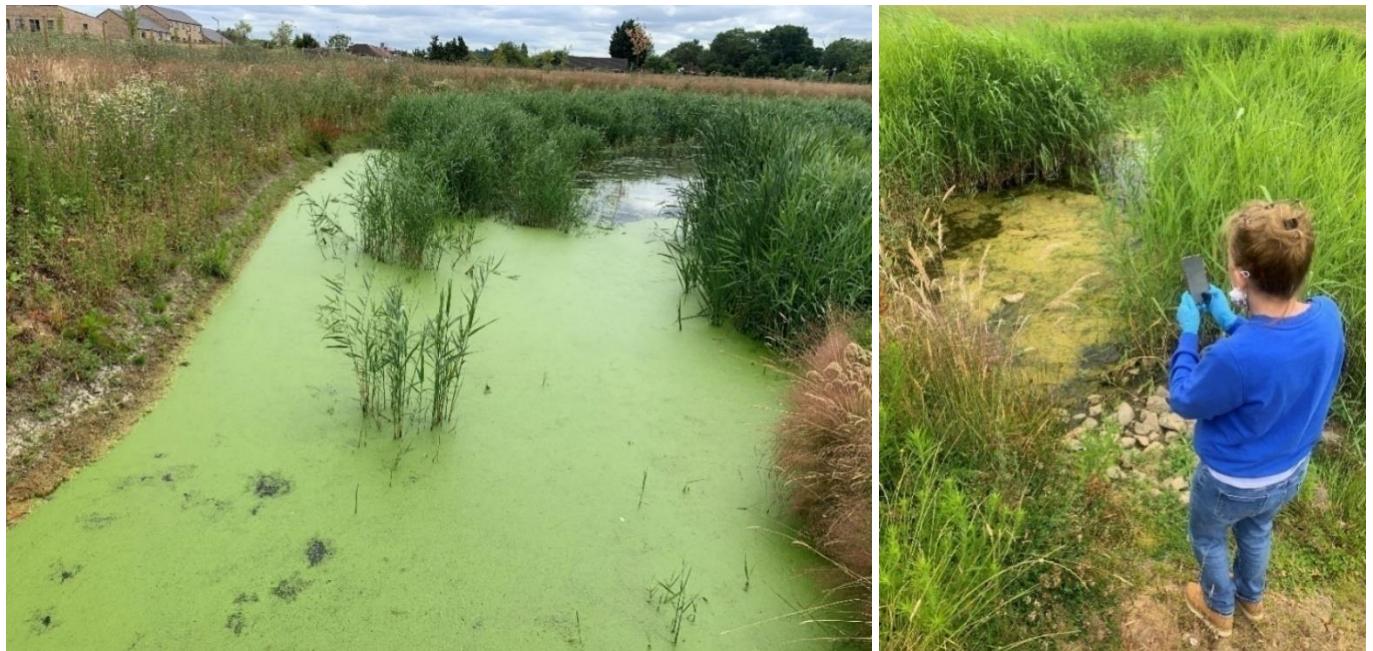
Figure 4.14: (Left) Image of Wetland outlet cell with extensive cover of duckweed. **(Right)** FoHMP volunteer documenting the presence of dense algal biomass and blanked weed at outlet cell adjacent to outlet sonde during a water spot sample collection.

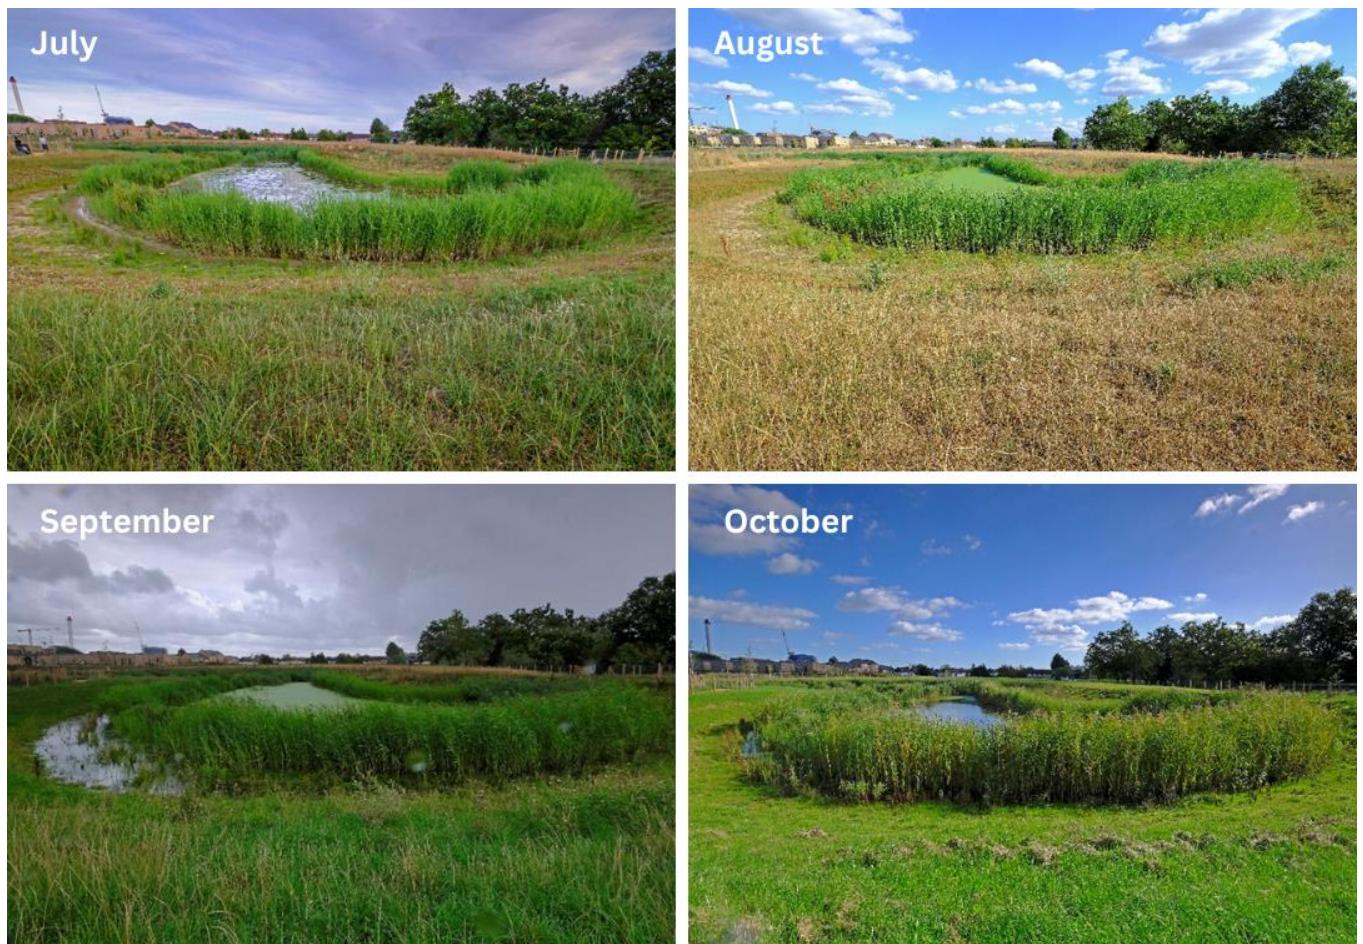
Figure 4.16: Fixed-Point Photography images of the outlet from July to October 2022. Credit: Peter Elton (FoHMP).

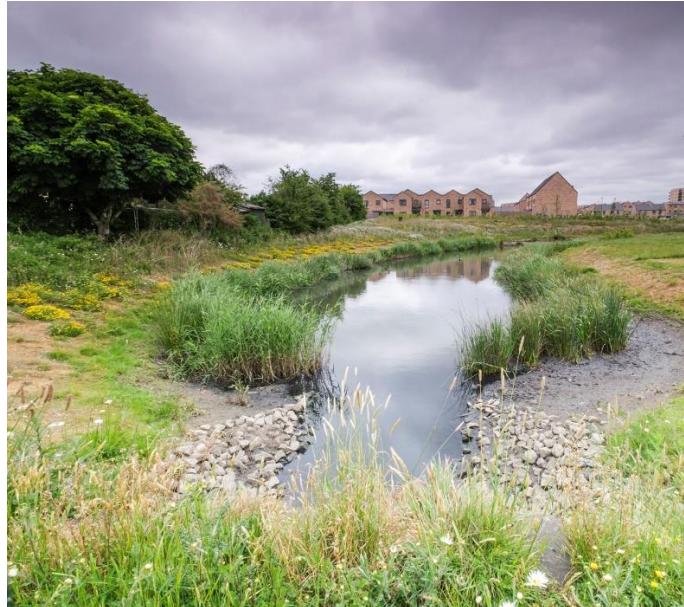
June Inlet:

Fixed Point Photography images from the wetland inlet and outlet (Credit: Peter Elton, FoHMP).
