Yeading Brook Restoration

London Wildlife Trust

cbec eco-engineering UK Ltd

Document Type: Final report

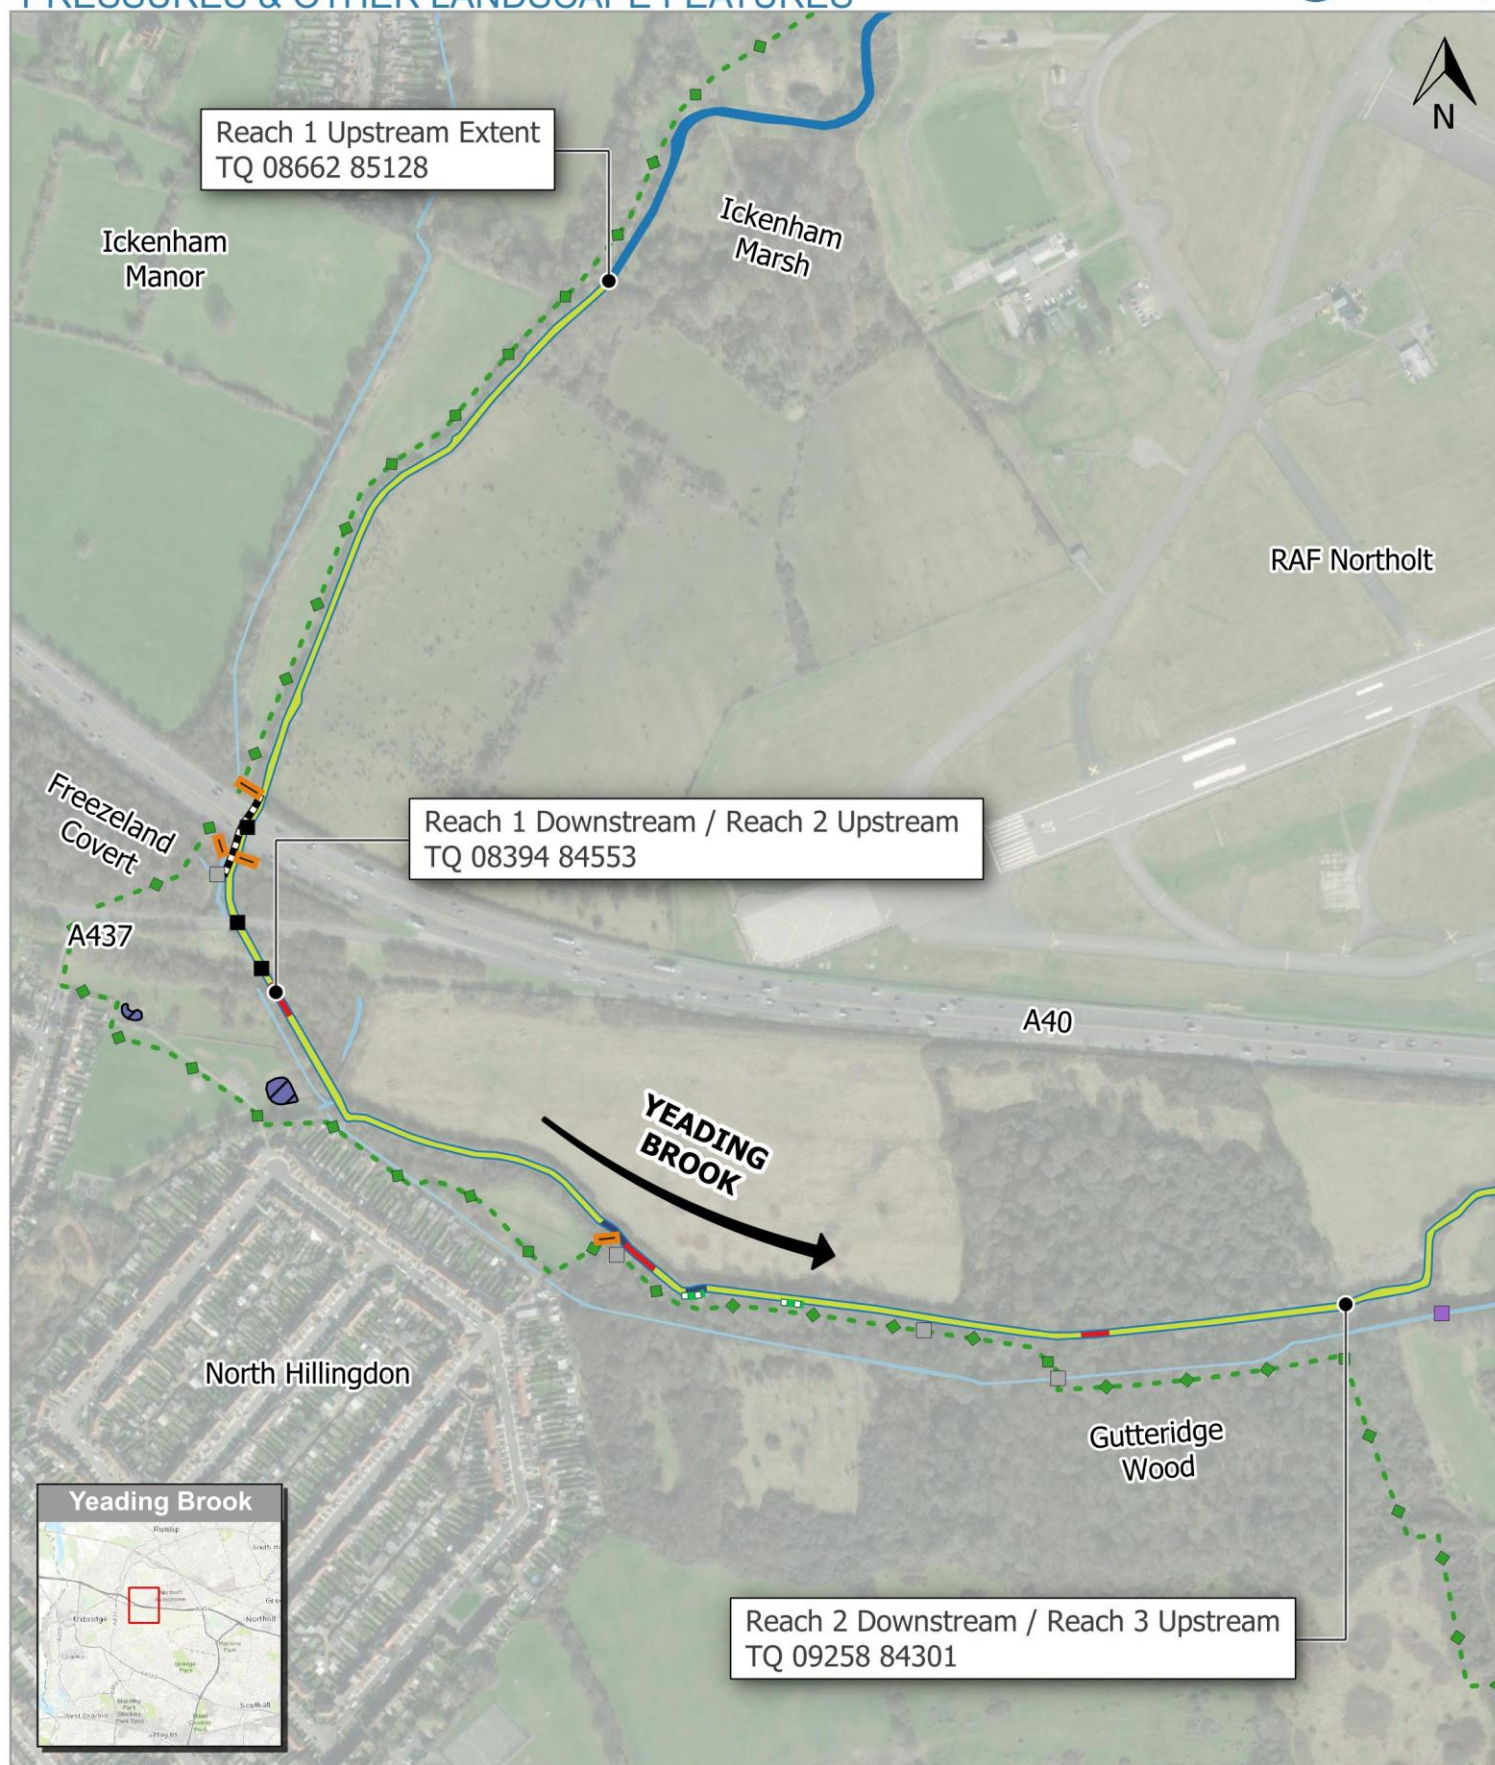
Figure 4.2 Flow types, engineering pressures and landscape features along Reaches 1 and 2.

Table 4.1 provides a summary for the fluvial audit while Figure 4.2 and Figure 4.3 show the locations and characteristics of physical features observed along Reach 1. Selected photographs are presented in Table 4.2 to illustrate site characteristics, in addition to drone imagery to show the landscape context.

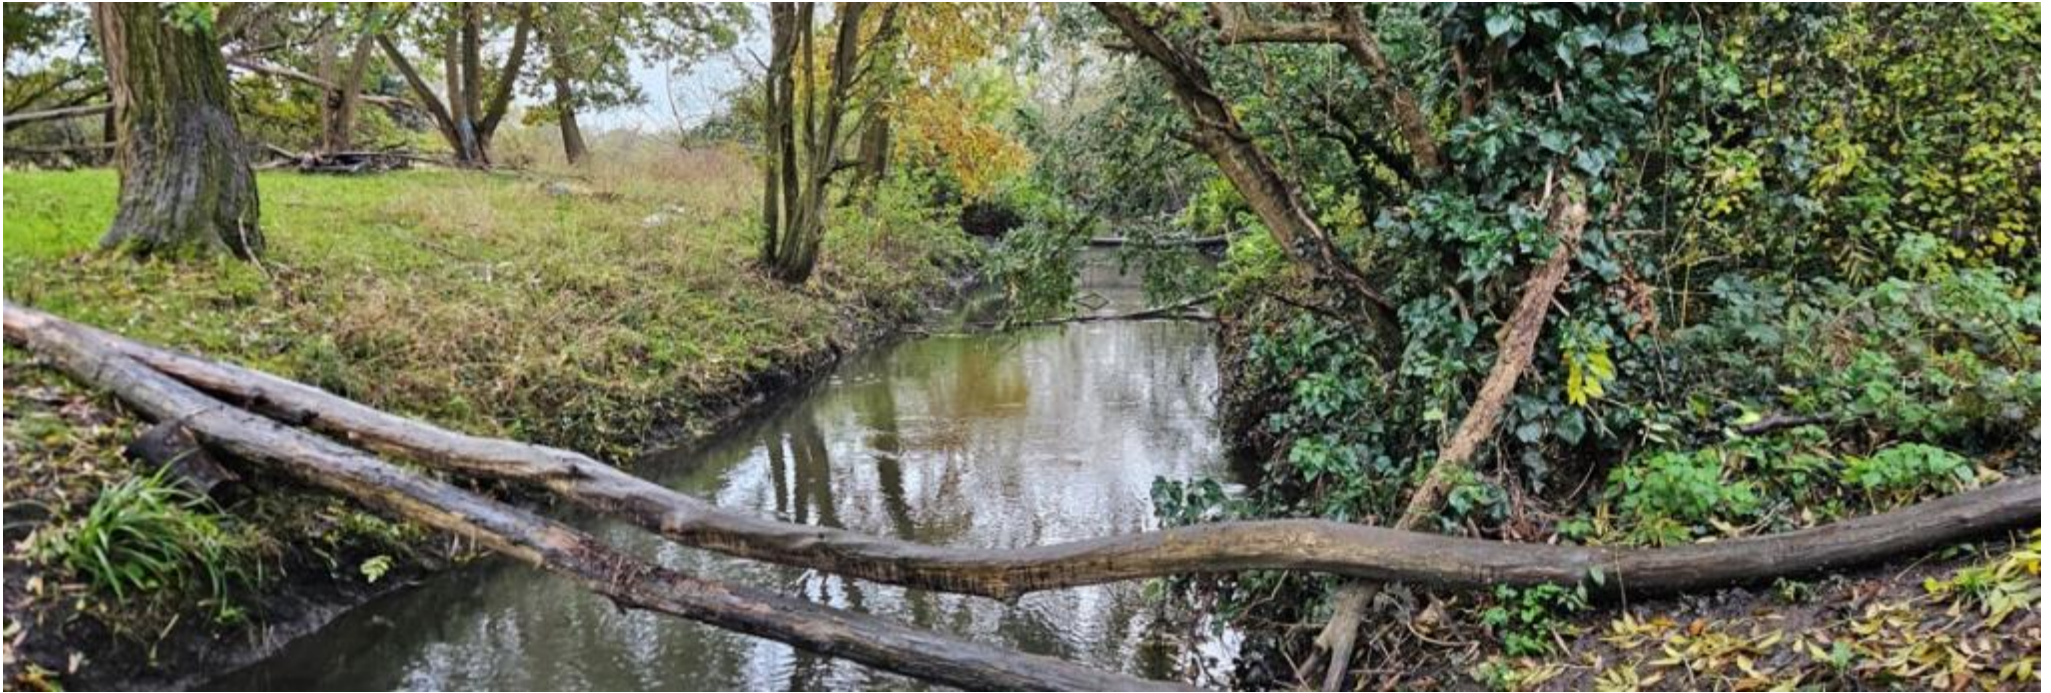
Figure 4.4 ↑ Upstream extent of Reach 1. The channel has been extensively modified; it has been straightened, resectioned, and is now disconnected from its floodplain. Marginal and in-channel vegetation is largely absent or poorly developed.

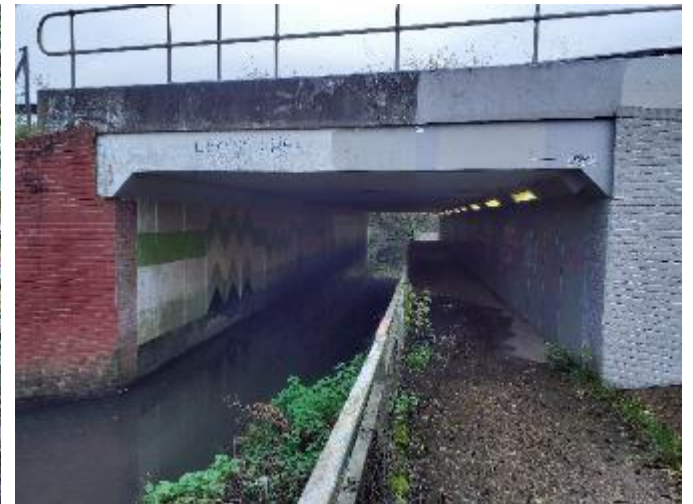
Figure 4.9 Looking downstream along the channel at the A40 road bridge. The beds and bank of the channel are reinforced with concrete.

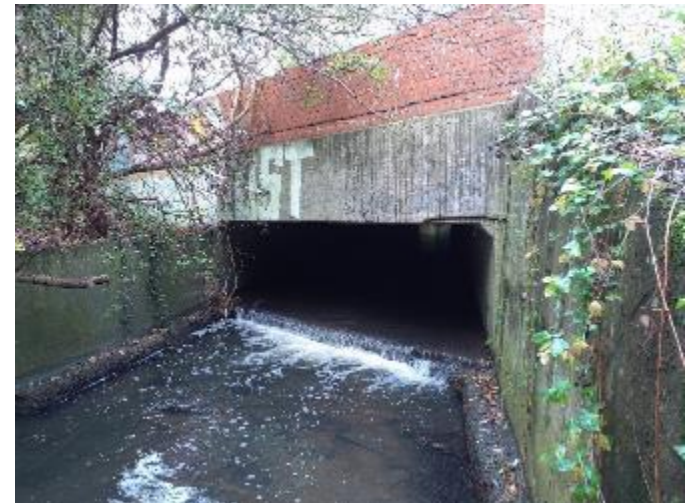
Figure 4.12 Step weir at the lower limit of Reach 1. The bed and banks of the Brook are reinforced with concrete as it flows beneath the A437.

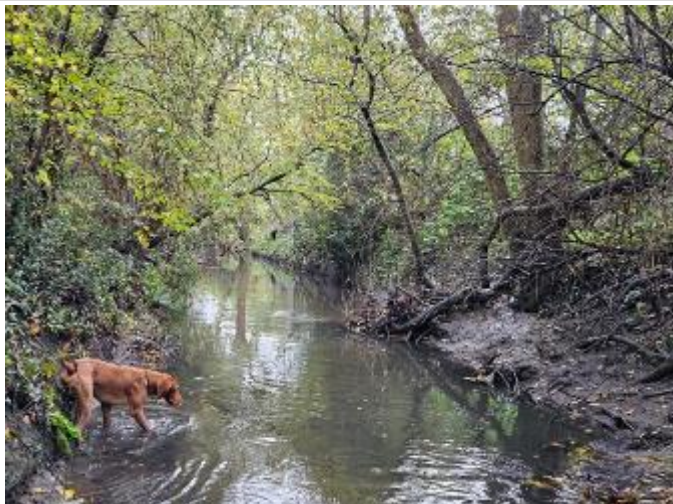
Figure 4.13 Looking downstream along Reach 2. The channel is overwide and slow flowing, with limited natural geomorphic features.

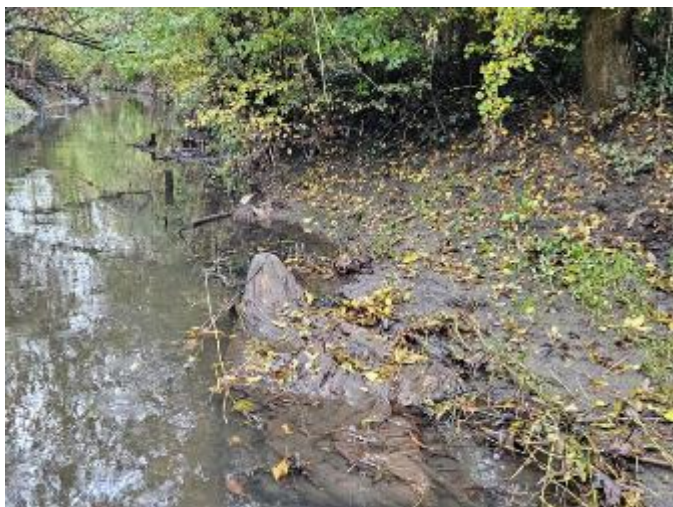
Figure 4.16 Evidence of former restoration attempts; berms built along the channel have failed leaving wooden stakes used to secure brushwood fascines.

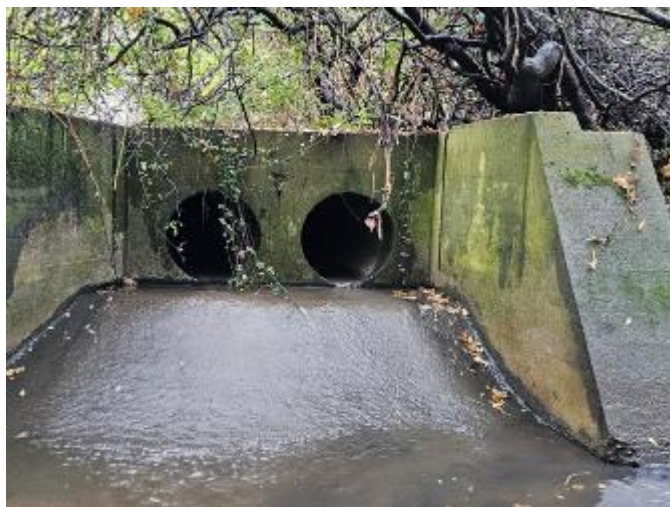
Figure 4.17 A culverted tributary flows into the channel in the upper reach. This likely conveys runoff from roads and residential properties south of the Brook.

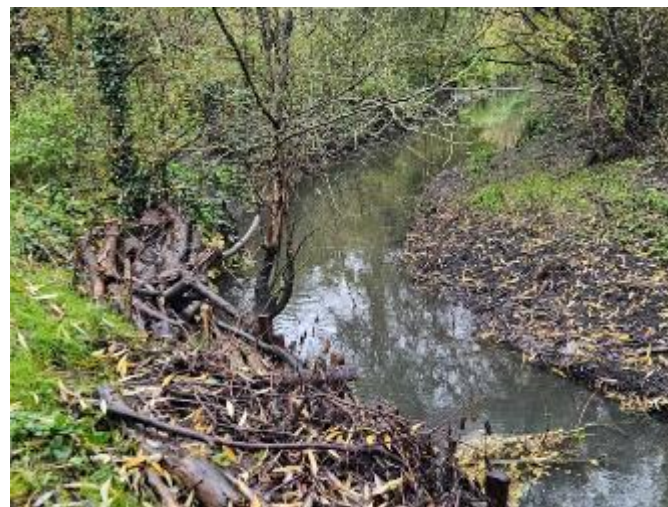
Figure 4.18 The channel exhibits toe scour (minor to moderate in severity). Short sections of erosion protection measures consisting of logs/brush have been installed.

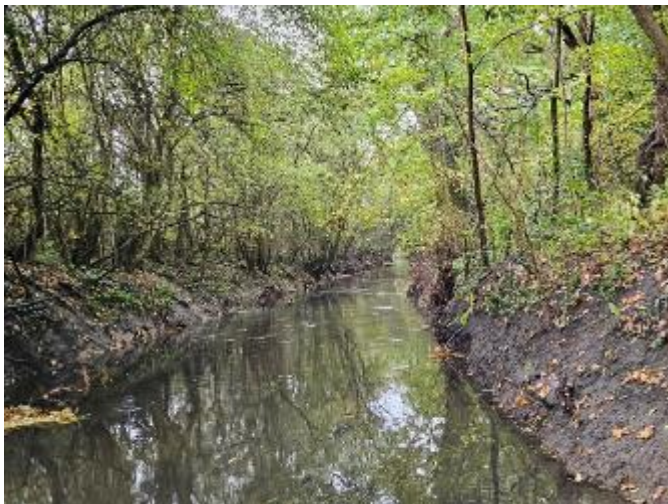
Figure 4.20 Looking downstream along the channel. Note the channel is largely devoid of natural alluvial bedforms and exhibits limited hydrological diversity.

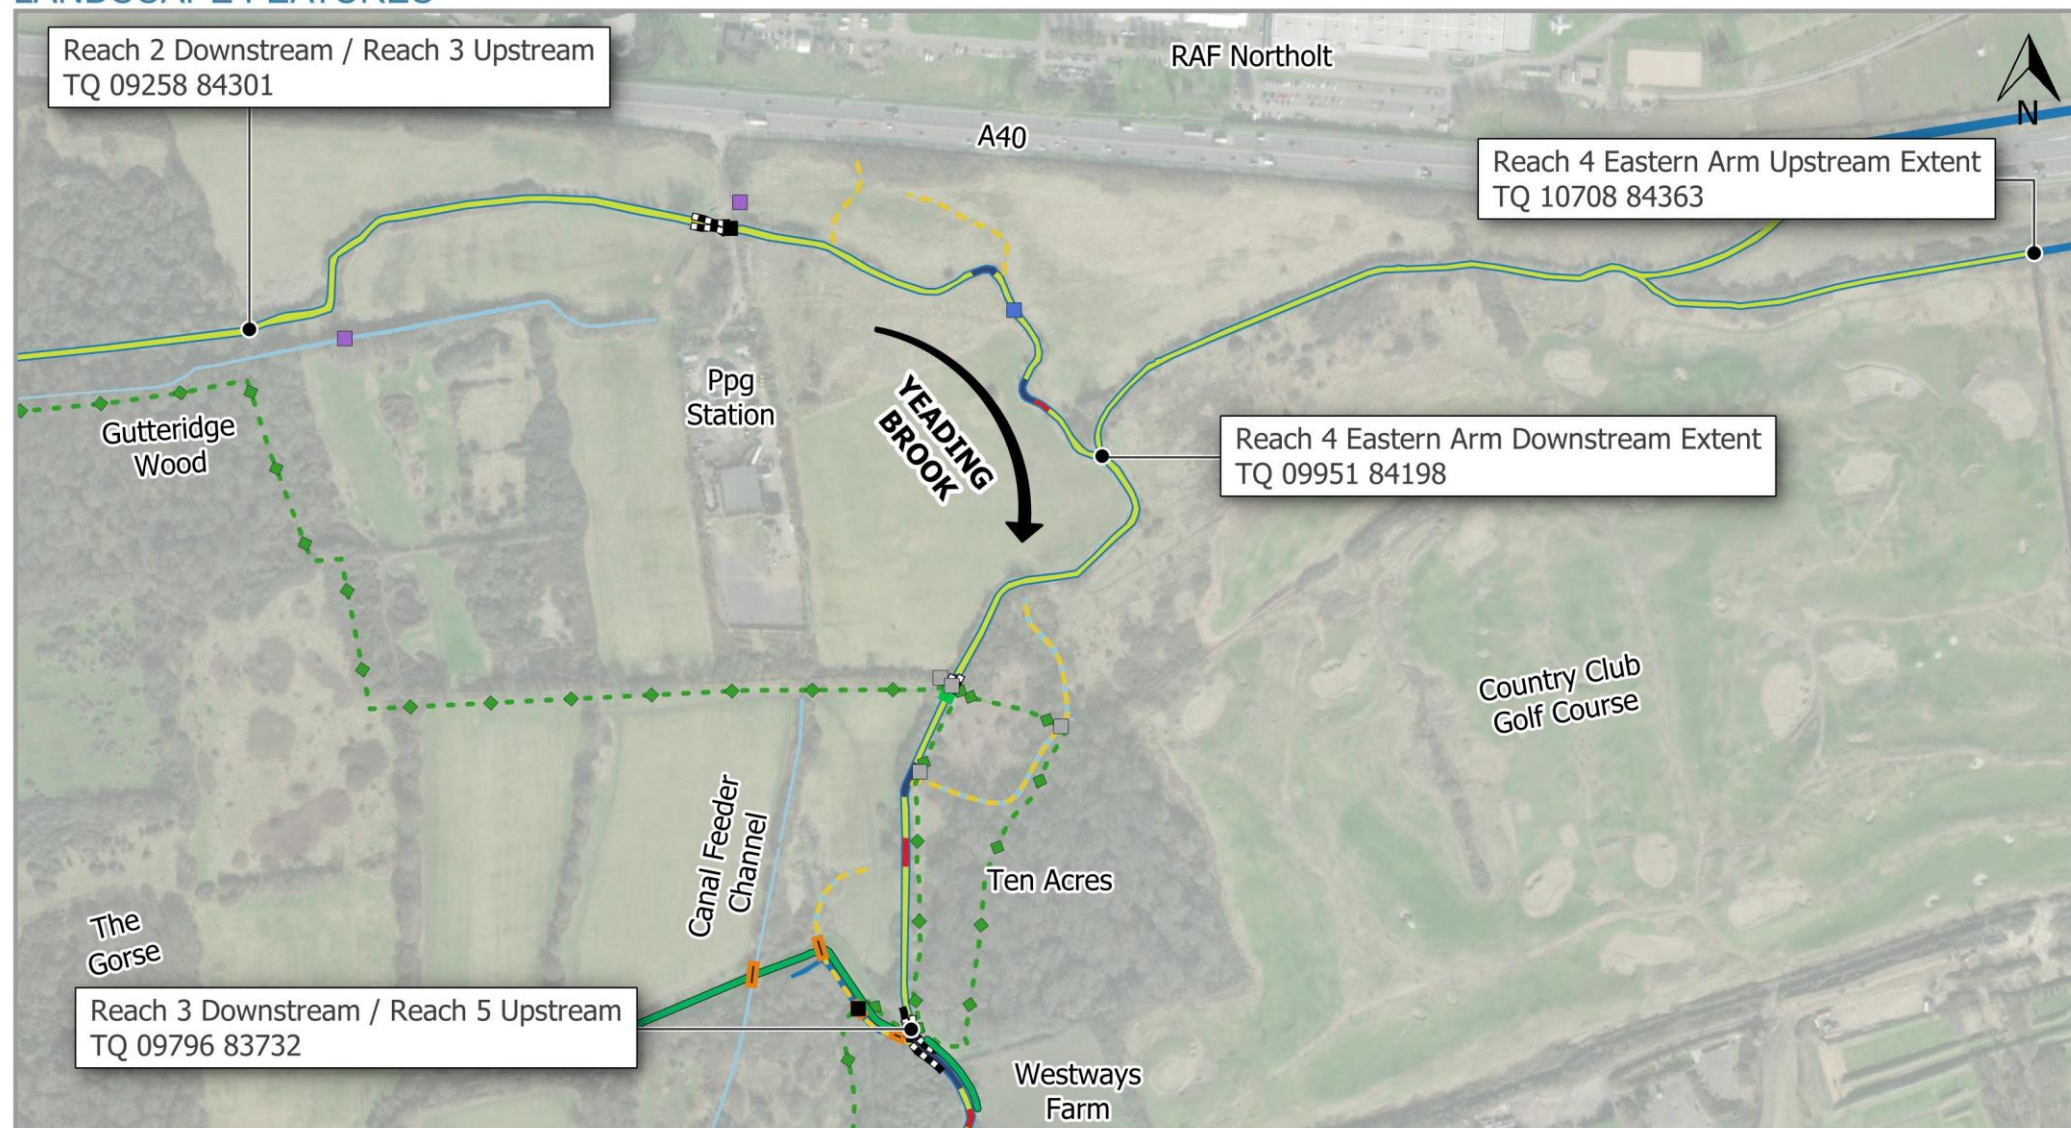
Figure 4.25 Flow types, engineering pressures and landscape features along Reach 3.

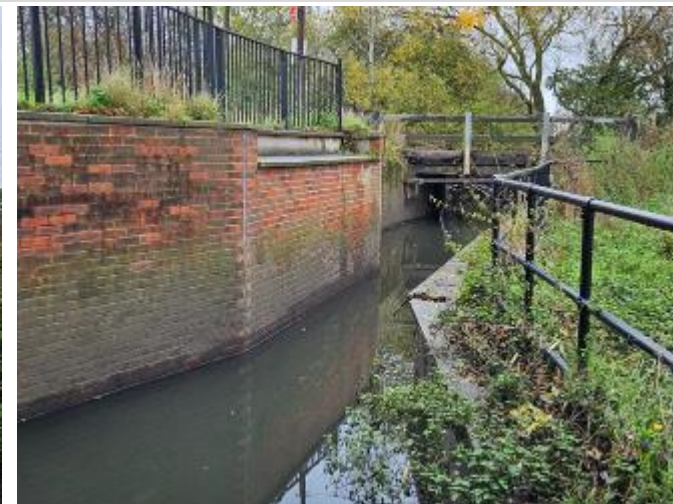
Figure 4.29 EA gauging station (Yeading Brook FSA – 36YB0202/SR01). Conversations with the EA confirm that this gauging station has been decommissioned.

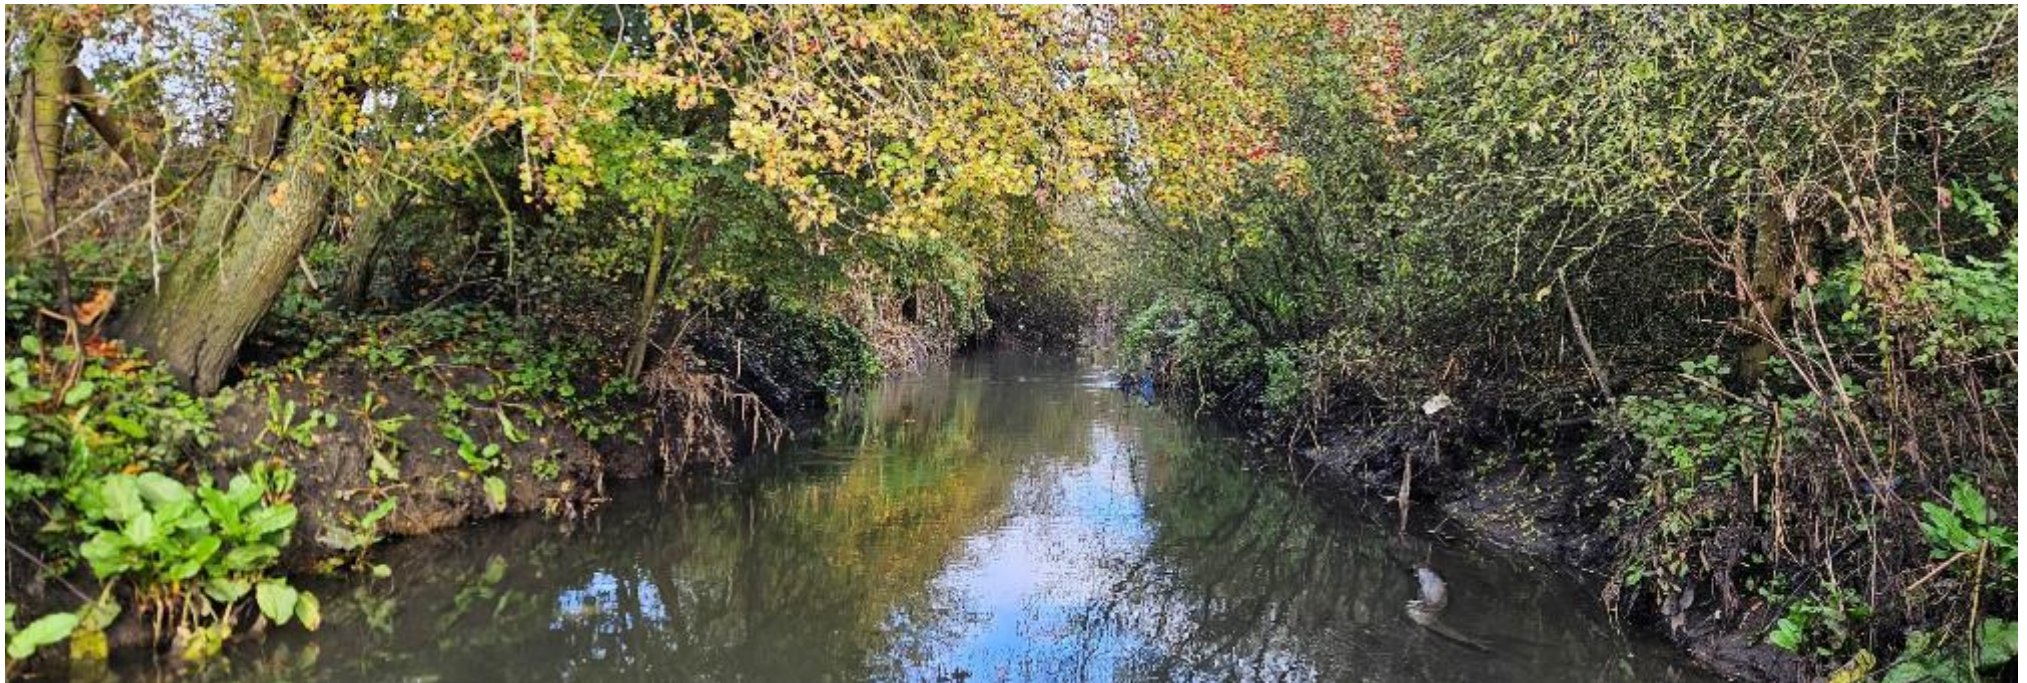
Figure 4.36 Look upstream from the pedestrian footbridge at TQ 09829 84012. Here, the channel is bordered by a line of mature trees and is shaded. Himalayan balsam was noted along the TLB and is also likely present along the TRB.

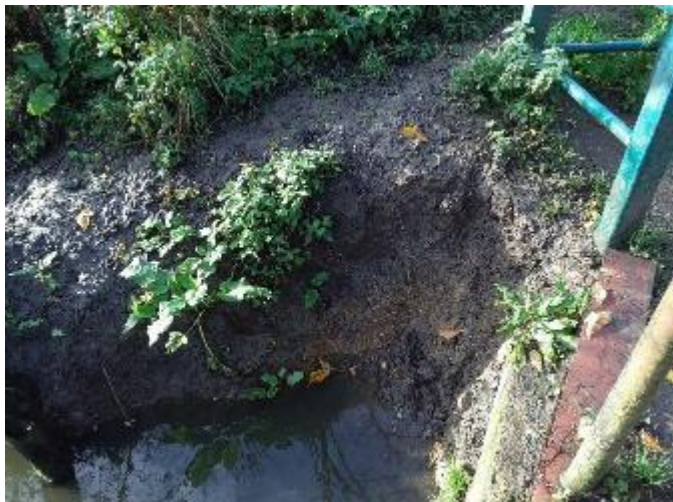
Figure 4.37 Poaching immediately downstream of pedestrian footbridge at TQ 09829 84012. Several sections of poaching were observed along the pedestrian footpath (TLB), likely caused by dogs entering the channel.

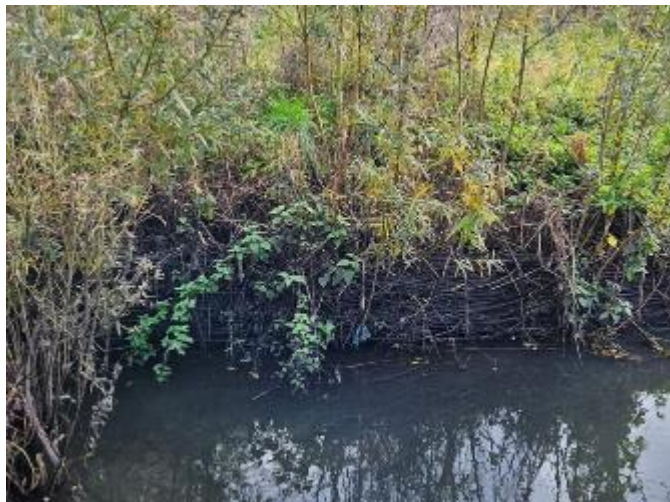
Figure 4.38 Live willow fencing along the TRL in the vicinity of the pedestrian footbridge at TQ 09829 84012.

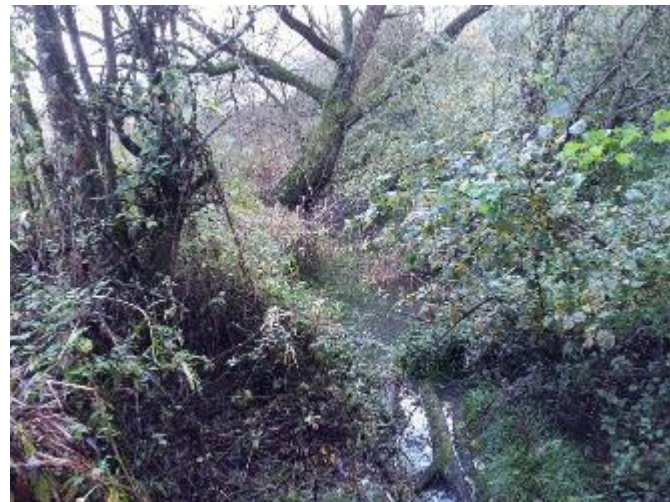
Figure 4.39 A relict meander is located in the TLB floodplain which was bypassed when the channel was straightened c. 1940. Himalayan balsam was observed in several locations along the relict meander.

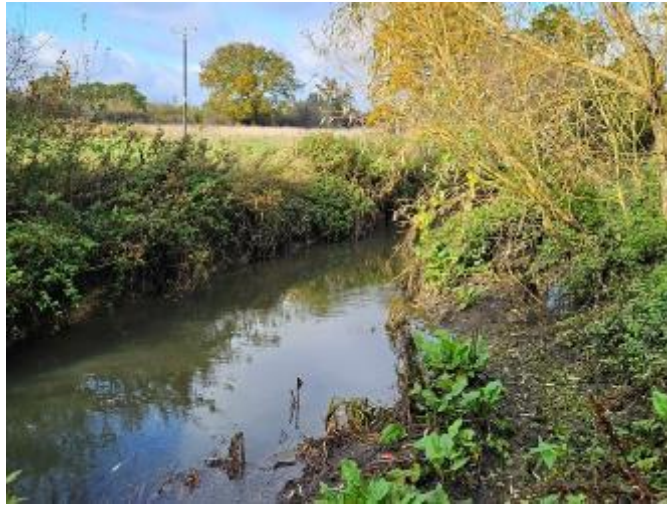
Figure 4.44 Looking downstream; vegetated lateral berms were observed along the lower section of the reach.

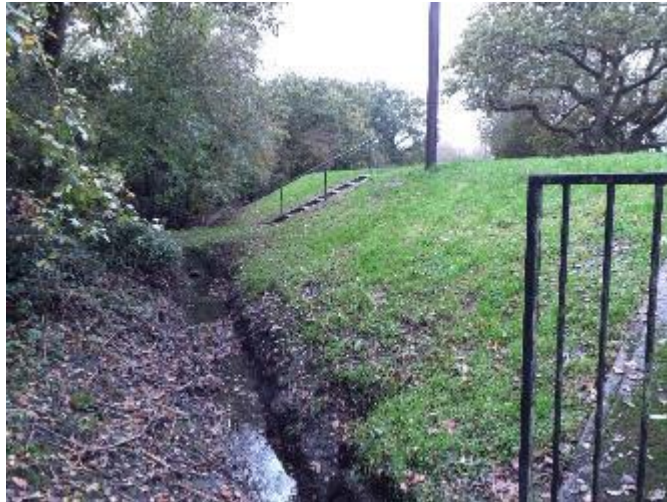
Figure 4.47 Flood embankment delineating Charville Lane FSA. Note the tributary in the foreground; this occupies a relict meander of the channel.

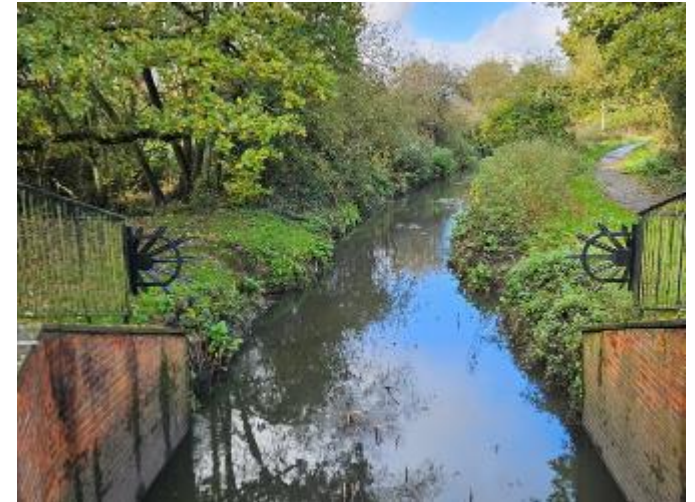
Figure 4.48 Looking upstream from Charville Lane gauging station (TQ 09796 83732). This structure marks the lower limit of the reach.

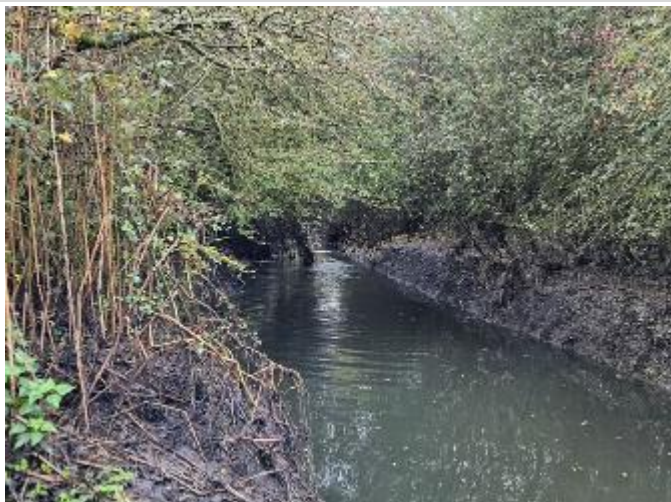
Figure 4.49 Looking downstream along the River Roxbourne (Eastern Arm). The channel is slow flowing and exhibits limited hydromorphological diversity. In places the bank and channel are heavily shaded.

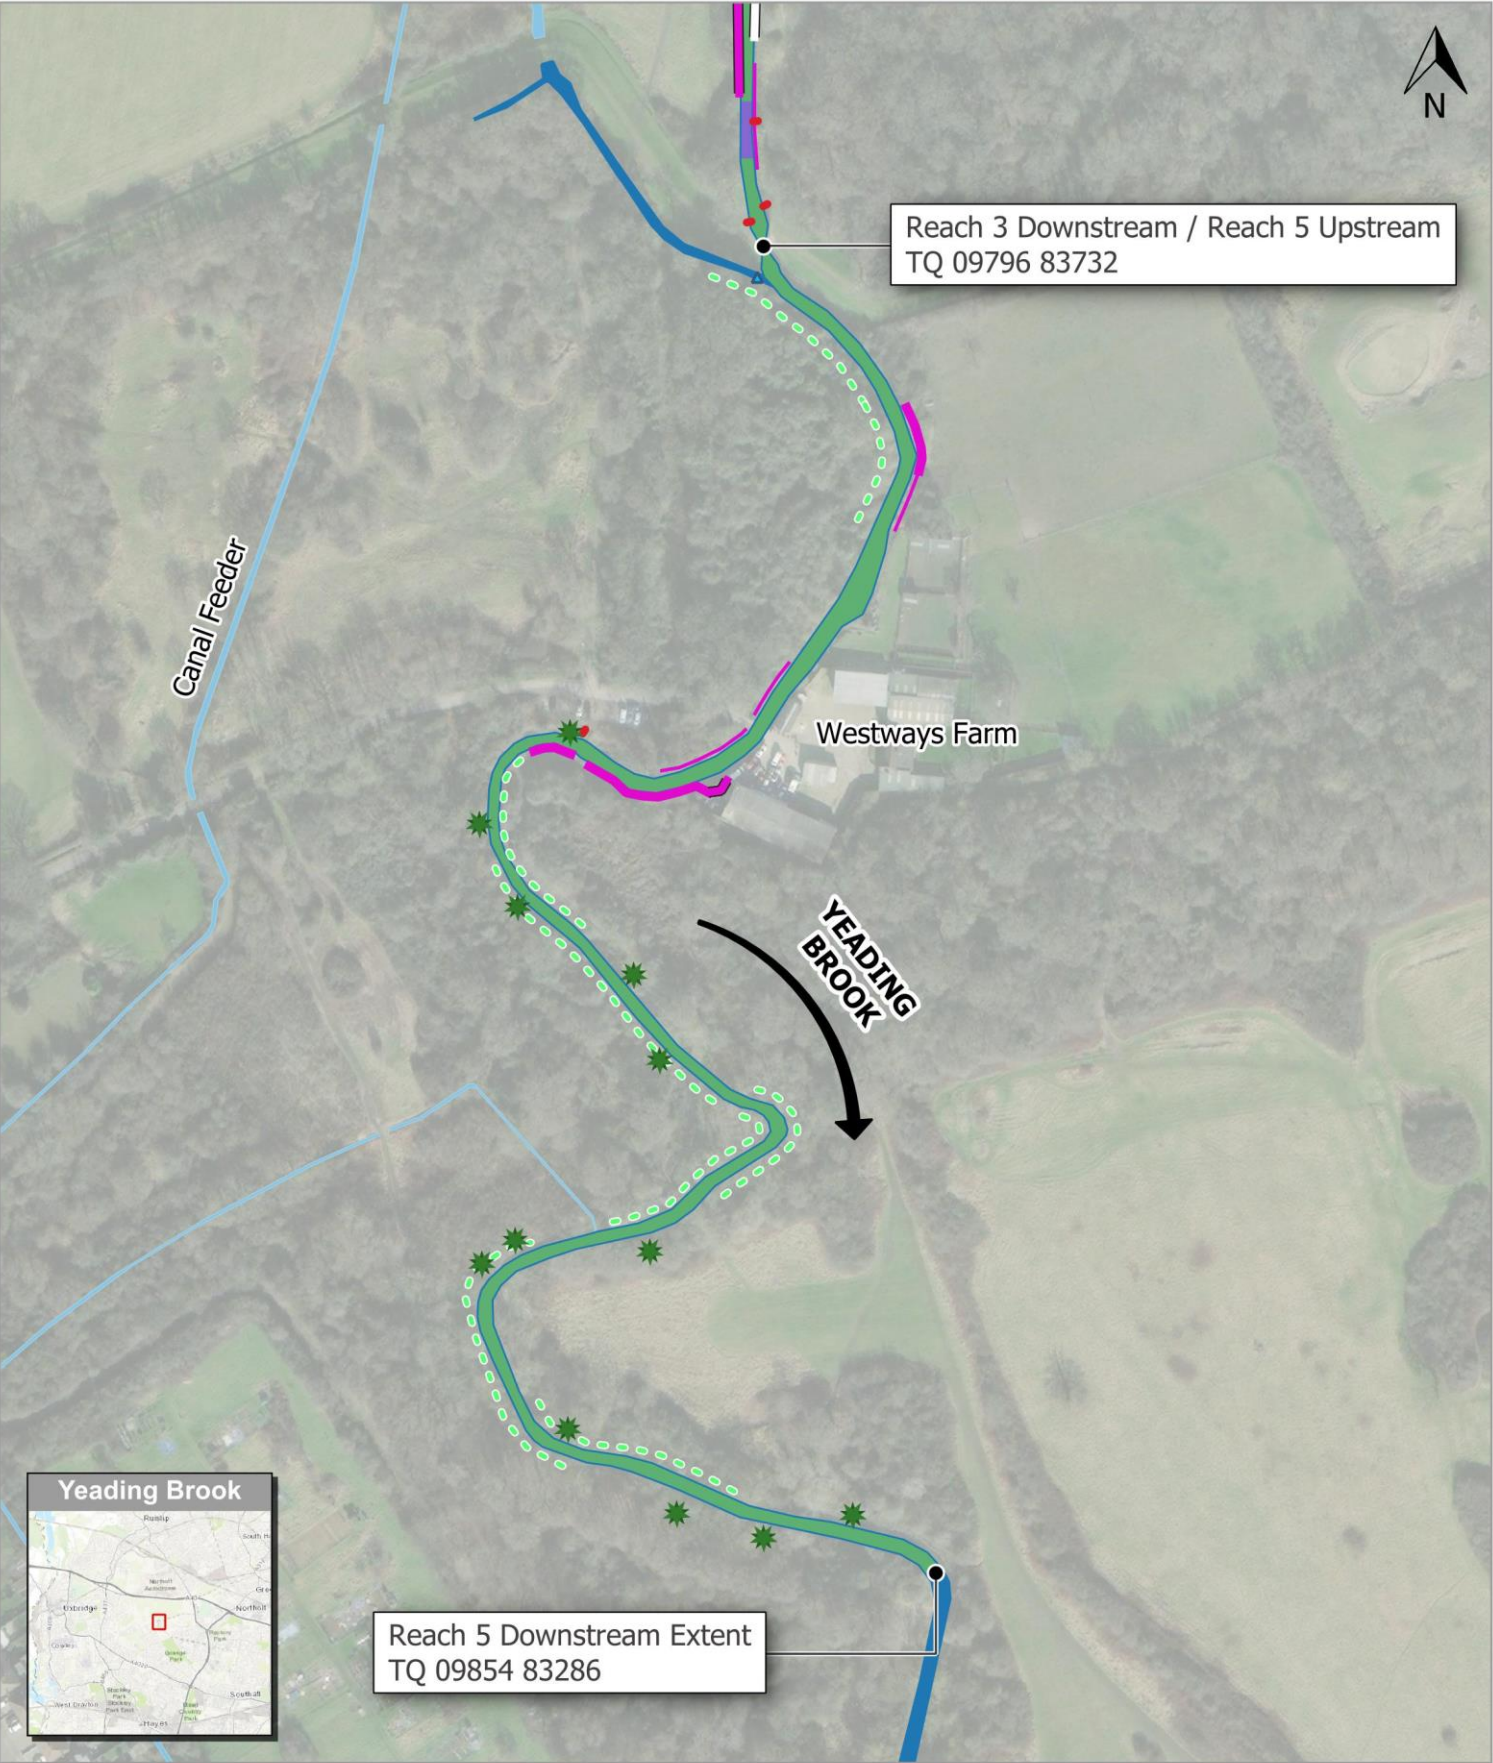
Figure 4.56 Sediment dynamics and vegetation characteristics along Reach 5.

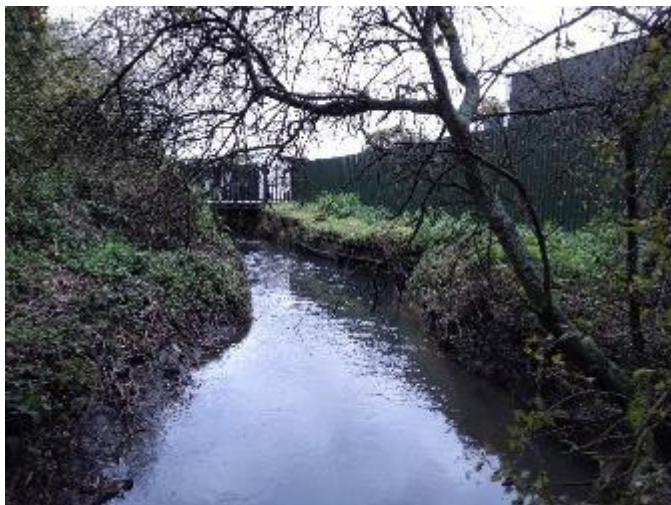
Figure 4.60 Looking upstream along the channel towards the vehicle bridge located at TQ 09794 83570. This provides access to Westway Farm. The banks in the vicinity of the bridge have been reinforced with wooden panels/fencing.

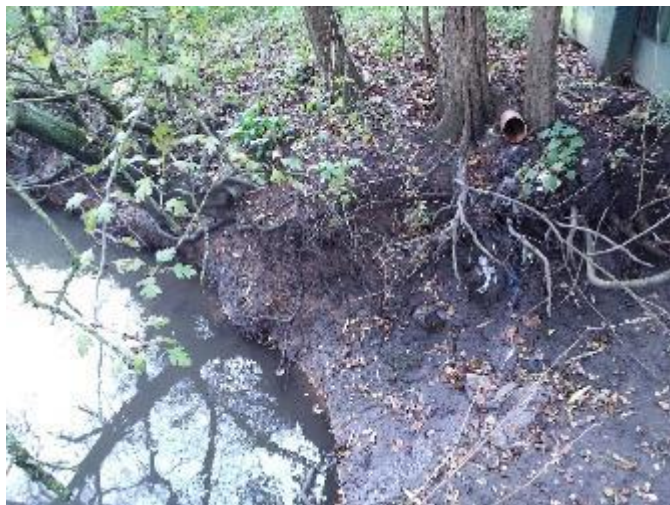
Figure 4.61 Moderate erosion (shear face) was observed along the right bank just downstream of Westways Farm

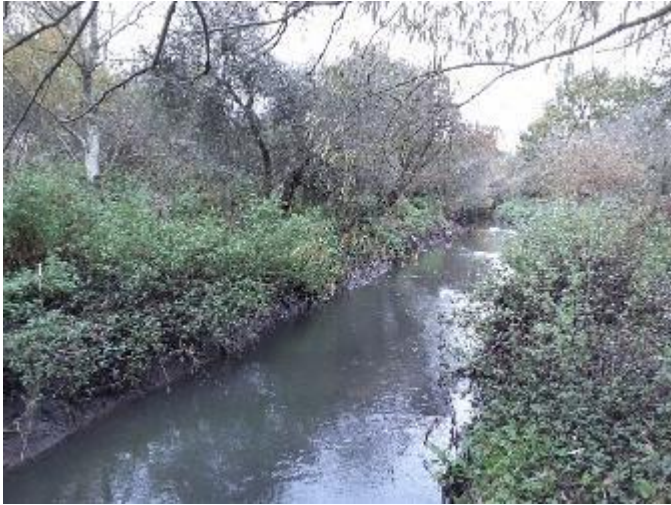
Figure 4.63 The channel is overwide and straight, exhibiting limited geomorphic variability and little in-channel habitat.

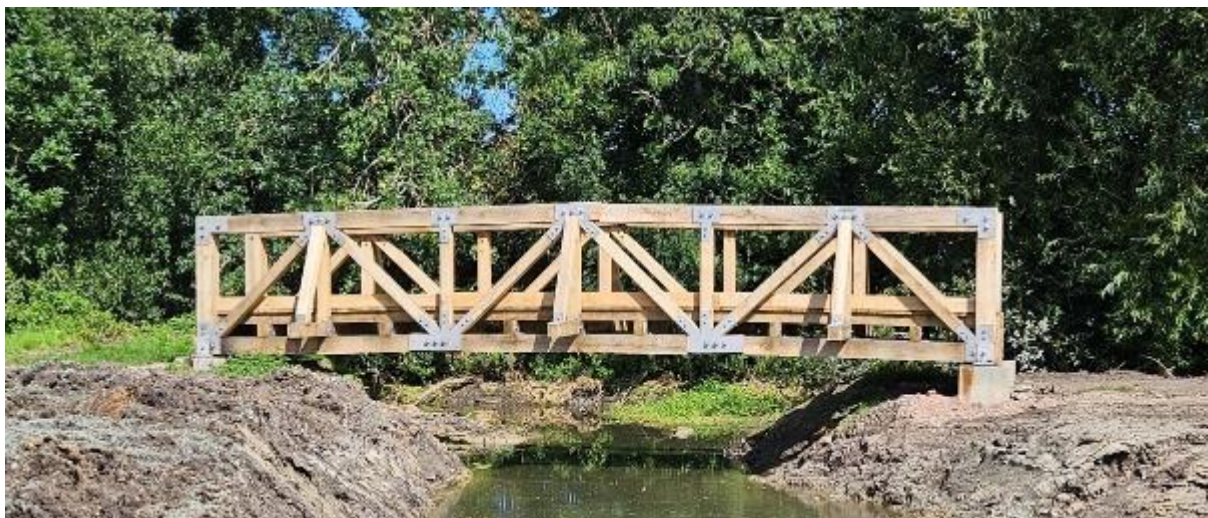
Figure 5.9 Example of a hardwood bridge being installed over a realigned channel. Source: cbec eco-engineering UK Ltd.

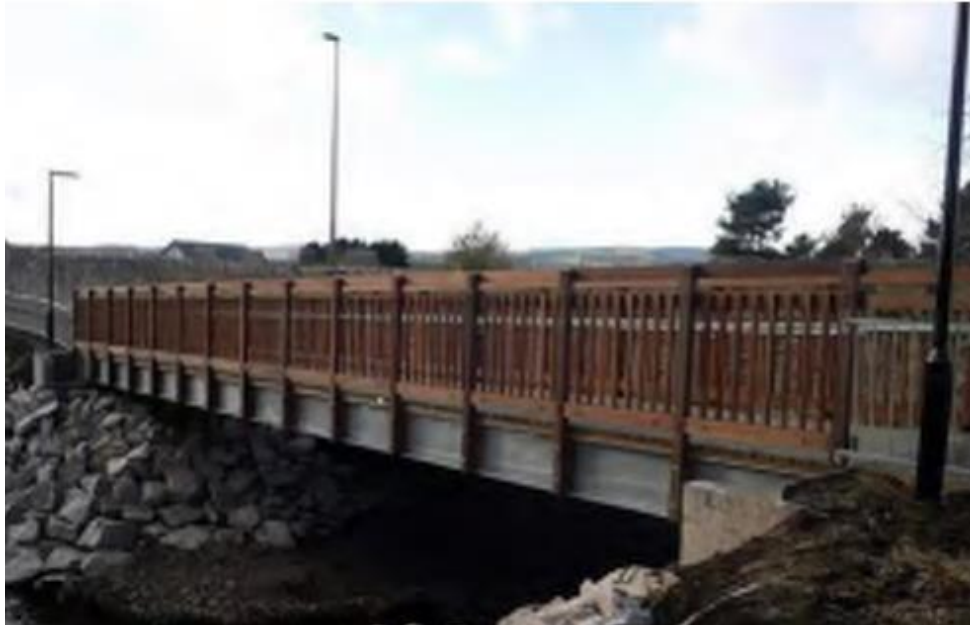
Figure 5.10 Example of a steel and timber bridge suitable for vehicles that could be installed (Photo courtesy CTS Bridges).
