# An Assessment of Barriers to Fish Passage in the Crane River Catchment

June 2016

*Crane Valley Partnership*

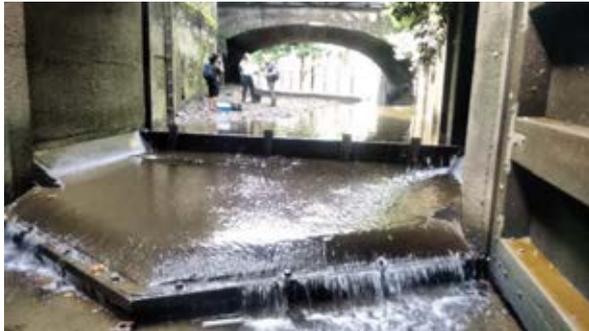
Wooden planks across the channel present a vertical barrier at low tide. There are four thin metal pieces along the crest of the structure. There is a ~10cm gap at the left bank resulting in lower hydraulic head and faster flows over/through the structure. The barrier is submerged at high tides.

*Figure 3.1.3.3a (left): Tidal Crane Barrier 2 in the background viewed from downstream*

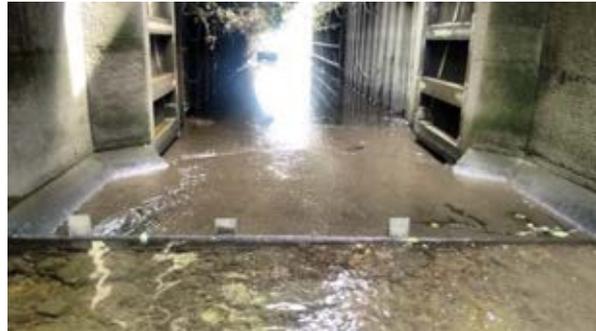
*Figure 3.1.3.3b (right): Tidal Crane Barrier 2 viewed from upstream*

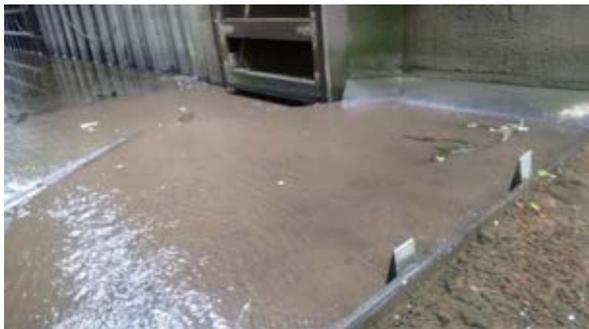
*Figure 3.1.3.3c: Tidal Crane Barrier 2 viewed along crest from left bank*

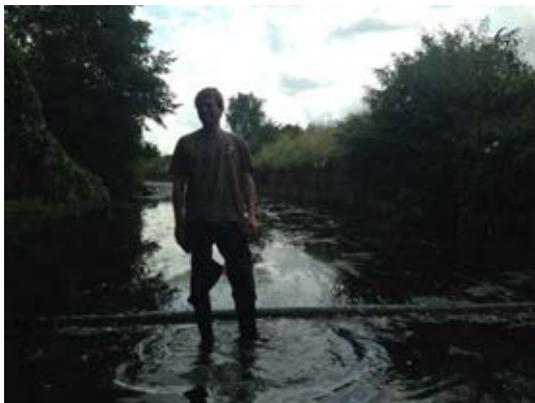
Small vertical weir made from pre-cast concrete that is fully submerged at high tides.

*Figure 3.1.4.3a (left): Tidal Crane Barrier 3 viewed from downstream*

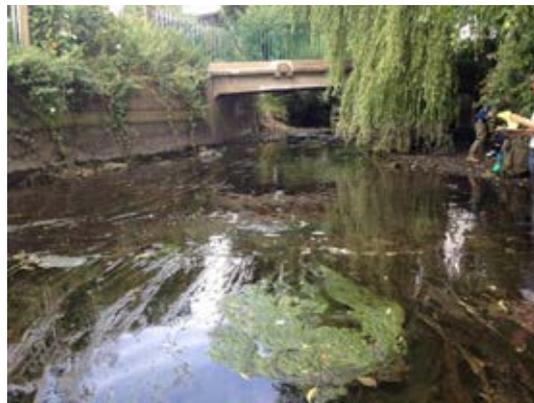
*Figure 3.1.4.3b (right): Tidal Crane Barrier 3 viewed from upstream*

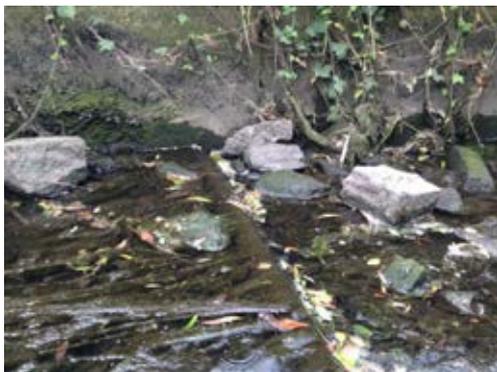
*Figure 3.1.4.3c: Tidal Crane Barrier 3 viewed along crest from mid-channel*

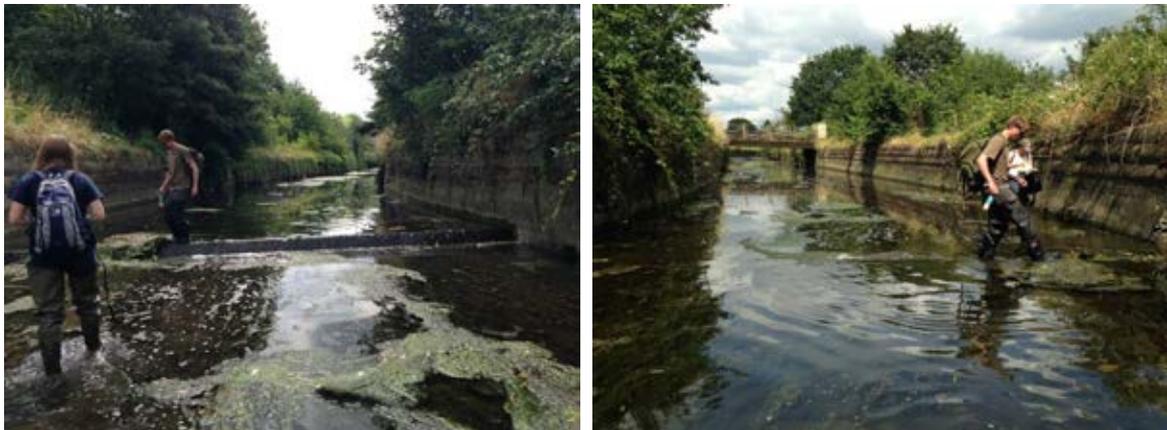
Small vertical weir made from pre-cast concrete that is fully submerged at high tides.

Figure 3.1.7.3a (left): Tidal Crane Barrier 6 viewed from downstream

Figure 3.1.7.3b (right): Tidal Crane Barrier 6 viewed from upstream

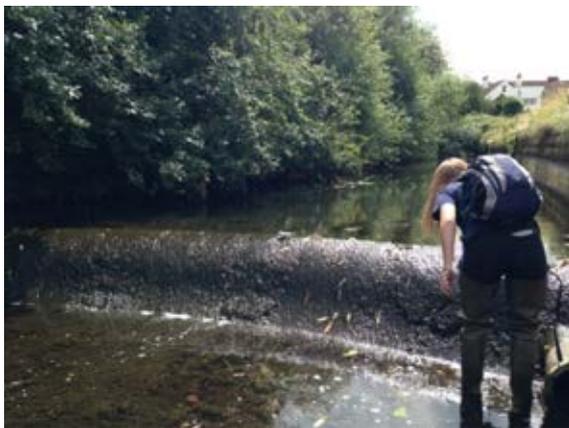
Large vertical weir made from pre-cast concrete with a slight curve along the crest. It is submerged at high tides.

*Figure 3.1.8.3a (left): Tidal Crane Barrier 7 viewed from downstream at left bank*

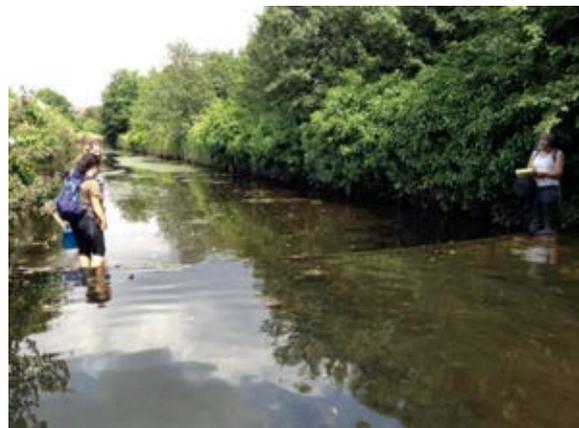
*Figure 3.1.8.3b (right): Tidal Crane Barrier 7 viewed from upstream at left bank*

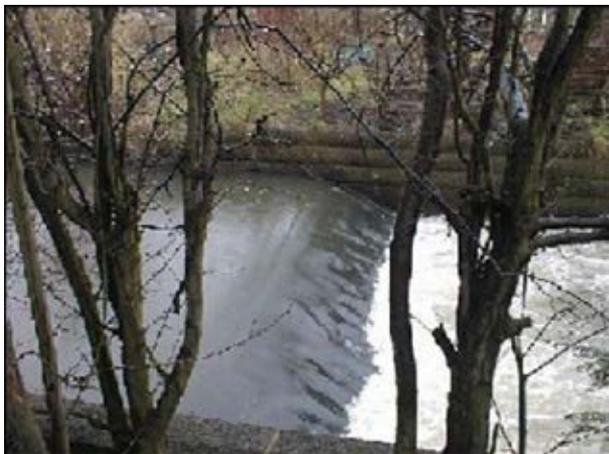
Sloping weir made from pre-cast concrete.

Figure 3.1.9.3a: Tidal Crane Barrier 8 viewed from right bank (Archive picture, not taken at time of survey)

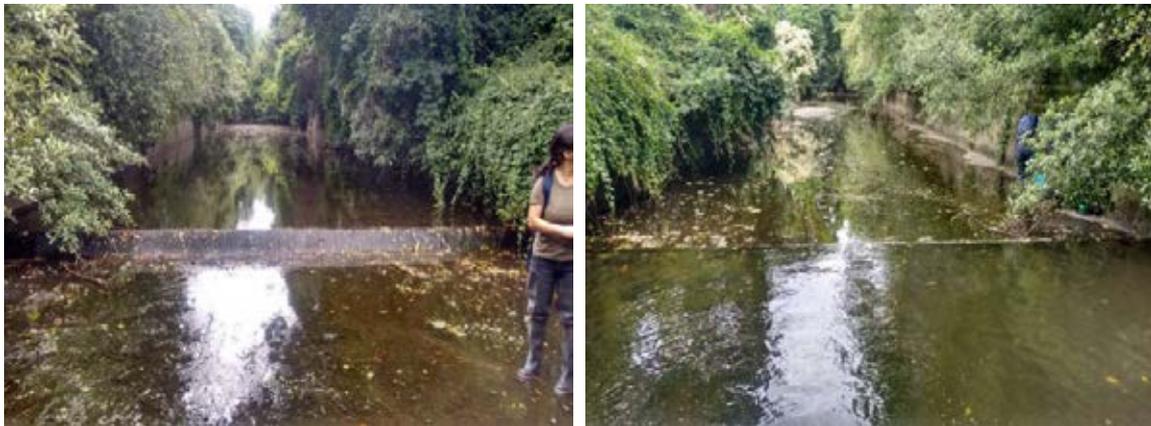
Small vertical weir made from pre-cast concrete

*Figure 3.1.10.3a (left): Twickenham Barrier 1 viewed from downstream*

*Figure 3.1.10.3b (right): Twickenham Barrier 1 viewed from upstream*

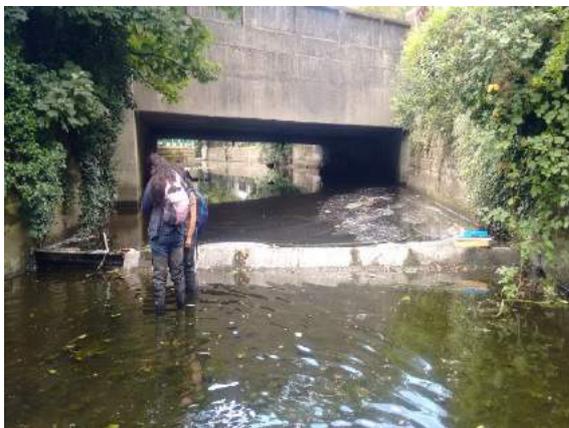
Small vertical weir made from pre-cast concrete. On the right bank, there is a broken section of the weir that has been repaired.

*Figure 3.1.14.3a (left): Twickenham Barrier 5 viewed from downstream*

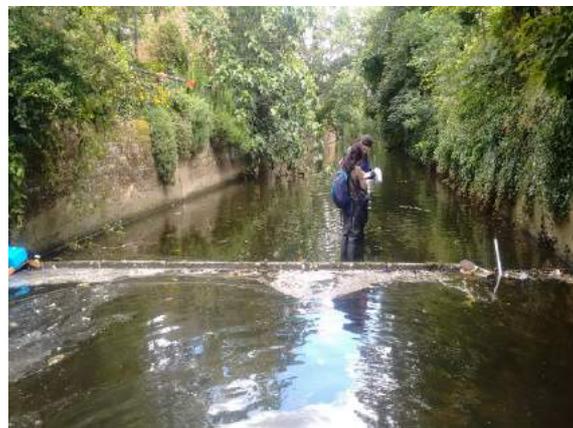
*Figure 3.1.14.3b (right): Twickenham Barrier 5 viewed from upstream*

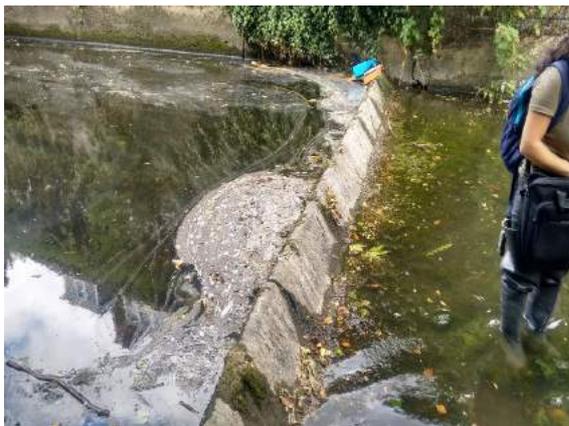
*Figure 3.1.14.3c: Twickenham Barrier 5 viewed along the crest from right bank*

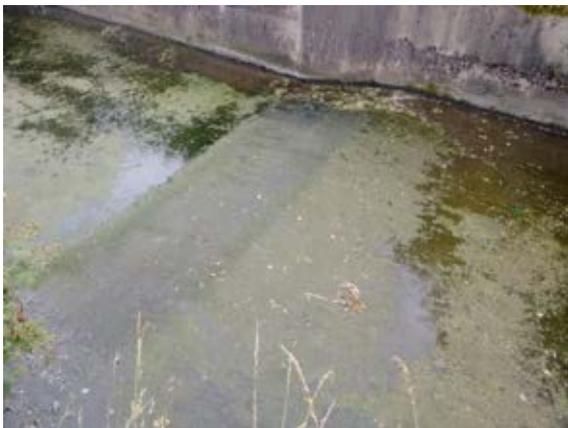
Sloping weir made from concrete (poured on site)

Figure 3.1.15.3a (left): Mereway Barrier 1 viewed from upstream at left bank

Flow conditions	Passability score	Reason/s
Coarse fish	Low	0	Water depth across slope; Gradient
	High	0.3	Gradient
Juvenile eels	Low	1	Climbing substrate present
	High	1	Climbing substrate present

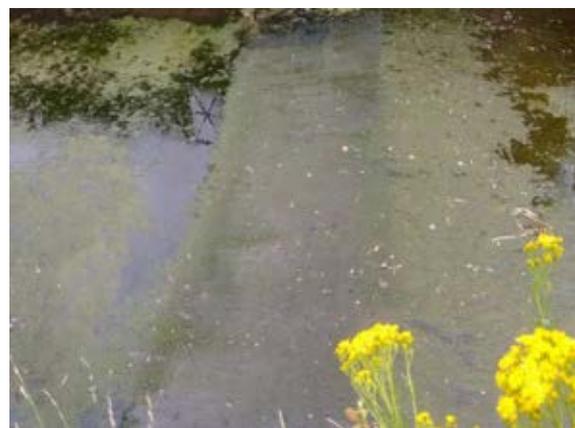
Figure 3.1.15.3b (right): Mereway Barrier 1 viewed along the crest from left bank

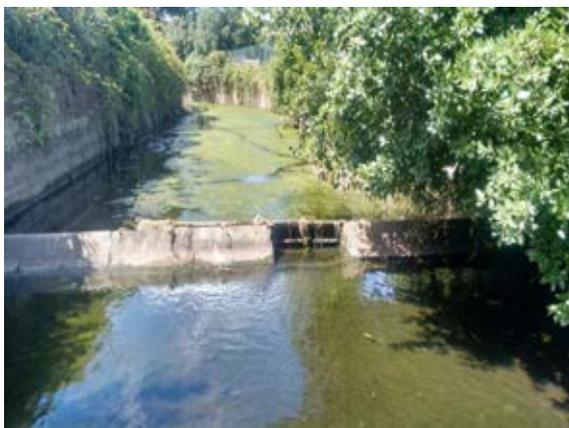
Small vertical weir made from pre-cast concrete. There was a notch in the centre of the weir but the missing section has been replaced.

Figure 3.1.16.3a: Mereway Barrier 2 viewed from downstream

Flow conditions	Passability score	Reason/s
Coarse fish	Low	0	Water depth at inlet; Hydraulic head
	High	0.6	Hydraulic head
Juvenile eels	Low	0	No climbing substrate; Water depth at inlet
	High	1	Should be sufficient water

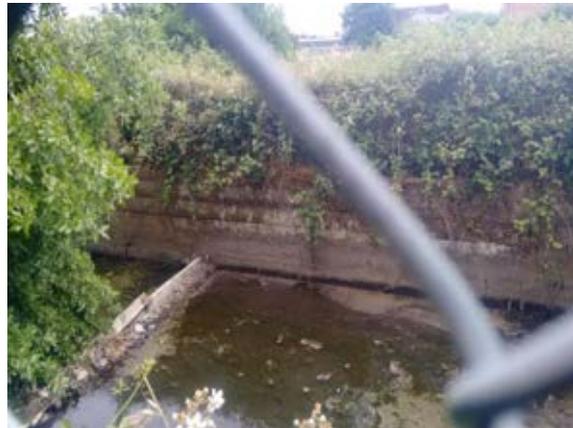
Figure 3.1.16.3b: Mereway Barrier 2 viewed from upstream at left bank

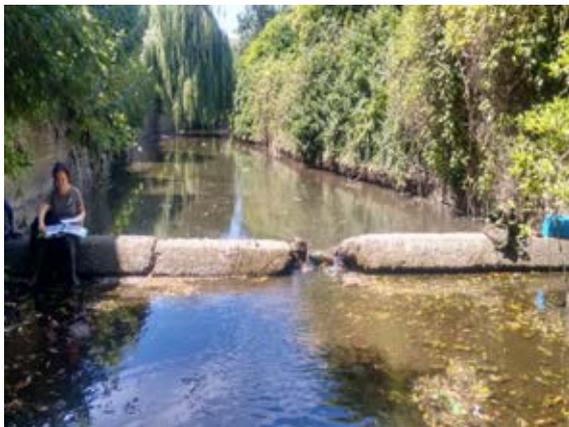
Small vertical weir made from pre-cast concrete. There was a notch in the centre of the weir but the notch has been blocked with two cement bags. There is some water flowing underneath the cement bags.

Figure 3.1.17.3a (left): Mereway Barrier 3 viewed from downstream

Flow conditions	Passability score	Reason/s
Coarse fish	Low	0	Water depth at inlet; Hydraulic head
	High	1	Should be sufficient water and reduced hydraulic head

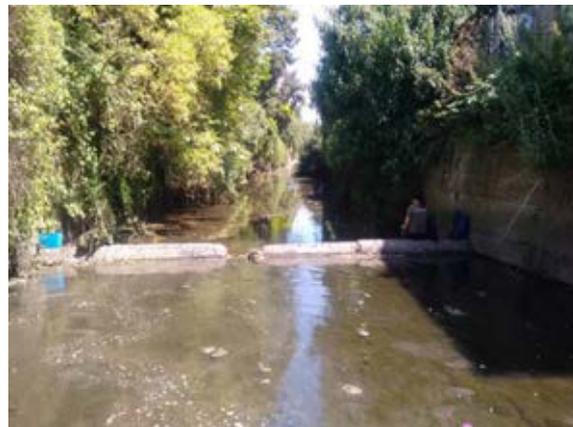
Figure 3.1.17.3b (right): Mereway Barrier 3 viewed from upstream

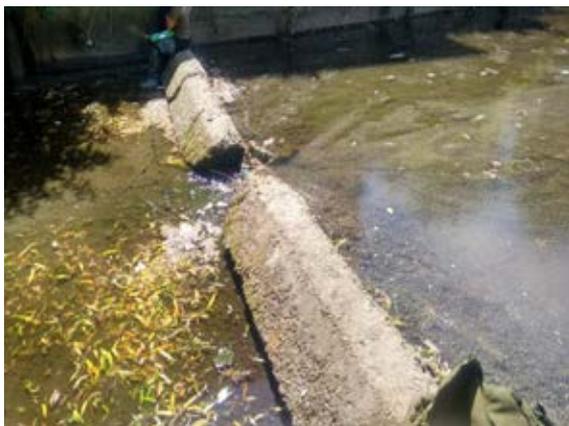
Figure 3.1.17.3c: Mereway Barrier 3 viewed along the crest from left bank

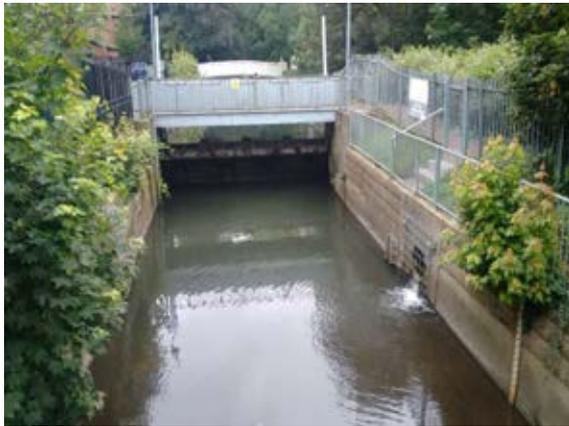
Large vertical tilting weir made from pre-cast concrete and metal. The structure is responsible for the flow split between the Lower Crane and Duke of Northumberland's River. Currently most of the Crane's flow is diverted down the DNR and it is this factor that is responsible for the areas of dry river bed and stagnating water found downstream on the lower Crane.

Figure 3.1.18.3a (left): Mereway Barrier 4 viewed from downstream

Flow conditions	Passability score	Reason/s
Coarse fish	Low	0	Water depth at inlet; Hydraulic head
	High	0	Hydraulic head
Juvenile eels	Low	0	No climbing substrate present; Water depth at inlet; Hydraulic head
	High	0	Hydraulic head

Flow conditions	Passability score	Reason/s
Coarse fish	Low	0	Water depth
	High	0.3	Damaging to DS migrants
Adult eels	Low	0	Water depth
	High	0.3	Damaging to DS migrants

The only option available is to replace the structure with one that still permits the regulation of flows, yet does not have a variable hydraulic head. If this was possible, and if the new structure allowed a greater volume of water to be diverted down the Lower Crane, a lariner fish pass could be installed to allow fish passage from the lower Crane to the middle reaches of the river.

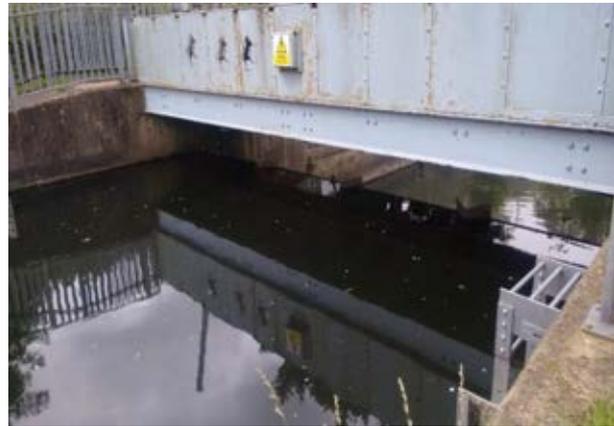
Figure 3.1.18.3b (right): Mereway Barrier 4 viewed from upstream at right bank

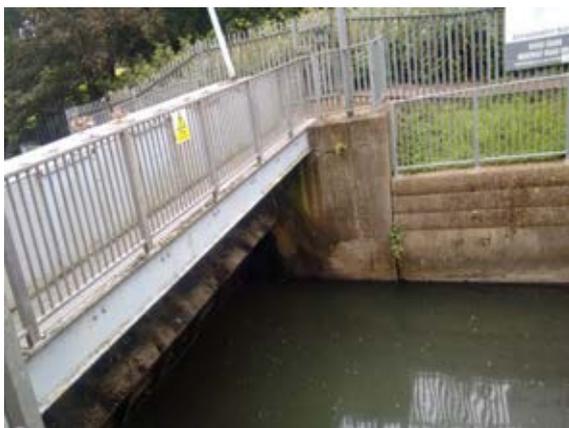
Figure 3.1.18.3c: Mereway Barrier 4 viewed along the crest from right bank

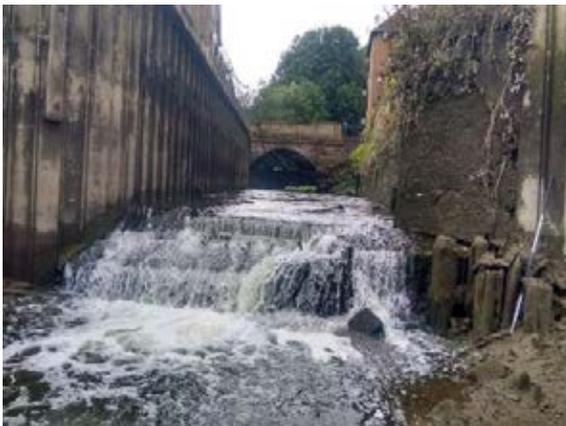
Concrete stepped weir consisting of 2/3 steps of poured concrete at the Duke of Northumberland/Thames confluence. This barrier is completely submerged at high tide.

*Figure 3.2.1.3a (left): Looking upstream from Thames at the stepped barrier*

Flow conditions	Passability score	Reason/s
Coarse fish	Low	0	Depth of water at the inlet, step water depth and height of step.
	High	1	Barrier submerged at high tide
Juvenile eels	Low	1	Climbing substrate present
	High	1	Barrier submerged at high tide

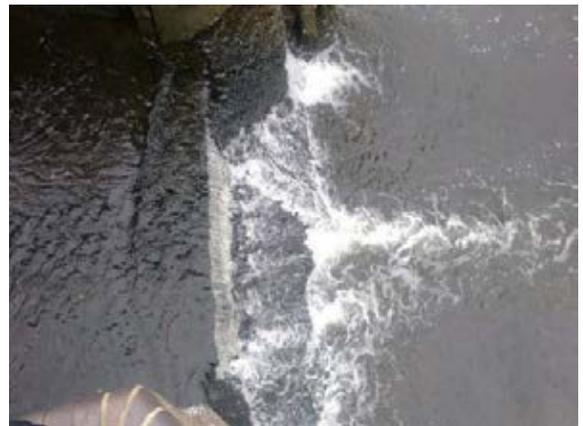
*Figure 3.2.1.3b (right): Birds eye view at the barrier*

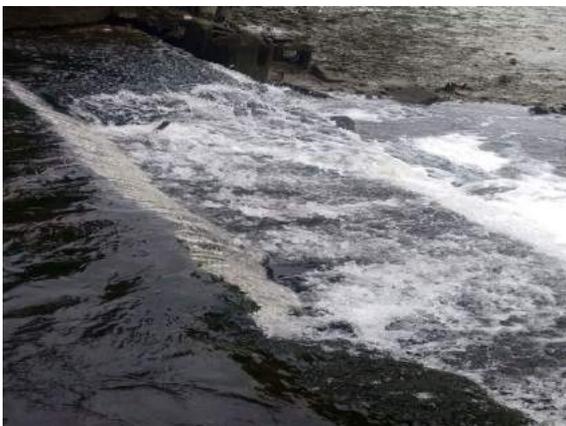
*Figure 3.2.1.3c: View from right bank of the stpped barrier*

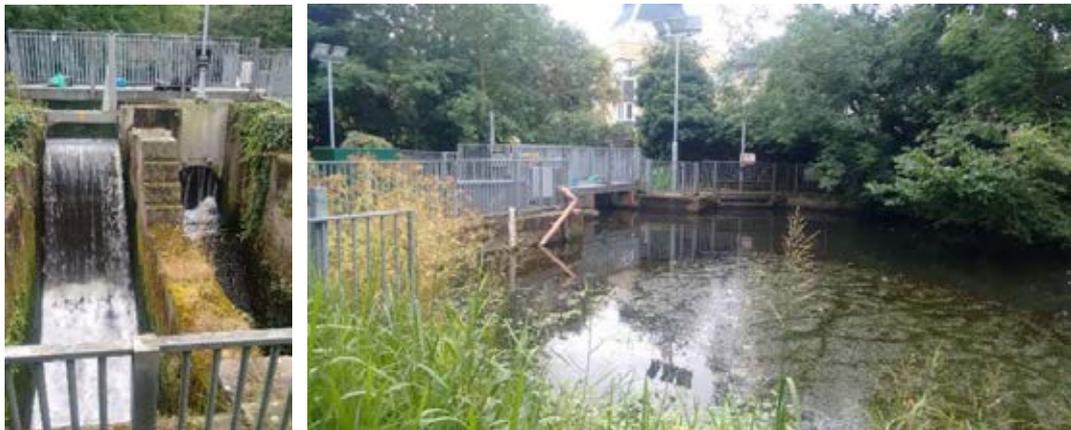
Steep vertical weir with a large hydraulic head made from pre-cast concrete and steel. The adjacent undershot sluice was not assessed as it was currently closed and does not present a potential pathway for fish migration. At high tide the water level rises by approximately 3m.

Figure 3.2.3.3a (left): Kids Mill Sluice front view from downstream. The undershot sluice not assessed is on the left bank

Figure 3.2.3.3b (right): Looking upstream at left bank from Kids Mill Sluice which is directly under the metal bridge as seen in the photo.

Flow conditions	Passability score	Reason/s
Coarse fish	Low	0	Hydraulic head
	High	0	Hydraulic head
Juvenile eels	Low	1	Presence of eel pass
	High	1	Presence of eel pass

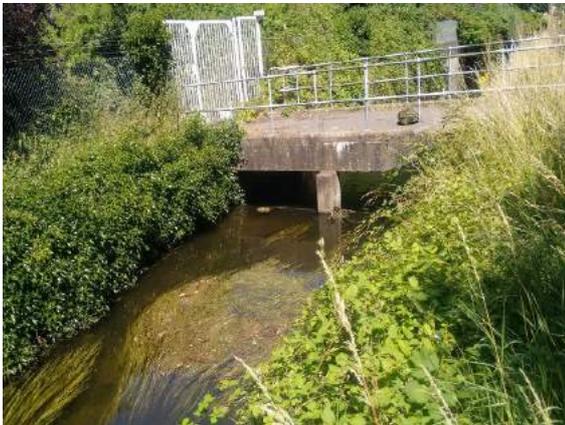
Small vertical weir made from steel which is under a small foot bridge. It divides into two channels due to the presence of a concrete wall under the footbridge.

*Figure 3.2.4.3a (left): Small vertical weir directly under the footbridge from right bank.*

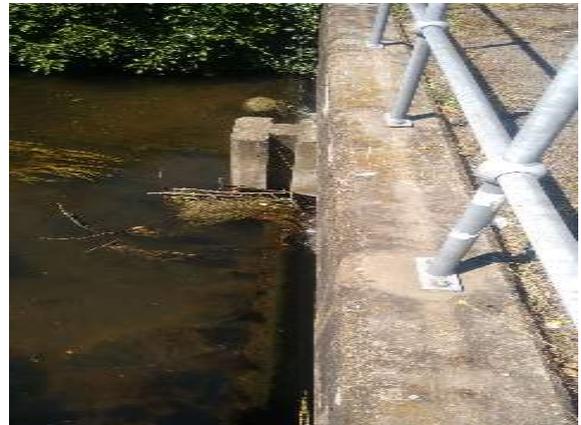
*Figure 3.2.4.3b (right): Steel vertical weir under footbridge from right bank.*

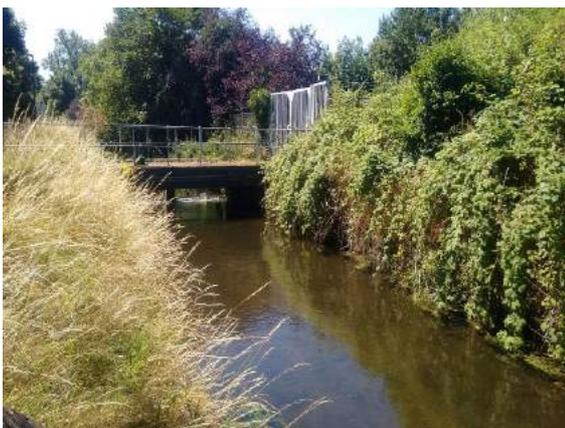
*Figure 3.2.4.3c: Photo taken at right bank looking upstream. The concrete wall under the footbridge separated this barrier to be assessed in two transversal sections.*

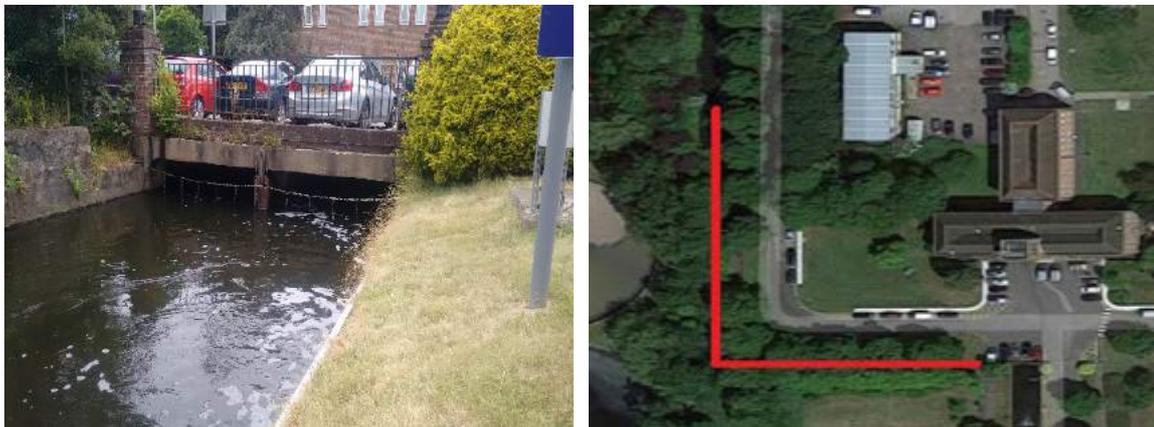
Culvert of approximately 135m in length located in Mogden Sewage Works site. The depth of water flowing through culvert is estimated at >10cm and flow of water is estimated at less than 1m/s.

Figure 3.2.5.3a (left): Entrance of Mogden Sewage Works culvert from upstream

Figure 3.2.5.3b (right): Length of culvert at Mogden Sewage Treatment Works

Flow conditions	Passability score	Reason/s
Coarse fish	Low	0.6	Length of culvert may present a barrier
	High	0.6	Length of culvert may present a barrier
Juvenile eels	Low	0.6	Length of culvert may present a barrier
	High	0.6	Length of culvert may present a barrier

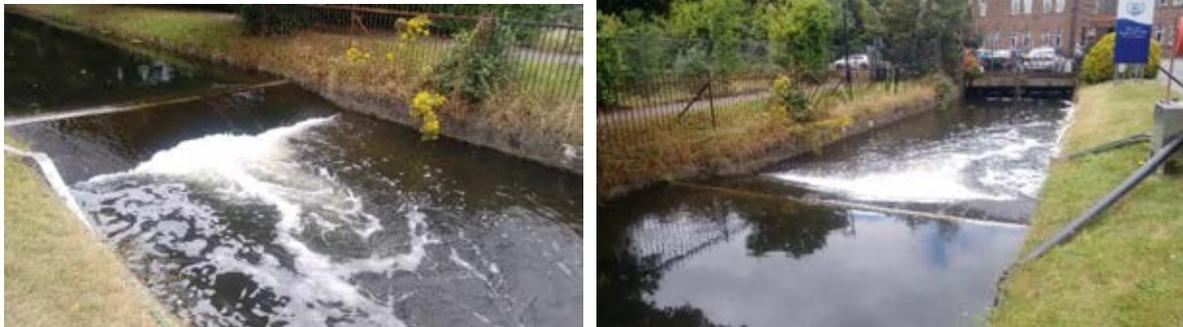
**3.2.6.2 Brief description:** Sloping weir made from poured concrete and steel at the Mogden Treatment Sewage Works. Used as Environment Agency Telemetry Station.

*Figure 3.2.6.3a (left): Mogden Sewage Works Barrier 3 viewed from downstream at right bank*

*Figure 3.2.6.3b (right): Mogden Sewage Works Barrier 3 viewed from upstream at right bank*

The structure causes excessive siltation upstream and prevents the migration of sediments.

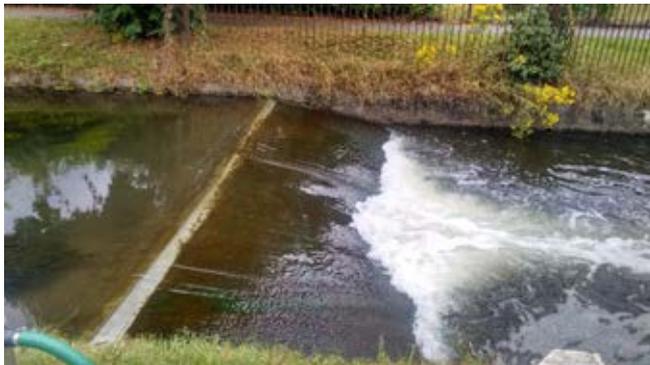
*Figure 3.2.6.3.c: Mogden Sewage Works Barrier 3 viewed along the crest at right bank*

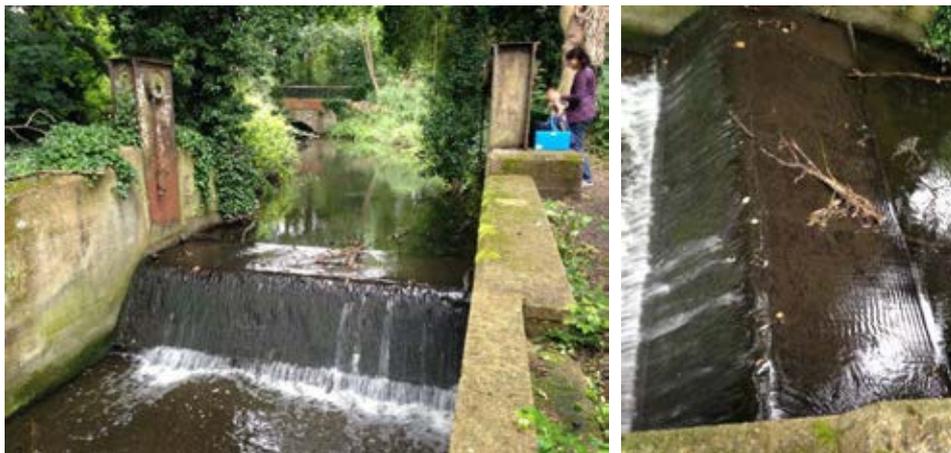
Vertical weir made from pre-cast concrete with a large hydraulic head and a small lip at the foot of the structure. There is a long concrete bed in the run-up to this barrier and a small lip further downstream. Note that this barrier is by-passable by the main river therefore in practice is completely passable.

*Figure 3.3.1.3a (left): Mill Road barrier viewed from downstream at left bank.*

*Figure 3.3.1.3b (right): Mill Road barrier viewed along the crest at left bank. This vertical barrier has a small lip at the foot of the structure.*

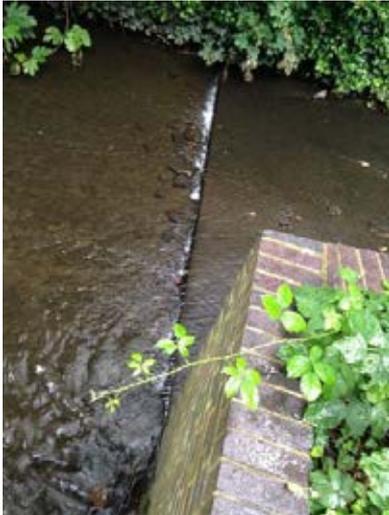
Figure 3.3.1.3.c: Small lip downstream from structure as viewed from left bank.

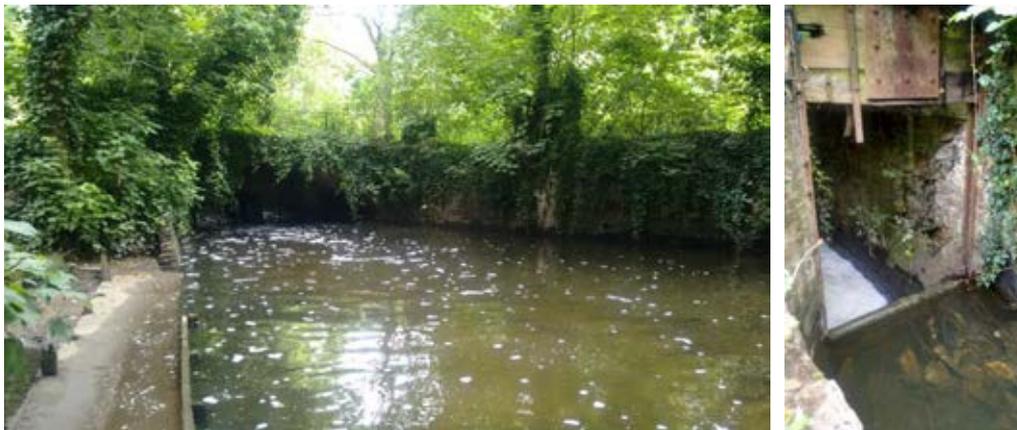
This barrier is in two sections: (1) ~10m culvert in a semi-circular shape made from brick, followed by (2) a vertical overshoot sluice made from brick, wood and metal. The river channel is narrowed upstream of the barrier making the water over the sluice especially fast flowing and turbid.

*Figure 3.3.3.3a (left): Brazil Mill Woods Barrier 1 viewed from downstream. The culvert entrance to the barrier is visible at the right bank.*

*Figure 3.3.3.3b (right): Brazil Mill Woods Barrier 1 viewed from upstream at left bank, showing the water flowing over the vertical overshoot sluice*

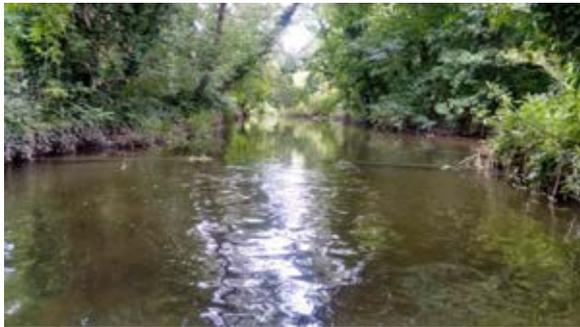
Vertical barrier made from pre-cast concrete and timber in a V-shape with three transversal sections – there are two wooden planks at the left and right banks, with a notch in the centre. The entire barrier is drowned at the time of survey.

Figure 3.3.4.3a (left): Brazil Mill Woods Barrier 2 viewed from downstream

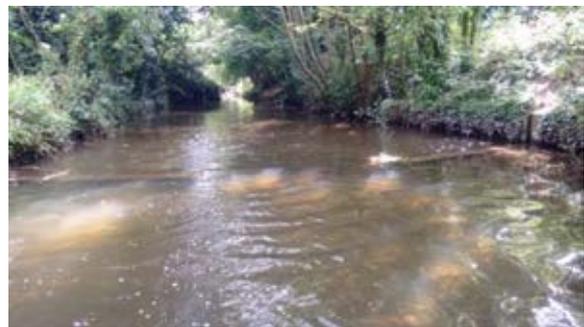
Figure 3.3.4.3b (right): Brazil Mill Woods Barrier 2 viewed from upstream

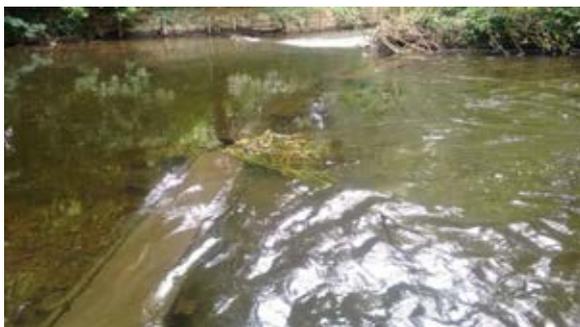
Figure 3.3.4.3c: Brazil Mill Woods Barrier 2 viewed along the crest from right bank

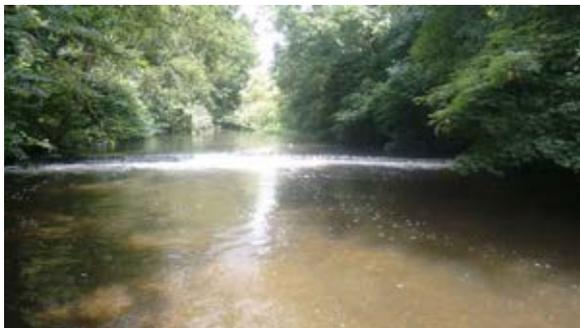
Figure 3.3.5.3a (left): Brazil Mill Woods Barrier 3 viewed from downstream.

Flow conditions	Passability score	Reason/s
Coarse fish	Low	0.3	Hydraulic head
	High	0.6	Hydraulic head
Juvenile eels	Low	1	Climbing substrate present
	High	1	Climbing substrate present

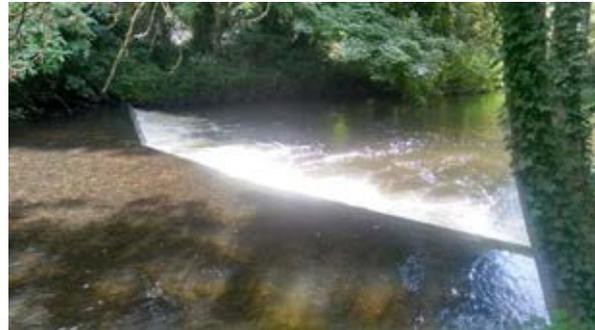
Figure 3.3.5.3b (right): Brazil Mill Woods Barrier 3 viewed from upstream at right bank

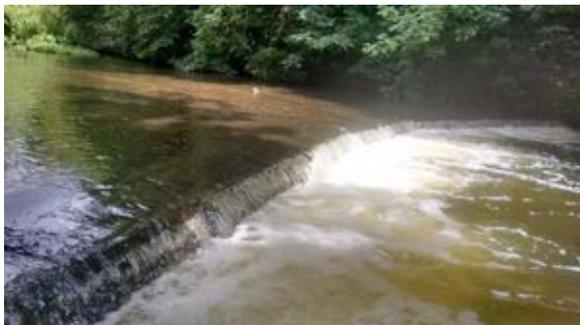
Figure 3.3.5.3c: Brazil Mill Woods Barrier 3 viewed along the crest from right bank

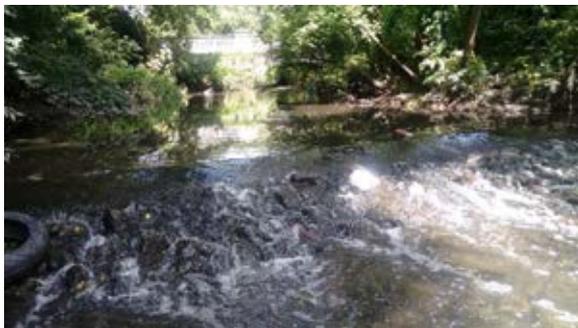
*Figure 3.3.6.3a (left): Crane Bank Barrier 1 viewed from downstream at right bank*

Flow conditions	Passability score	Reason/s
Coarse fish	Low	0	Depth of water across slope
	High	0.6	Effective length and gradient of slope

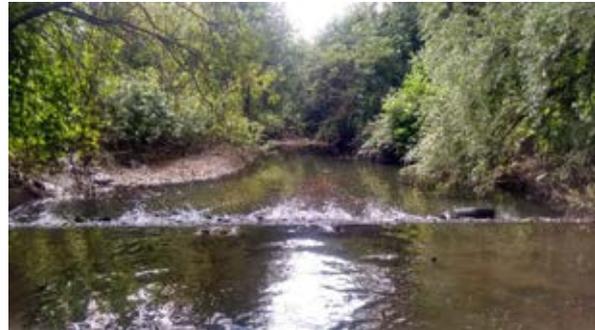
*Figure 3.3.6.3b (right): Crane Bank Barrier 1 viewed from upstream*

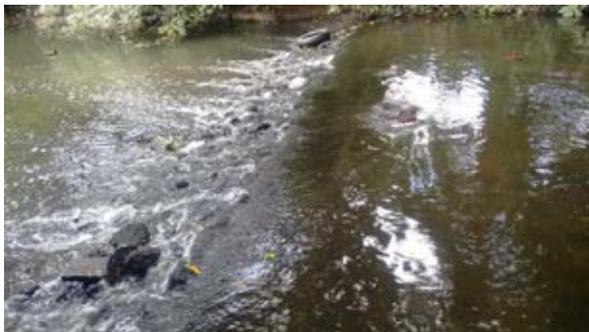
*Figure 3.3.6.3c: Crane Bank Barrier 1 viewed along the crest from left bank*

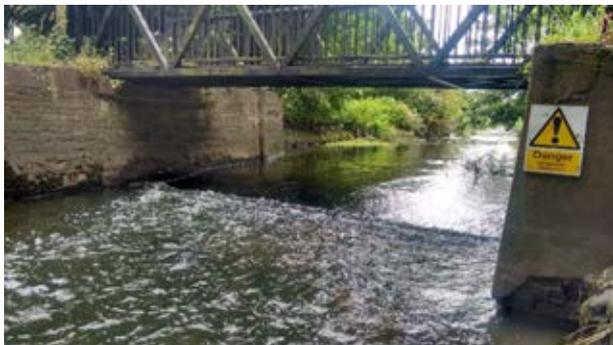
Figure 3.3.7.3a (left): Cranford Park Barrier 1 viewed from downstream at left bank

Flow conditions	Passability score	Reason/s
Coarse fish	Low	0	Depth of water across slope; high velocity
	High	0.6	Effective length of slope

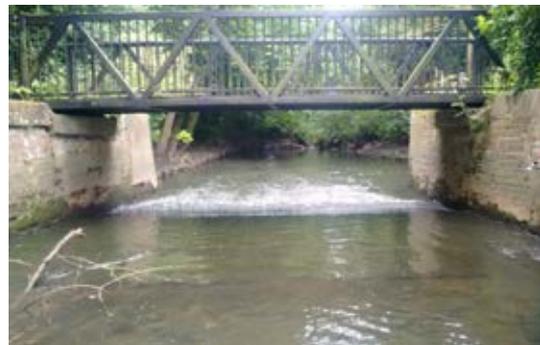
Figure 3.3.7.3b (right): Cranford Park Barrier 1 viewed from upstream

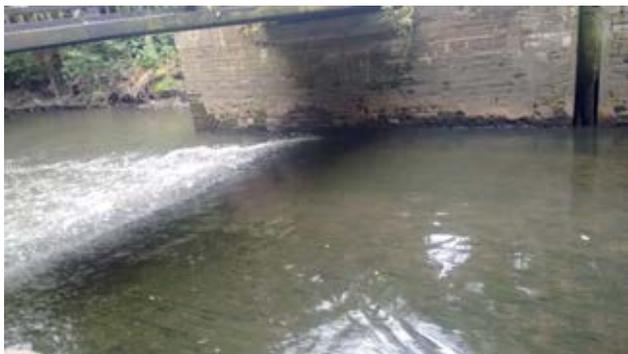
Figure 3.3.7.3c: Cranford Park Barrier 1 viewed along the crest from left bank

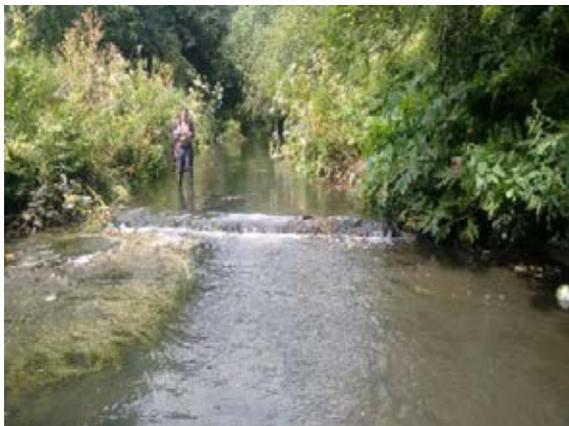
Vertical weir made from concrete poured-on-site. The barrier is notched at right bank.

Figure 3.3.9.3.a (left): Hillingdon Barrier 1 viewed from downstream.

Flow conditions	Passability score	Reason/s
Coarse fish	Low	0.6	Water depth; hydraulic head
	High	1	Should be sufficient depth and hydraulic head would reduce
Juvenile eels	Low	1	Climbing substrate present
	High	1	Climbing substrate present

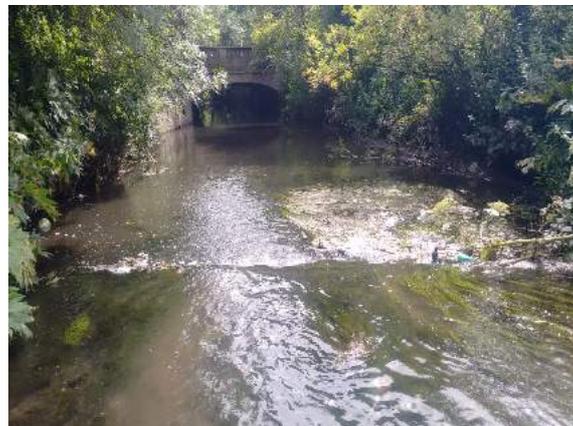
Figure 3.3.9.3b (right): Hillingdon Barrier 1 viewed from upstream

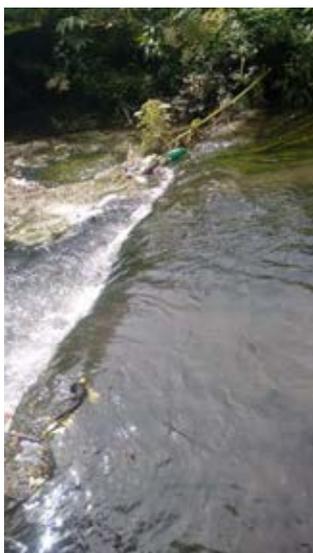
Figure 3.3.9.3c: Hillingdon Barrier 1 viewed along the crest from left bank

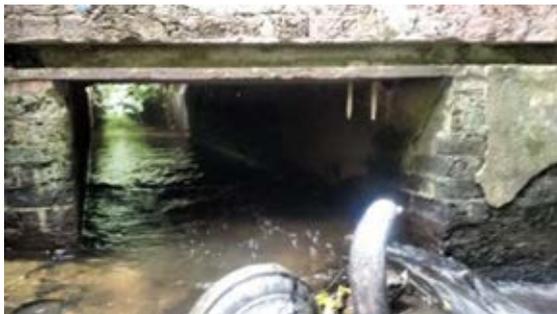
Figure 3.4.2.3c: The chute on the left bank just before the vertical drop where the course of the river changes.

Flow conditions	Passability score	Reason/s
Coarse fish	Low	0	Large hydraulic head at the vertical drop

- *Priority for action:* Low. This would provide upstream passage into the Mill Stream from the Crane so this does not ease fish passage on the Crane.
- *Consideration of options*  
None recommended. Easing fish passage is not advantageous in this location as it would provide access to the millstream from the River Crane. The upper millstream is impeded by another obstruction that requires easing in order to provide access back to the main river.

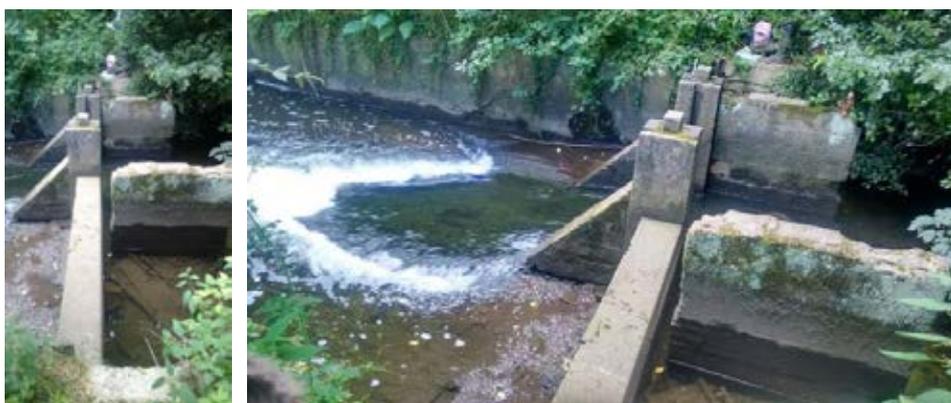
Figure 3.4.3.3c (left): Photo of the breeze blocks behind the barrier shown from left bank

Figure 3.4.3.3d (right): Mill Stream Barrier 3 viewed from upstream at left bank. The strong velocity associated with the sloping part of the weir can be seen at the foot of the slope.

Flow conditions	Passability score	Reason/s
Coarse fish	Low	0	Velocity of water and gradient
	High	0	Velocity of water would increase
Juvenile eels	Low	0	No climbing substrate
	High	0	No climbing substrate

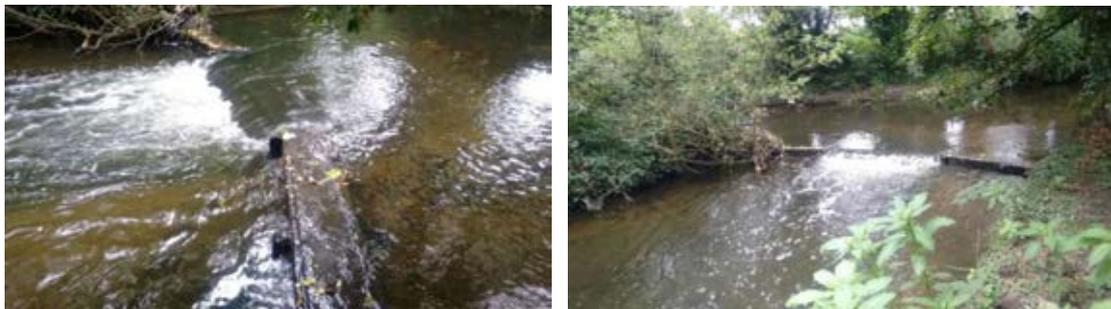
Vertical weir barrier in the middle of the river channel. Made from timber and pre-cast concrete. 100% of channel flow is going through the centre of the barrier.

*Figure 3.4.4.3a (left): Mill Stream Barrier 4 viewed along the crest from left bank*

*Figure 3.4.4.3b (right): Mill Stream Barrier 4 viewed from downstream at left bank*

Flow conditions	Passability score	Reason/s
Coarse fish	Low	0.3	Medium level turbulence and standing wave
	High	1	Medium level turbulence and standing wave would lessen under high flows
Juvenile eels	Low	1	Climbing substrate present
	High	1	Climbing substrate present

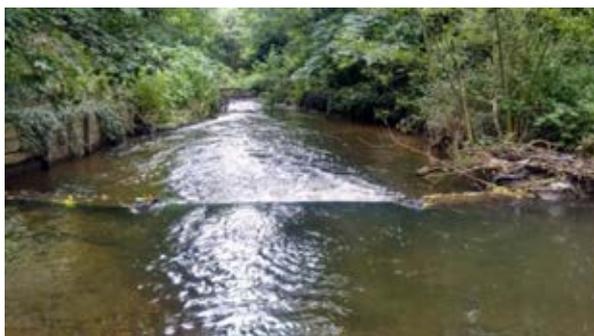
*Figure 3.4.4.3c: Mill Stream Barrier 4 viewed from upstream*

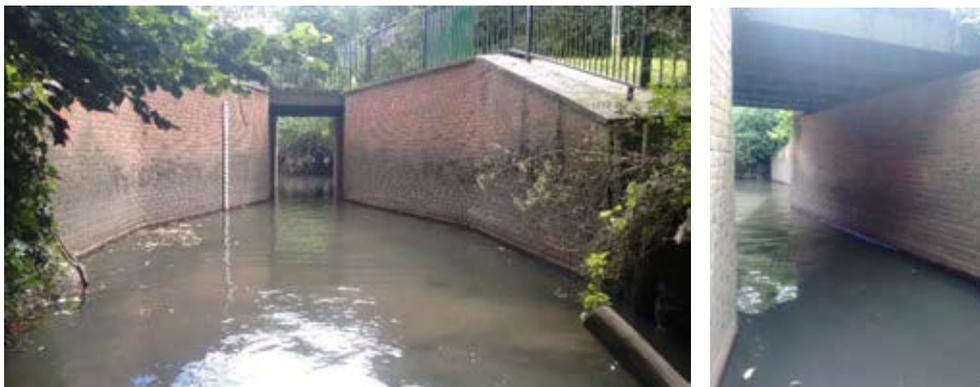
Hydrobrake made from cast-in-place concrete. The hydrobrake is short in length but narrows the river channel, thus increasing water velocities at the centre of the structure.

Figure 3.5.1.3a (left): Ten Acre Woods Barrier 1 viewed from downstream.

Figure 3.5.1.3b (right): Ten Acre Woods Barrier 1 viewed from upstream through the centre of the hydrobrake

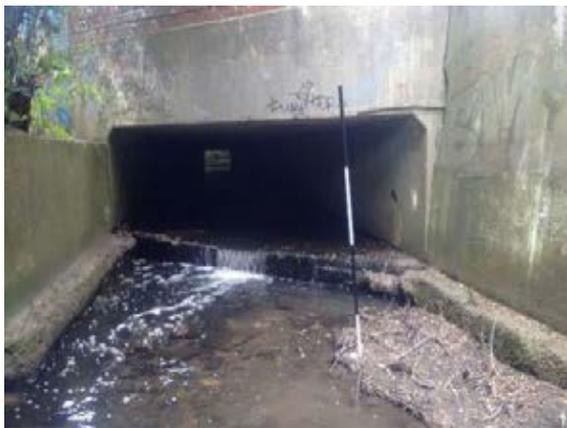
Long slightly sloping culvert of 186m made from pre-cast concrete, followed by a small vertical drop. The vertical drop spans the channel at an angle, thus increasing the length of its crest, spreading flows over a wider area than the width of the river channel.

*Figure 3.6.2.3a (left): Gutteridge Woods Culvert viewed from downstream. There is a vertical drop at the outlet of the culvert.*

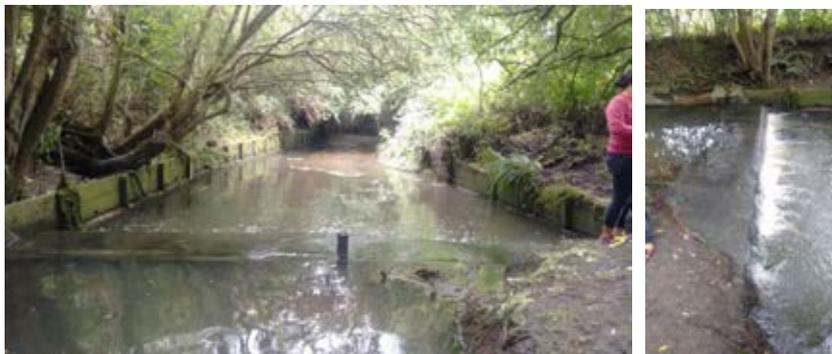
Small vertical weir made from pre-cast concrete with a small concrete sill.

Figure 3.6.3.3a (left): Stafford Road Barrier 1 viewed from upstream

Figure 3.6.3.3b (right): Stafford Road Barrier 1 viewed along the crest from right bank

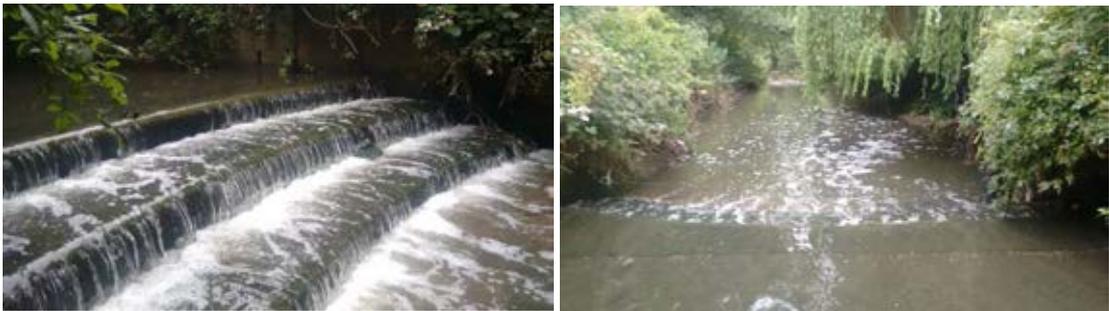
Large stepped weir consisting of 3 steps spanning the entire length of the channel in a curved in a semi-circular shape. The barrier is made from pre-cast concrete. Upstream from the barrier consists of a concreted bed before the channel splits into two and gets culverted. The depth of water over the concrete channel is very shallow.

*Figure 3.6.4.3a (left): Stafford Road Barrier 2 viewed along the crest at right bank*

*Figure 3.6.4.3b (right): Stafford Road Barrier 2 viewed from upstream*

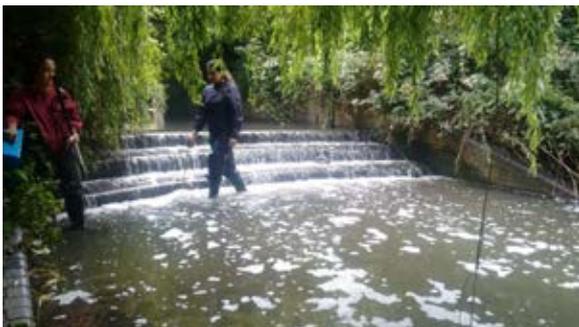
*Figure 6.4.3c: Stafford Road Barrier 2 viewed from downstream*

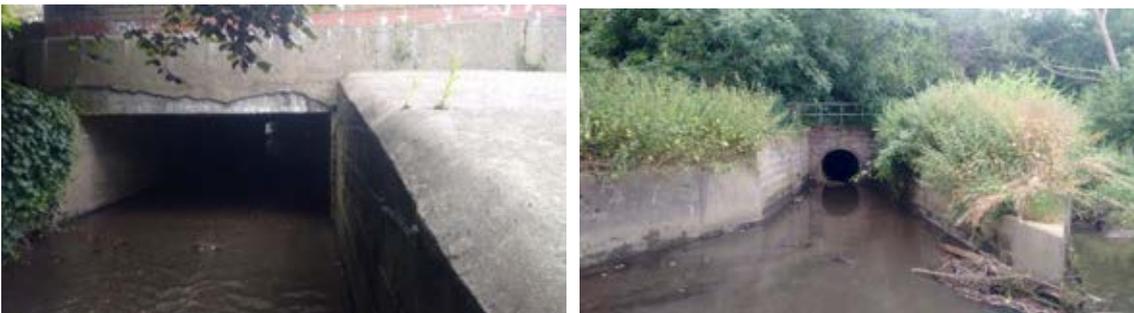
*Figure 3.6.5.3c (left): Viewed from upstream, the left channel continues and opens up on the other side of the bridge/road.*

*Figure 3.6.5.3d (right): Viewed from upstream, the right channel diverted into pipes opens up on the other side of the bridge/road as single pathways (1<sup>st</sup> pipe view)*

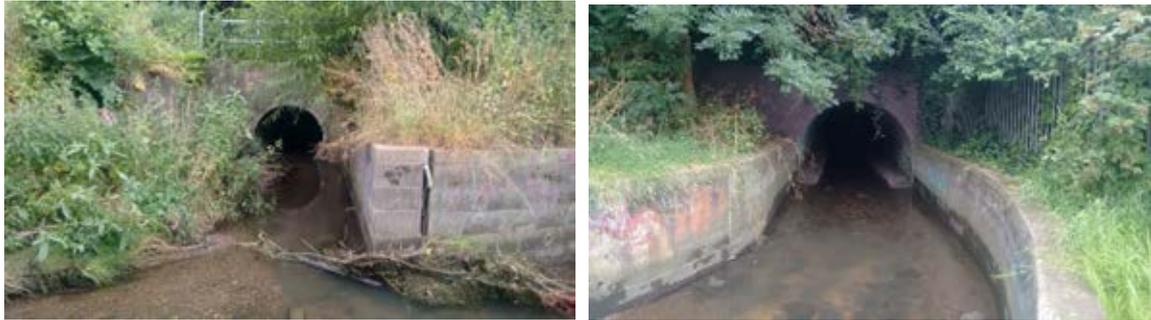
Figure 3.6.5.3e (left): Viewed from upstream, the right channel diverted into pipes opens up on the other side of the bridge/road as single pathways (2<sup>nd</sup> pipe view)

Figure 3.6.5.3f (right): Viewed from upstream, the left channel emerges on the other side of the bridge/road.

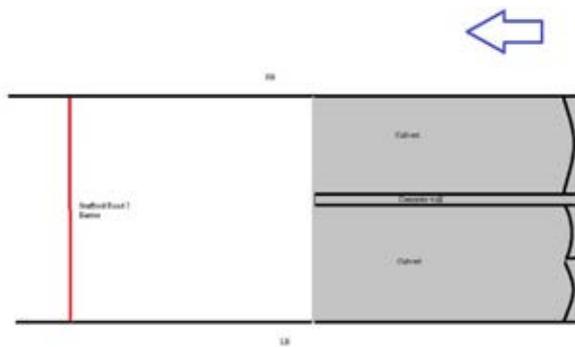
Figure 6.6.4a: Field sketch of culvert. The two paths are shown with two further opening from the split at left bank.

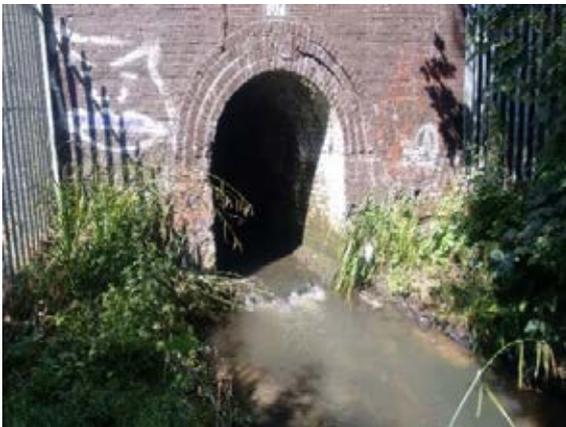
A culvert made from masonry with a small vertical drop at the entrance.

Figure 3.6.7.3a (left): Viewed from downstream at right bank, Roxbourne Park Culvert 2 has a small vertical drop at the entrance

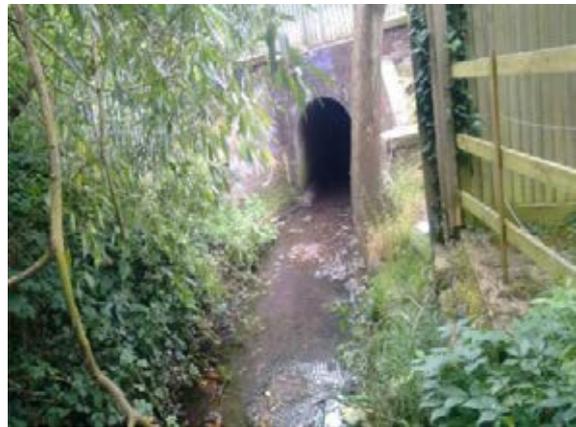
Figure 3.6.7.3b (right): Viewed from upstream, the culvert emerges the other side of the road

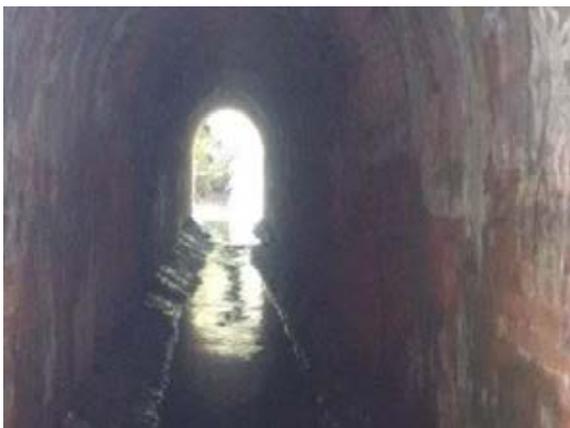
Figure 3.6.7.3c (left): Roxbourne Park Culvert 2 viewed from the inside

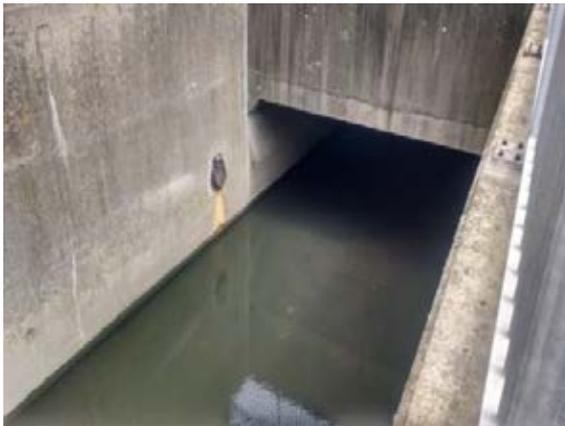
This culvert is 559m in length. It consists of an underground section that passes beneath the A40, an open section that flows adjacent to the A40 and an underground section that flows past the Polish War Memorial in the London Borough of Hillingdon. The river in this location is extremely shallow due to the widened nature of the culvert.

Figure 3.7.1.3a (left): Polish War Memorial Culvert 1 viewed from downstream

- *Priority for action:* Low
- *Consideration of options:*  
Currently water quality is extremely poor in the Yeading Brook East and encouraging fish passage to this part of the catchment is not recommended. If water quality improves in future years, the culvert could be made passable via a two staged channel. A two staged channel would increase the depth of water at the centre of the river and provide areas for marginal habitat to establish.

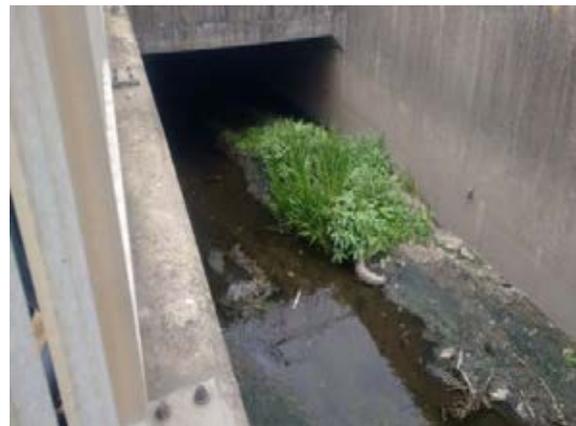
Figure 3.7.1.3b (right): Polish War Memorial Culvert 1 viewed from upstream
