# An Assessment of Barriers to Fish Passage in the Crane River Catchment

June 2016

*Crane Valley Partnership*

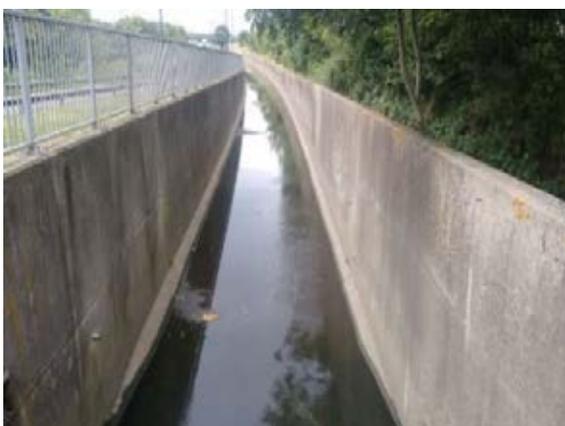
Figure 3.7.1.3c: Downstream of the underground culvert is a long, straight, concreted section of the river

The obstructions recorded in this report are not the only features preventing fish passage in the Yeading Brook East. In many locations where the river flows through concrete channels, water depths were observed to be insufficient to allow fish passage. One such location is the Polish War Memorial culvert (990019), located just upstream of the river's confluence with the Yeading Brook, and running adjacent to the A40. The river is placed in an open culvert that does not provide the depths of water required for fish passage. Similar reaches of river can be found throughout the Yeading Brook East and as a result of this, coupled with poor water quality, it is not recommended that fish passage is encouraged to this part of the catchment.

A sensible option would be to improve biological water filtration at the lower end of the river. The Polish War Memorial culvert could be planted with reeds or turned into a sustainable urban drainage scheme in order to treat polluted water in before it reaches The Yeading Brook. This would also have an impact on river levels, possibly increasing them to an extent where fish passage would be possible. Extensive habitat improvement works throughout the Yeading Brook East are required to make it a suitable home for coarse fish and eel populations.

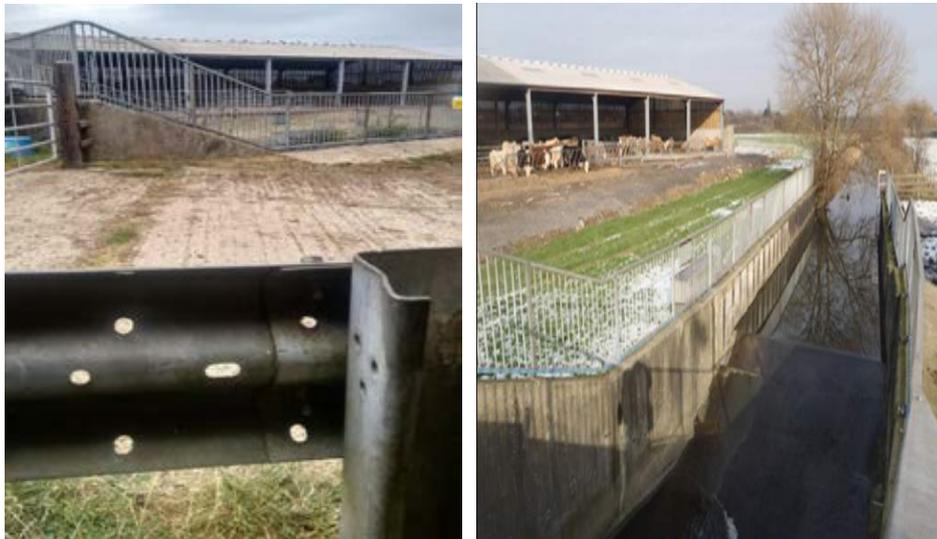
Sloping weir made of pre-cast concrete. Note that we were unable to access this barrier as it is located on private property.

Figure 3.7.2.3a (left): Polish War Memorial Barrier 2 viewed from the road at left bank (unable to see barrier)

Figure 3.7.2.4b (right): Polish War Memorial Barrier 2 viewed from downstream

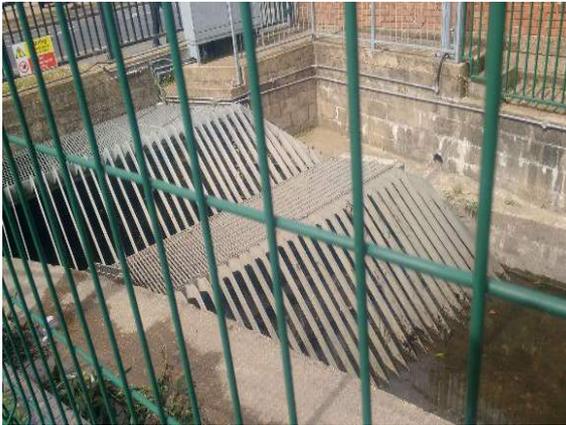
Field End Screen, assessed as vertical weir made from pre-cast concrete. Primarily used to collect debris and placed immediately before a culvert.

Figure 3.7.4.3a (left): Field End Screen viewed from right bank. The screen has a two-stage screen arrangement.

- *Priority for action:* Low
- *Consideration of options:*  
None recommended. Limited options available.

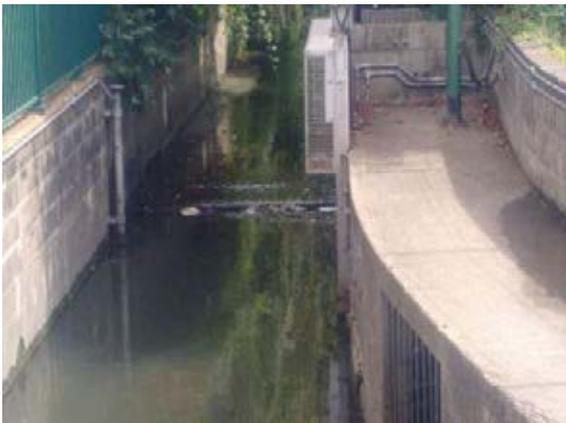
Figure 3.7.4.3c: The vertical weir at Field End Screen viewed from downstream

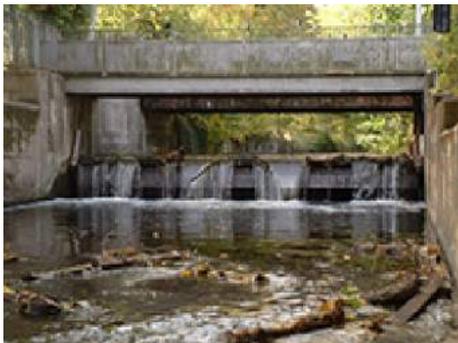
Before

Useful case studies already exist in the Crane Catchment where barrier removal projects have been completed. One such example is the former Mill Road Weir, located in Crane Park, Twickenham (TQ 14264 72867). The structure once played an essential role in retaining water upstream in order to power a watermill that has long since disappeared from the local landscape. The head retaining structure has now been removed and the result is an attractive, fast-flowing reach of river.
