Lower Crane Restoration Pilot Project Report

River Crane Smarter Water Catchments Project

February 2023

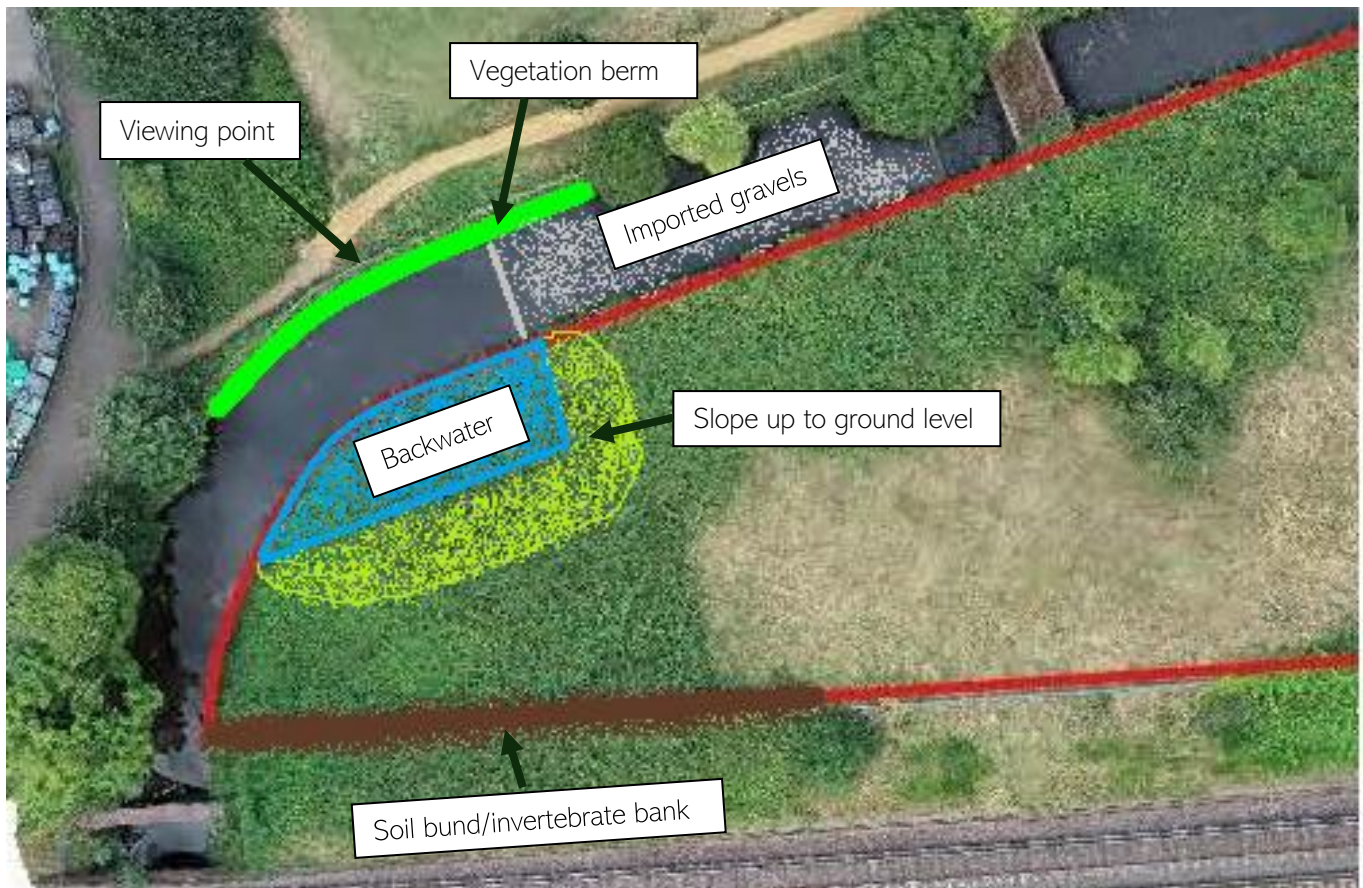
Figure 3.2: Aerial image of restoration site with key design features indicated.

Backwater: Approximately 18.1m of concrete removed along the length of the channel, with a maximum 6m wide area of bank removed for the creation of a backwater habitat (dug to the same depth as the existing riverbed and a minimum 4m width at the upstream end of the backwater habitat).

Berm design: 30m rock roll berm back filled with a mixture of imported and site won clay/loam soil and material and covered in 2m wide coir pallets tethered to rock rolls. The berm was planted with yellow iris, marsh marigold, purple loosestrife, lesser pond sedge, soft rush and hemp agrimony.

Gravels: 20 tonnes of gravels graded 20-60mm were spread across an approximate 20m (L) x 8m (W) x ~0.075m (depth) to create a more natural bed habitat.

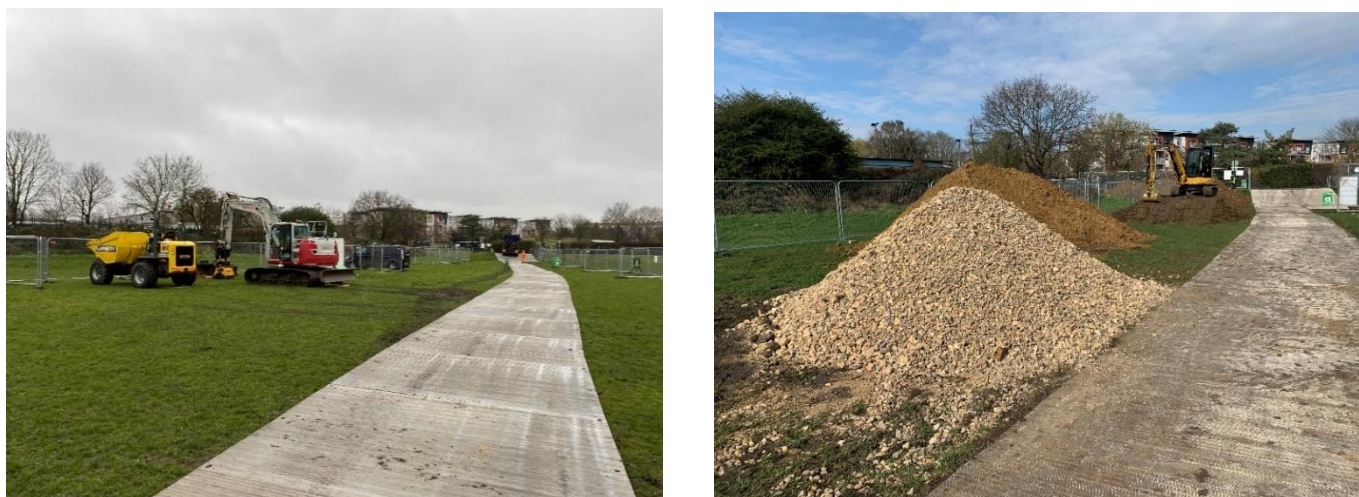
Although in principle, a larger restoration project would have likely been better value in terms of increasing the proportion of the overall cost spent on restoration .e.g. creating a longer berm, addition of larger volumes of gravel substrates, or removal of a longer section of the concrete bank, the choice was made instead to pay the premium involved in having a smaller trial. This in turn maximised the benefits of this project in terms of learning from the techniques employed and informing further restoration works at this site as well as future projects within the catchment.

Figure 4.2: Temporary road and construction site built for the duration of the restoration project. Left image credit: ©Wild Future.

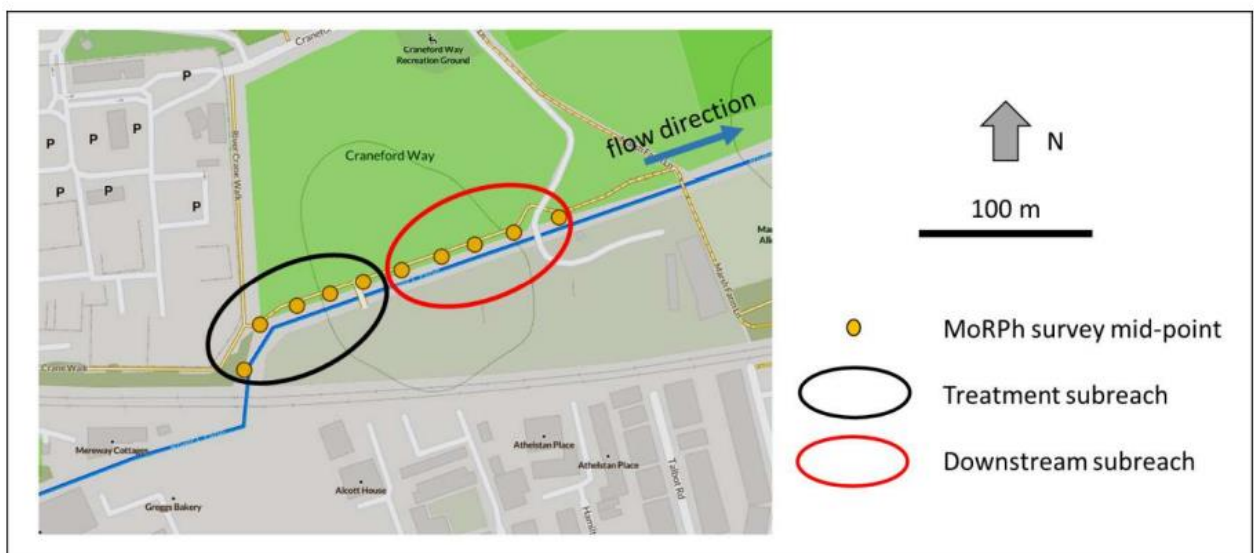
Figure 5.3: 'Treatment' and 'Downstream' subreaches and MoRPh survey mid-points at Craneford Fields.

Results of the RCA show that the restoration practices at the lower Crane restoration site have resulted in an increase of one class in the Final River Condition Assessment from Poor in the downstream reach to Fairly Poor in the 'Treatment' reach. For further details please see full report.
